The Arcade Room

Restaureringen af Jomfruklosteret

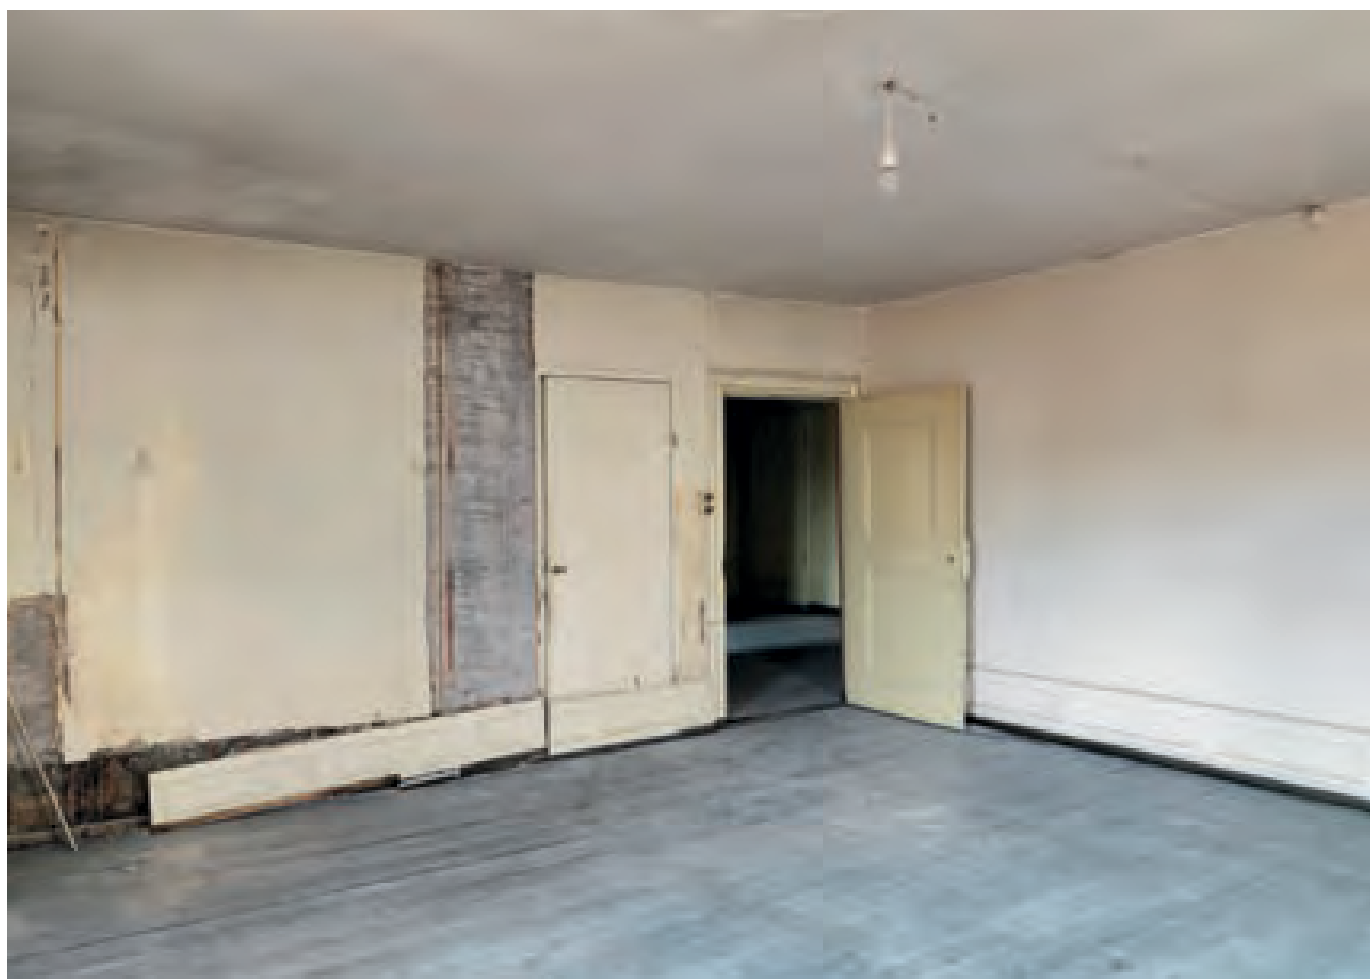
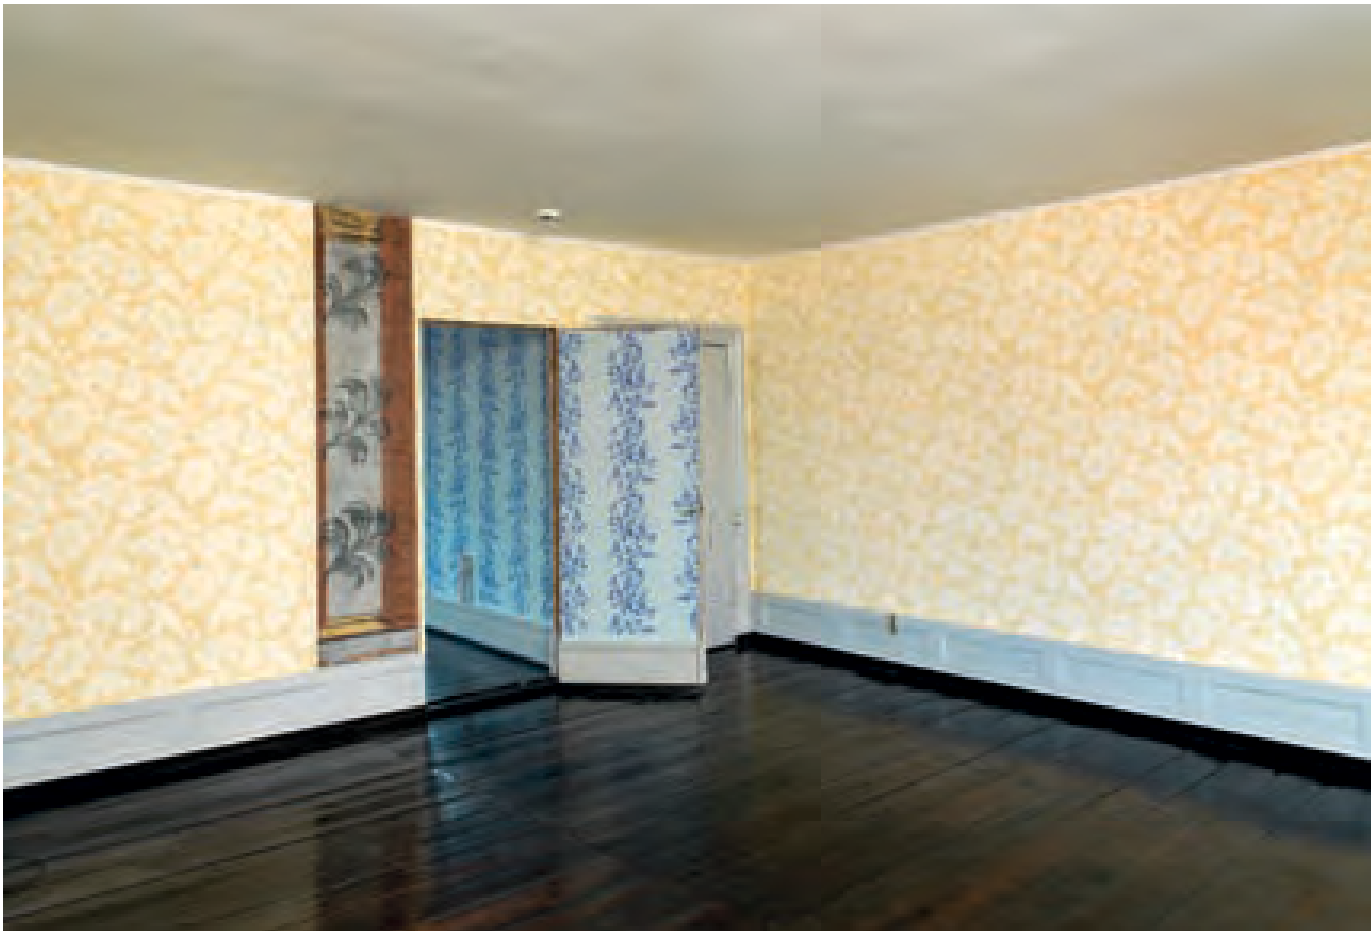
Rum 208 før og efter restaureringen. Det senere så beskedne rum var dekoreret med et mønster i stor skala, før der blev sat lærred op i 1770'erne.

*Room 208 before and after the restoration. The later modest room was decorated with a pattern to a large scale before canvas was put up in the 1770’s.
Photo: Roberto Fortuna.*

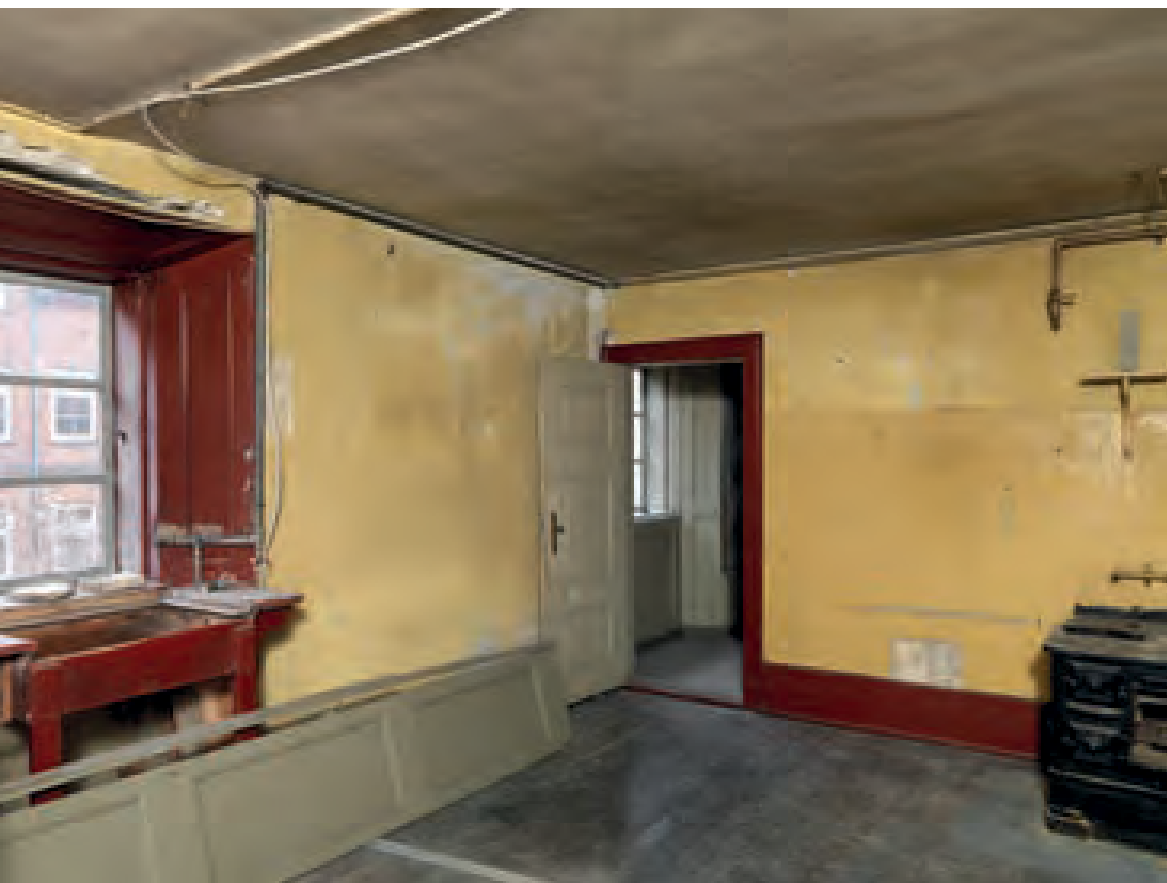
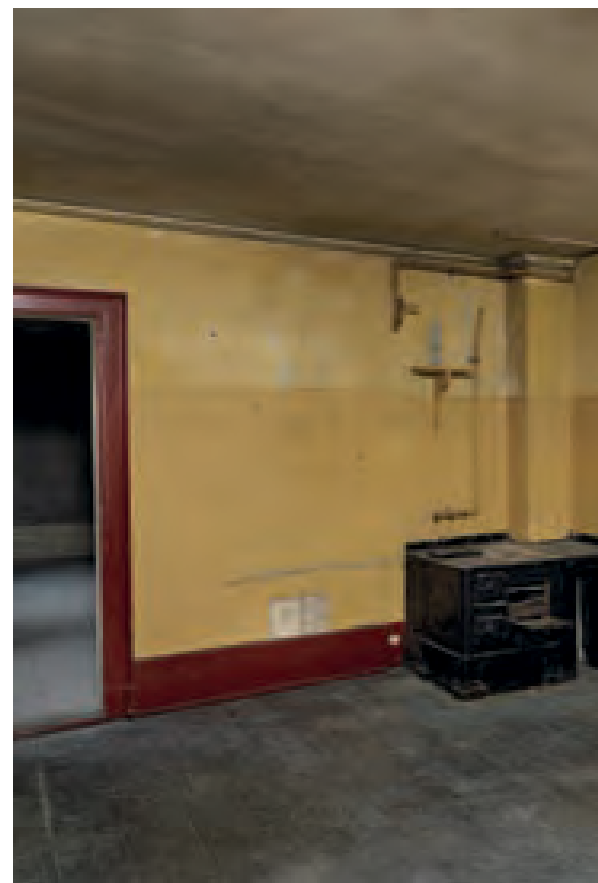
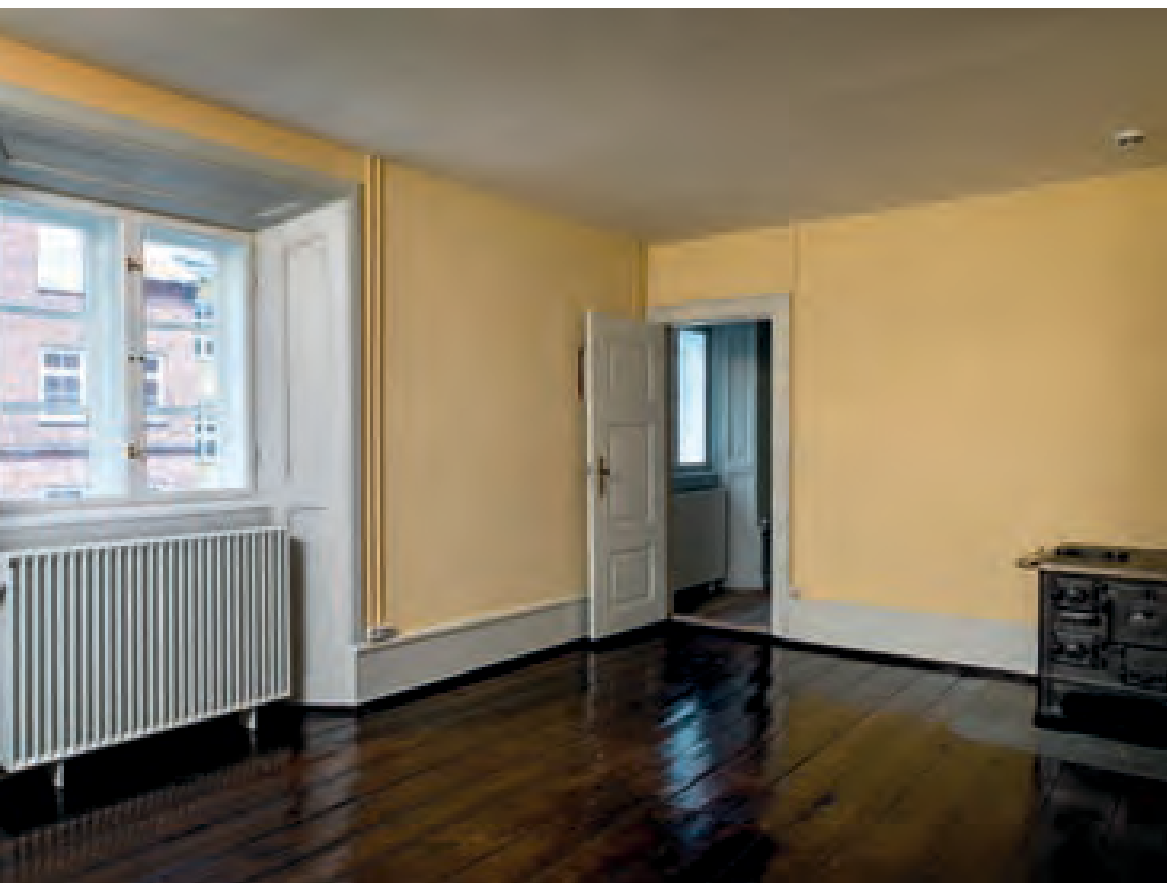
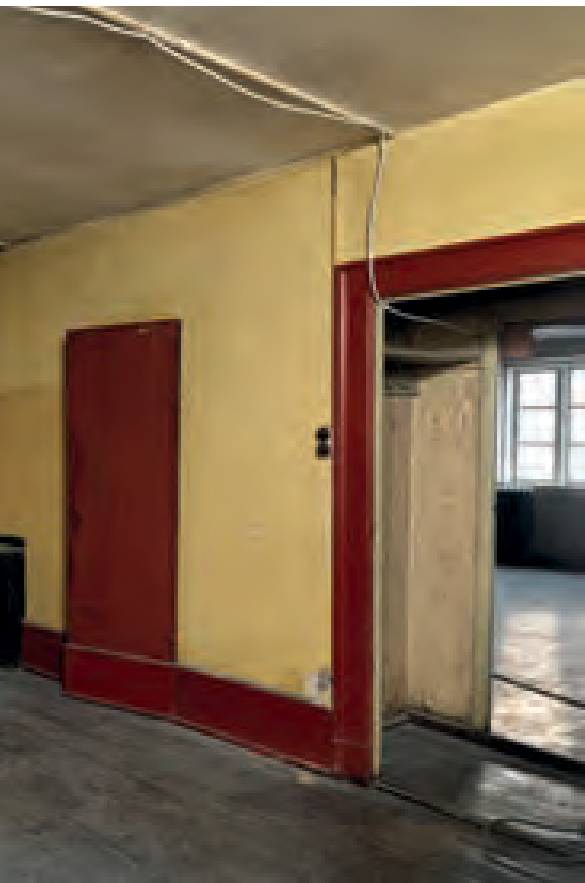
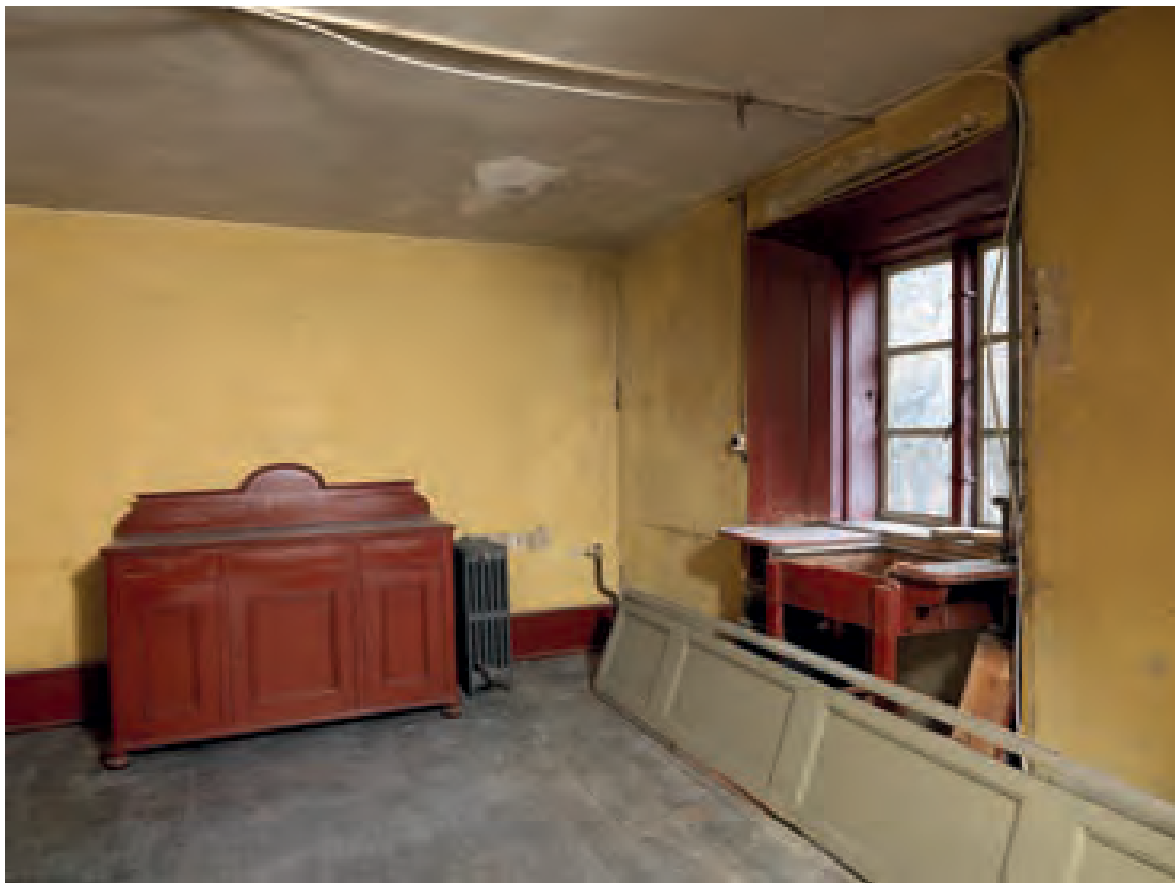
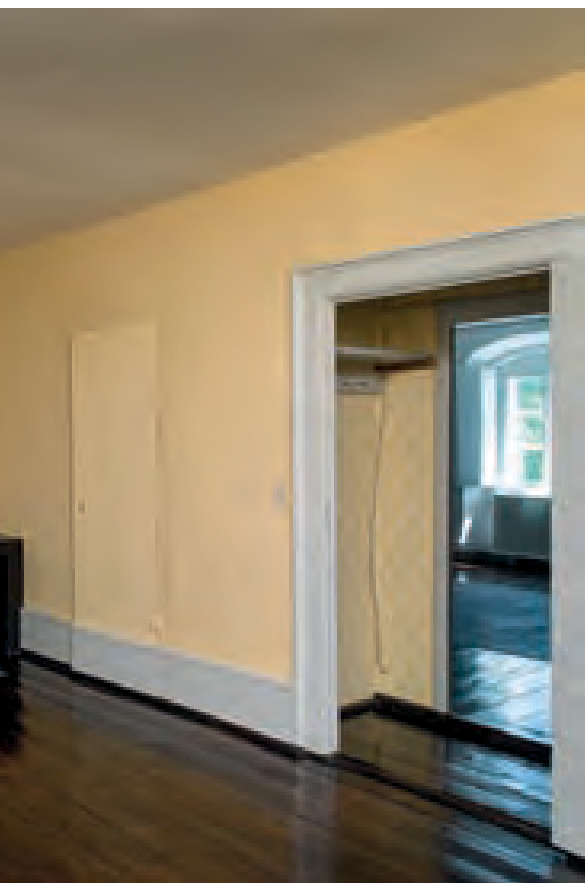
Rum 202 før og efter restaurering. Det blev indrettet som køkken i 1898, da frøkenene fik hver deres husholdning, med indbyggede skabe bag en ny skillevæg. Det lillebitte støbejernskomfur er nu istandsat, så det virker, og poleret med ovnsvæerte og Brasso, mens køkkenbordet med vask ved vinduet er fjernet. Foto: Roberto Fortuna.

Room 202 before and after the restoration. It was fit out as a kitchen in 1898, when the common household was abandoned, with built-in closets behind a new partition wall. The tiny cast iron cooking range has now been restored to work and polished with stove polish and Brasso, while the kitchen table with sink by the window has been removed. Photo: Roberto Fortuna.

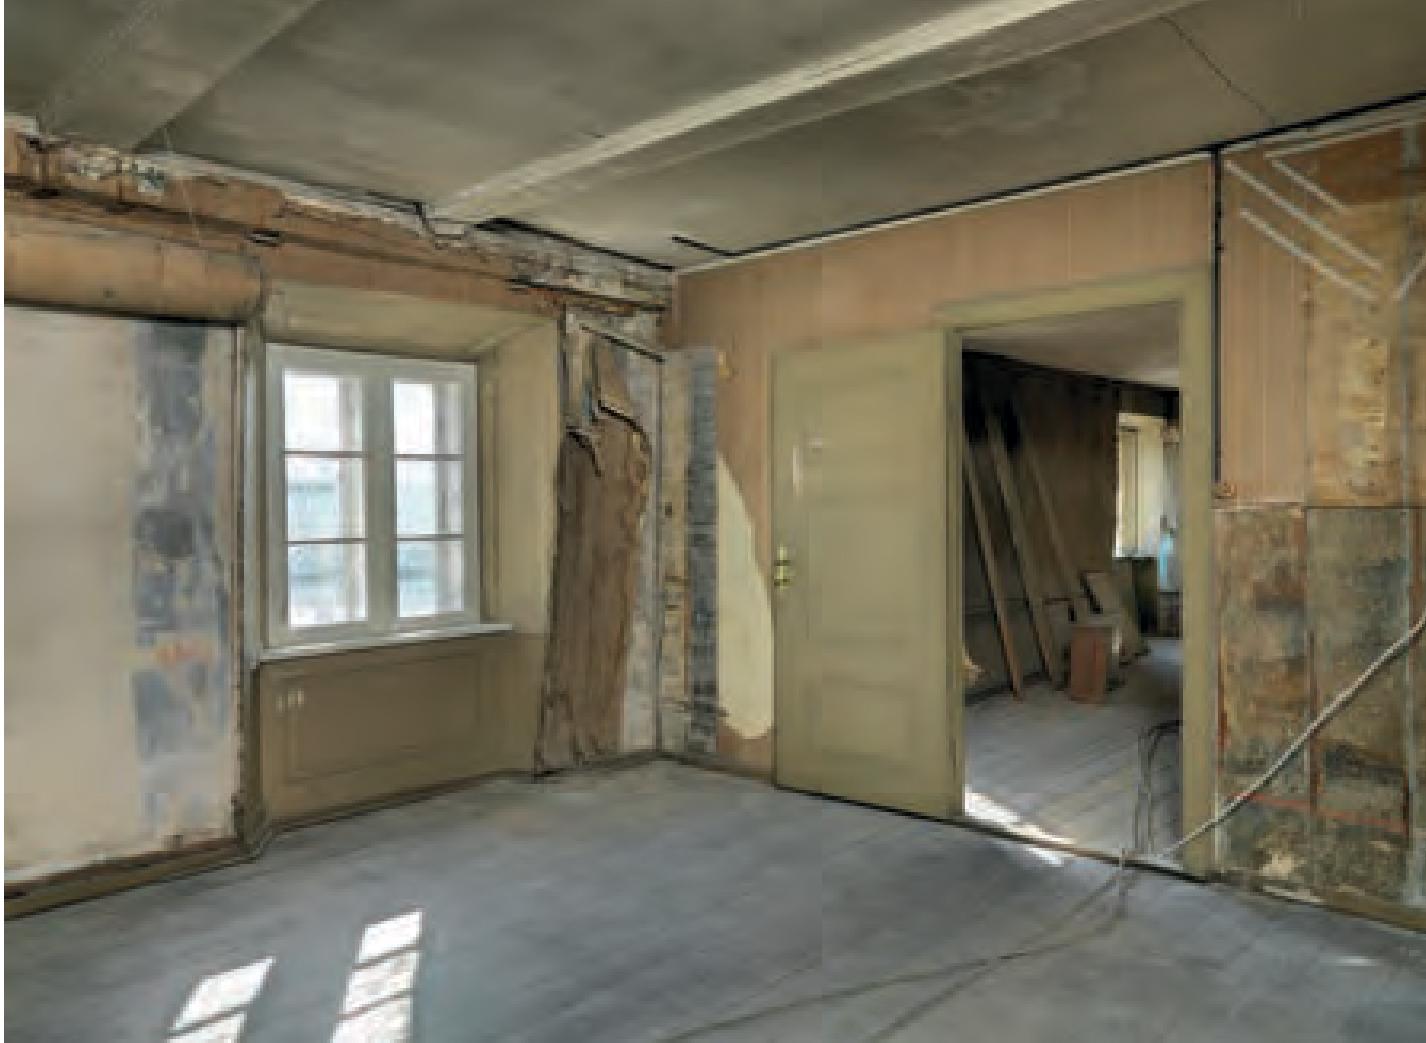
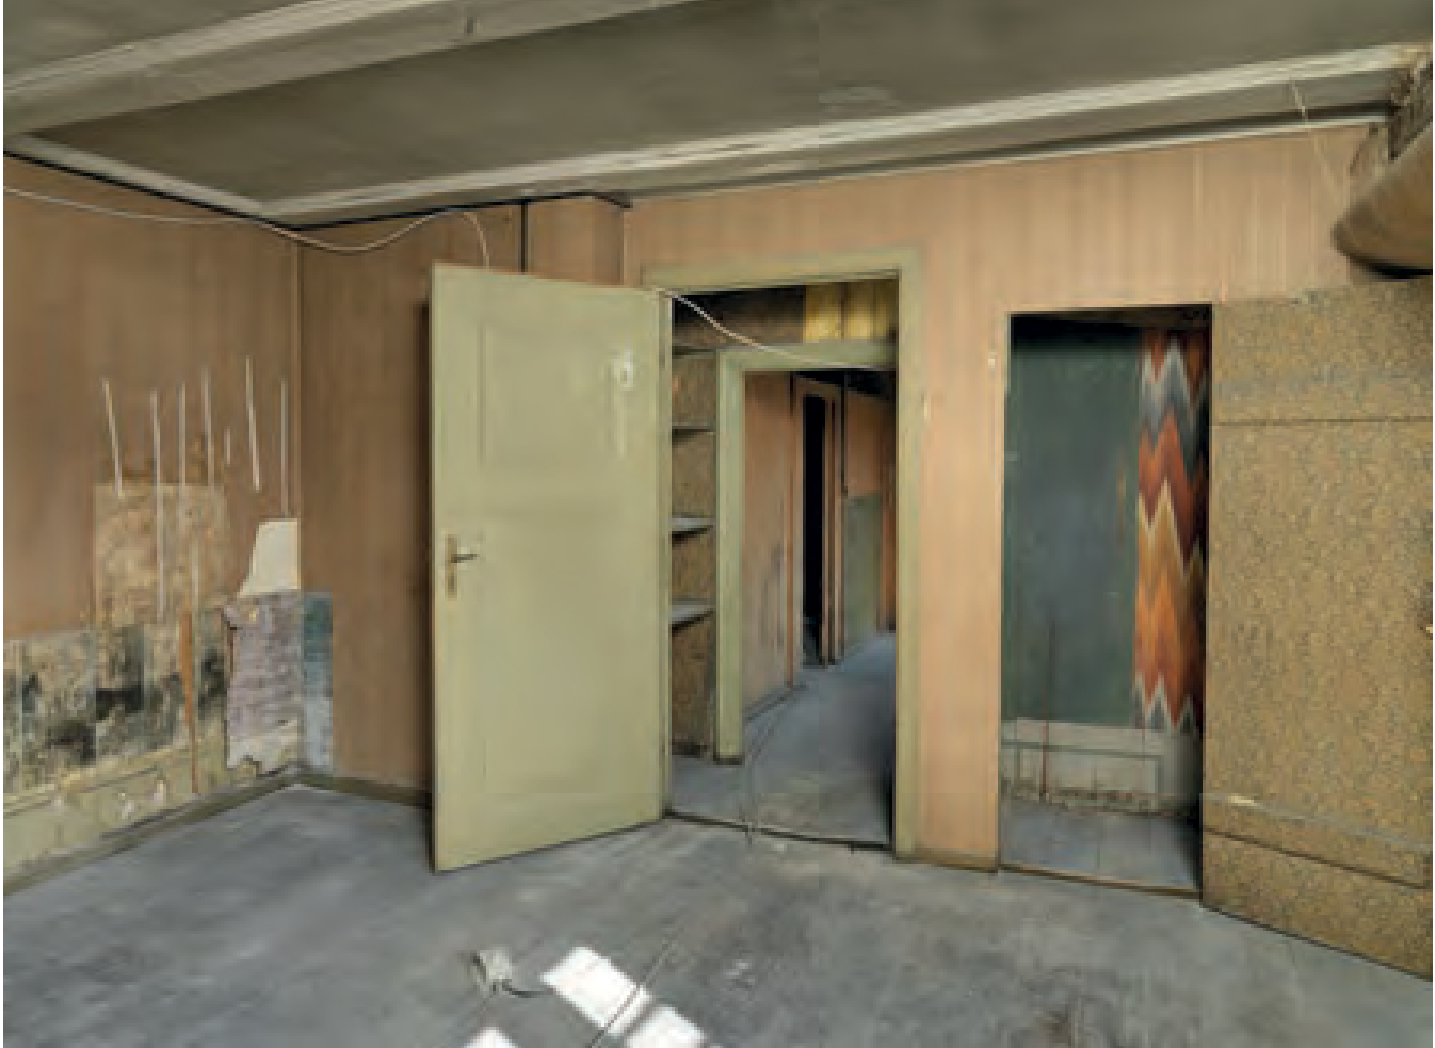
Rum 213 er et af de få, hvor et par af beboerne kendes, og den sidste af dem havde soveværelse her. Rummet stod formentlig

tomt fra 1891 til klosteret lukkede og var i meget dårlig forfatning. Foto: Roberto Fortuna.

Room 213 is one of the few, where a couple of the residents are known, and the last of them had her bedroom here. The room

was probably empty from 1891 until the Convent was closed and in very poor condition. Photo: Roberto Fortuna.

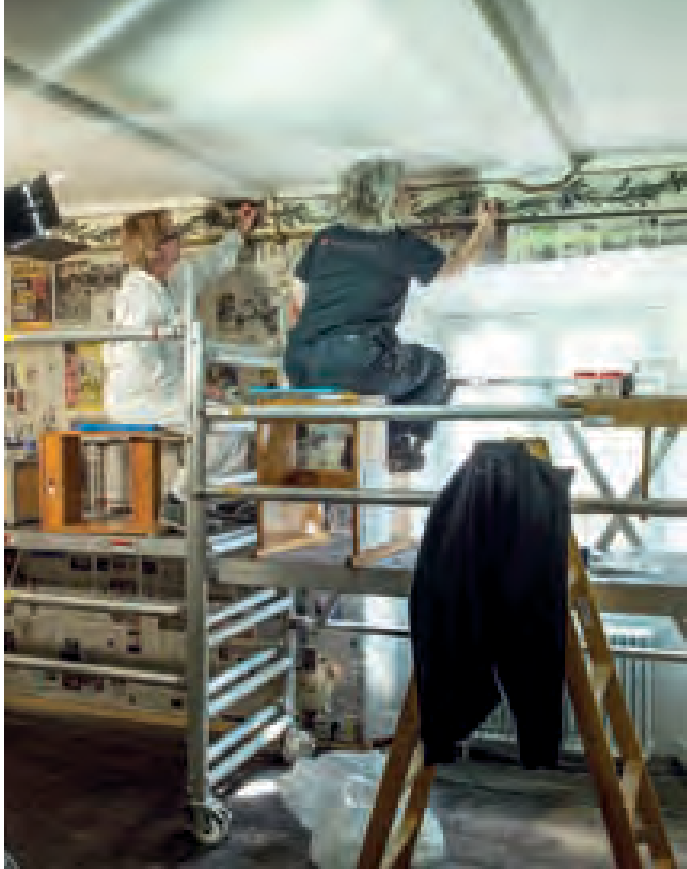
Loftbjælken langs ydervæggen i rum 213 var overtapetsret. Konservatorerne afdækkede den forsigtigt og genskabte den oprindelige dekoration, der var malet på frihånd. Foto: Roberto Fortuna. Modsatte side: Kurt Rodahl Hoppe.

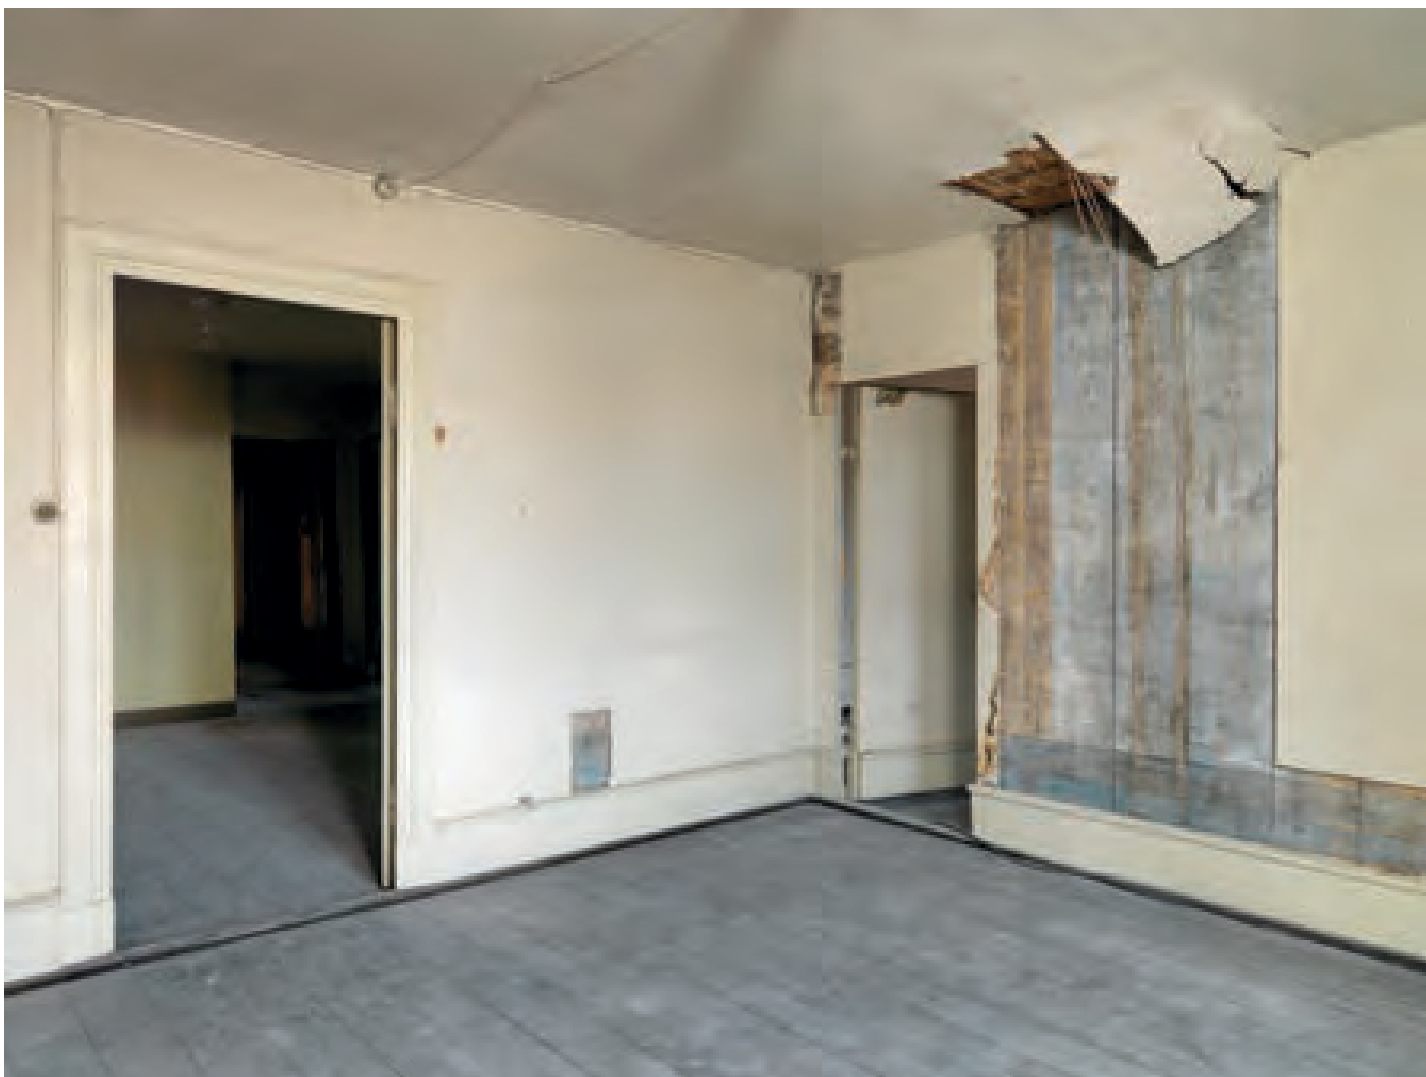
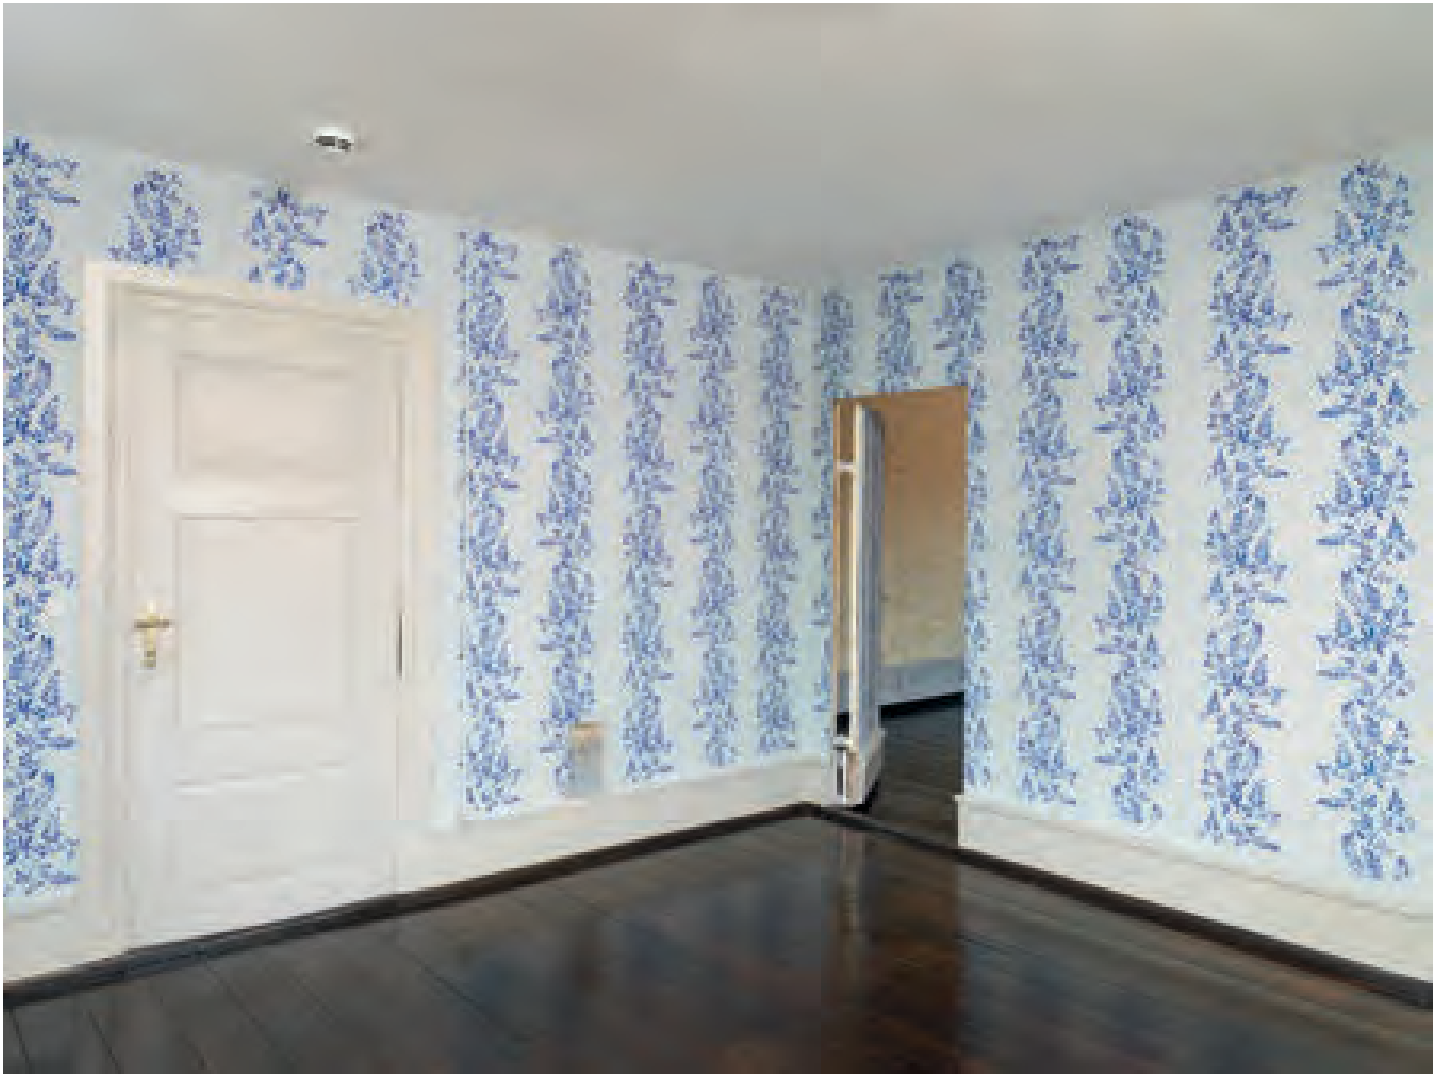
Rum 209, hvor en tidligere skabelonmaling er genskabt. Til højre ses tapetdøren ind til rum 208. Foto: Roberto Fortuna.

*Room 209, where a previous stencil painting has been re-created. To the right, the jib door to room 208 is seen.
Photo: Roberto Fortuna.*

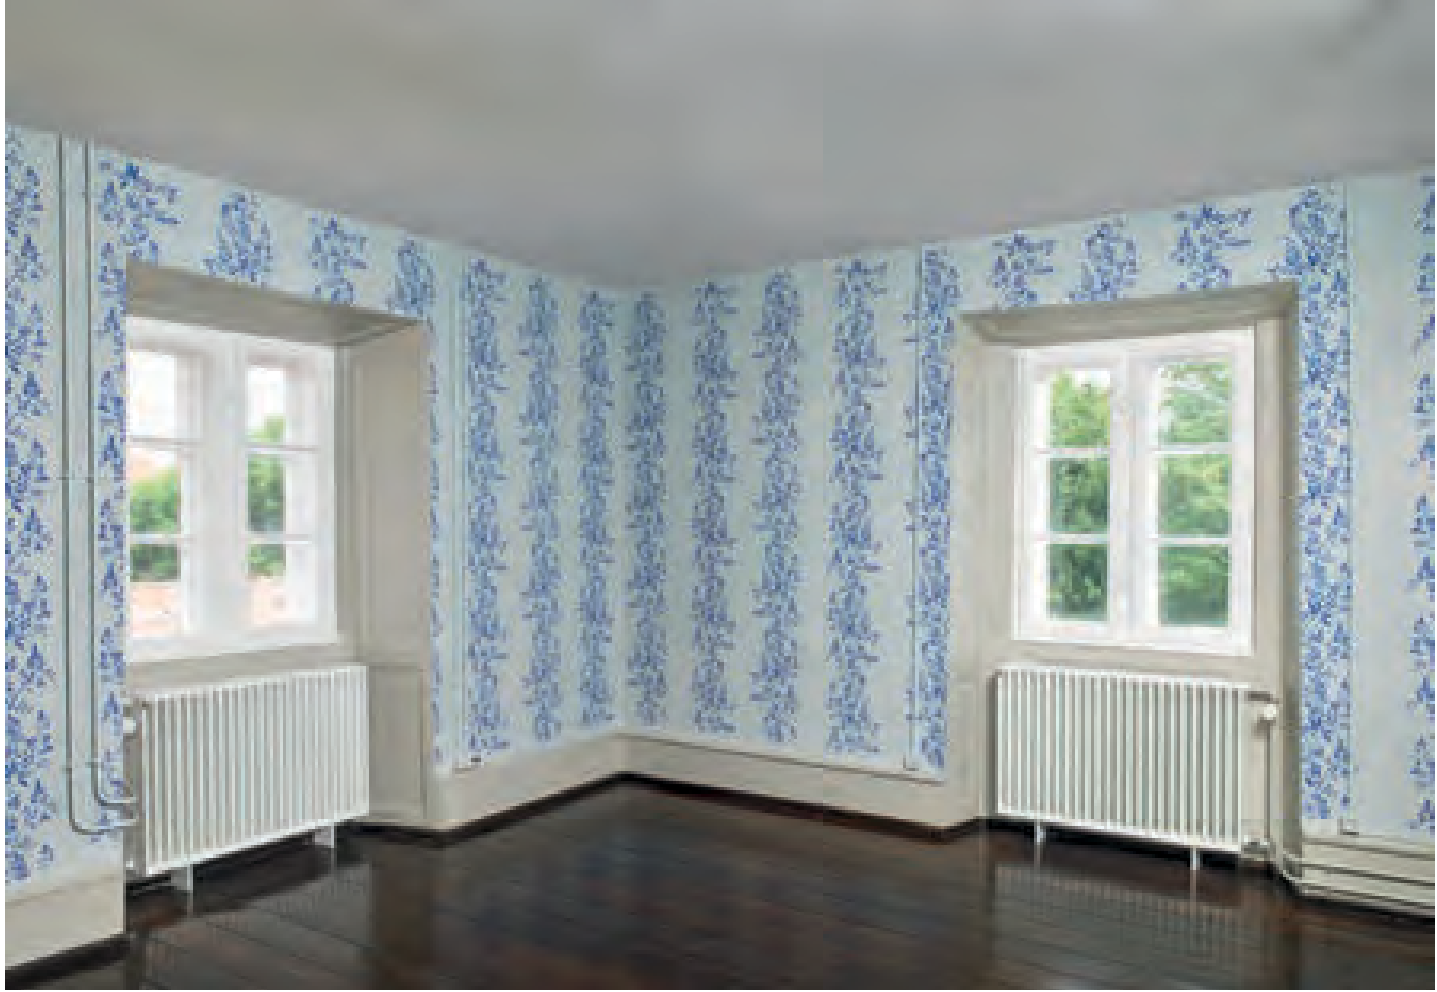
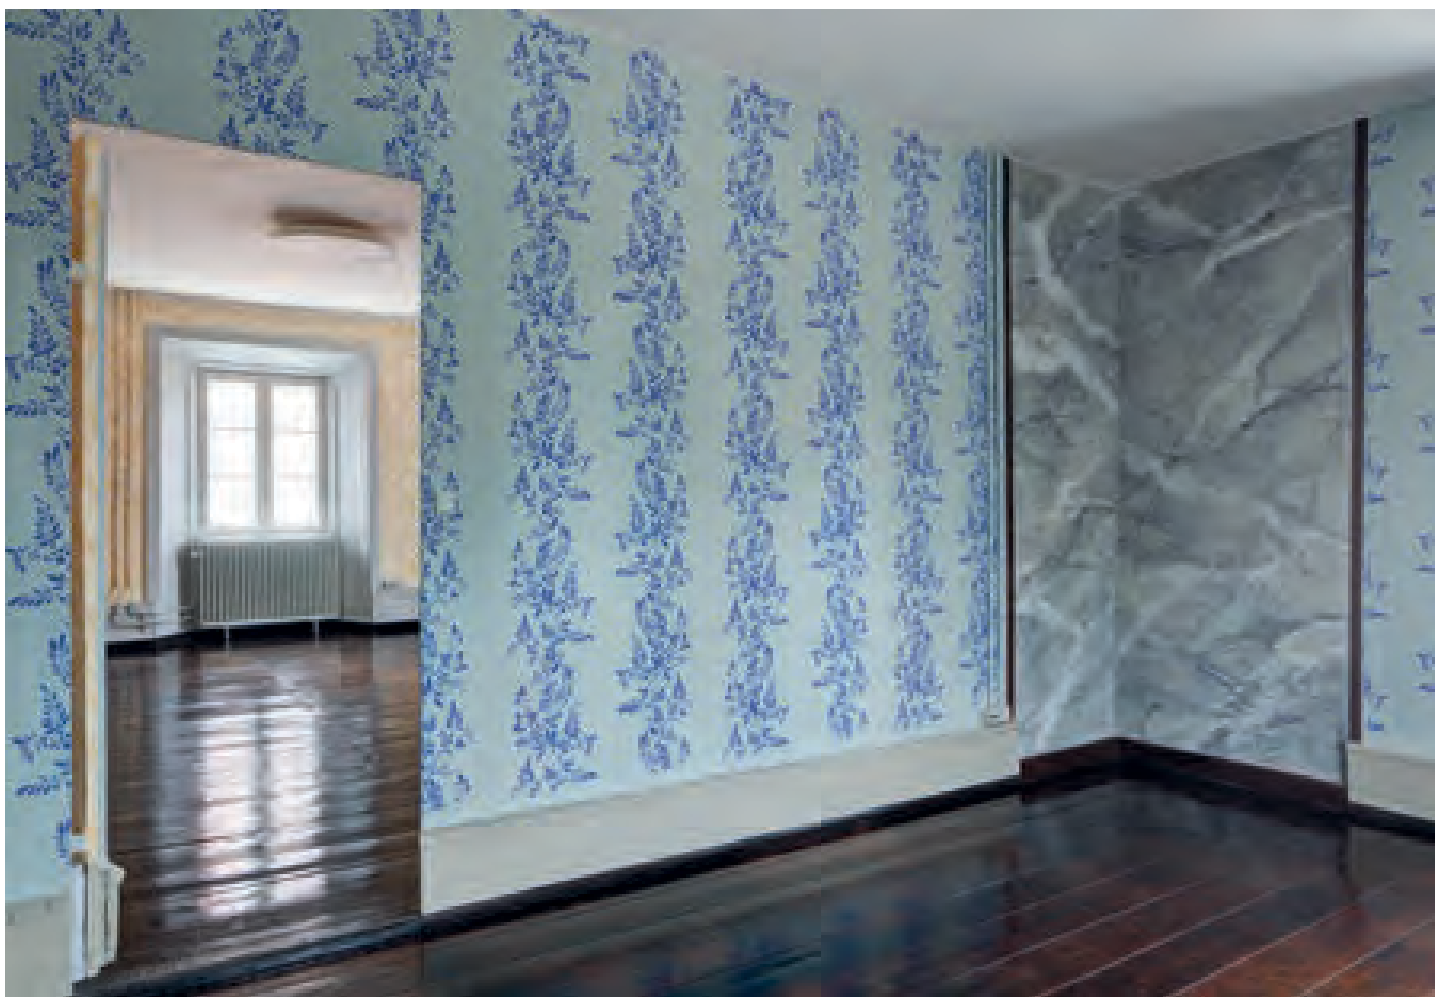
*Room 209. During the restoration, all windows were thoroughly reconditioned, the openings being covered for the duration. The stove in the marbled niche had pipes to the chimney of the gable end fireplace; it no longer works, which is why no stove was put up here after the restoration.
Photo: Roberto Fortuna. Bottom: Kurt Rodahl Hoppe.*

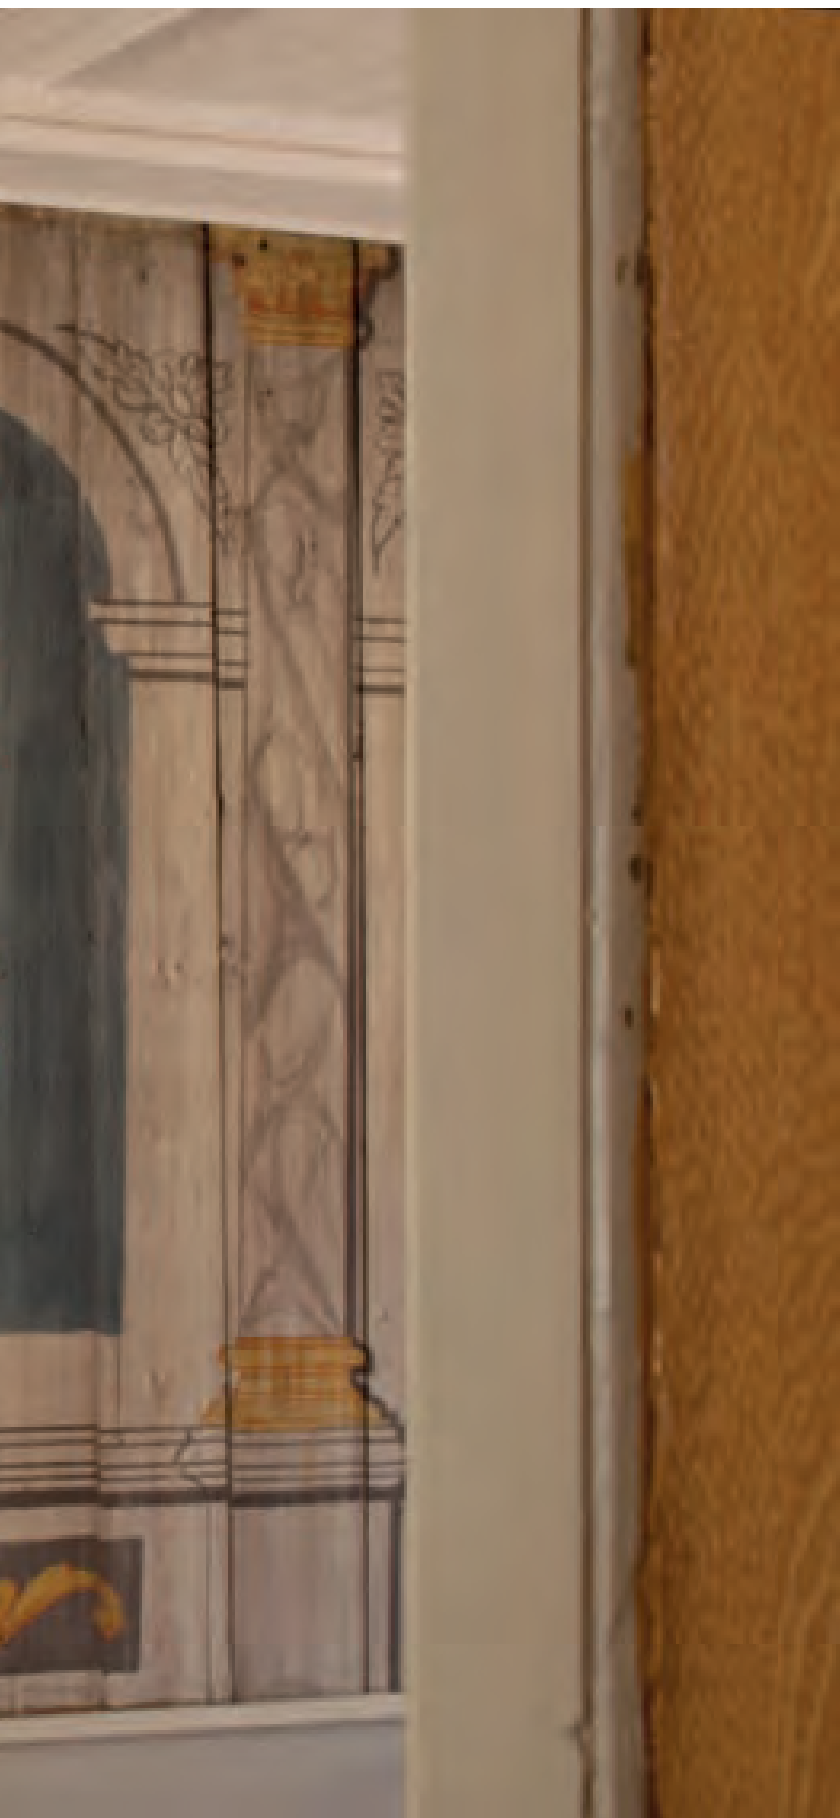
The inside of the door to room 206, the Arcade Room. The conservators have uncovered a paintwork, which appears to come from a different time period than the decoration on the partition wall. 2013. Photo: Kurt Rodahl Hoppe.

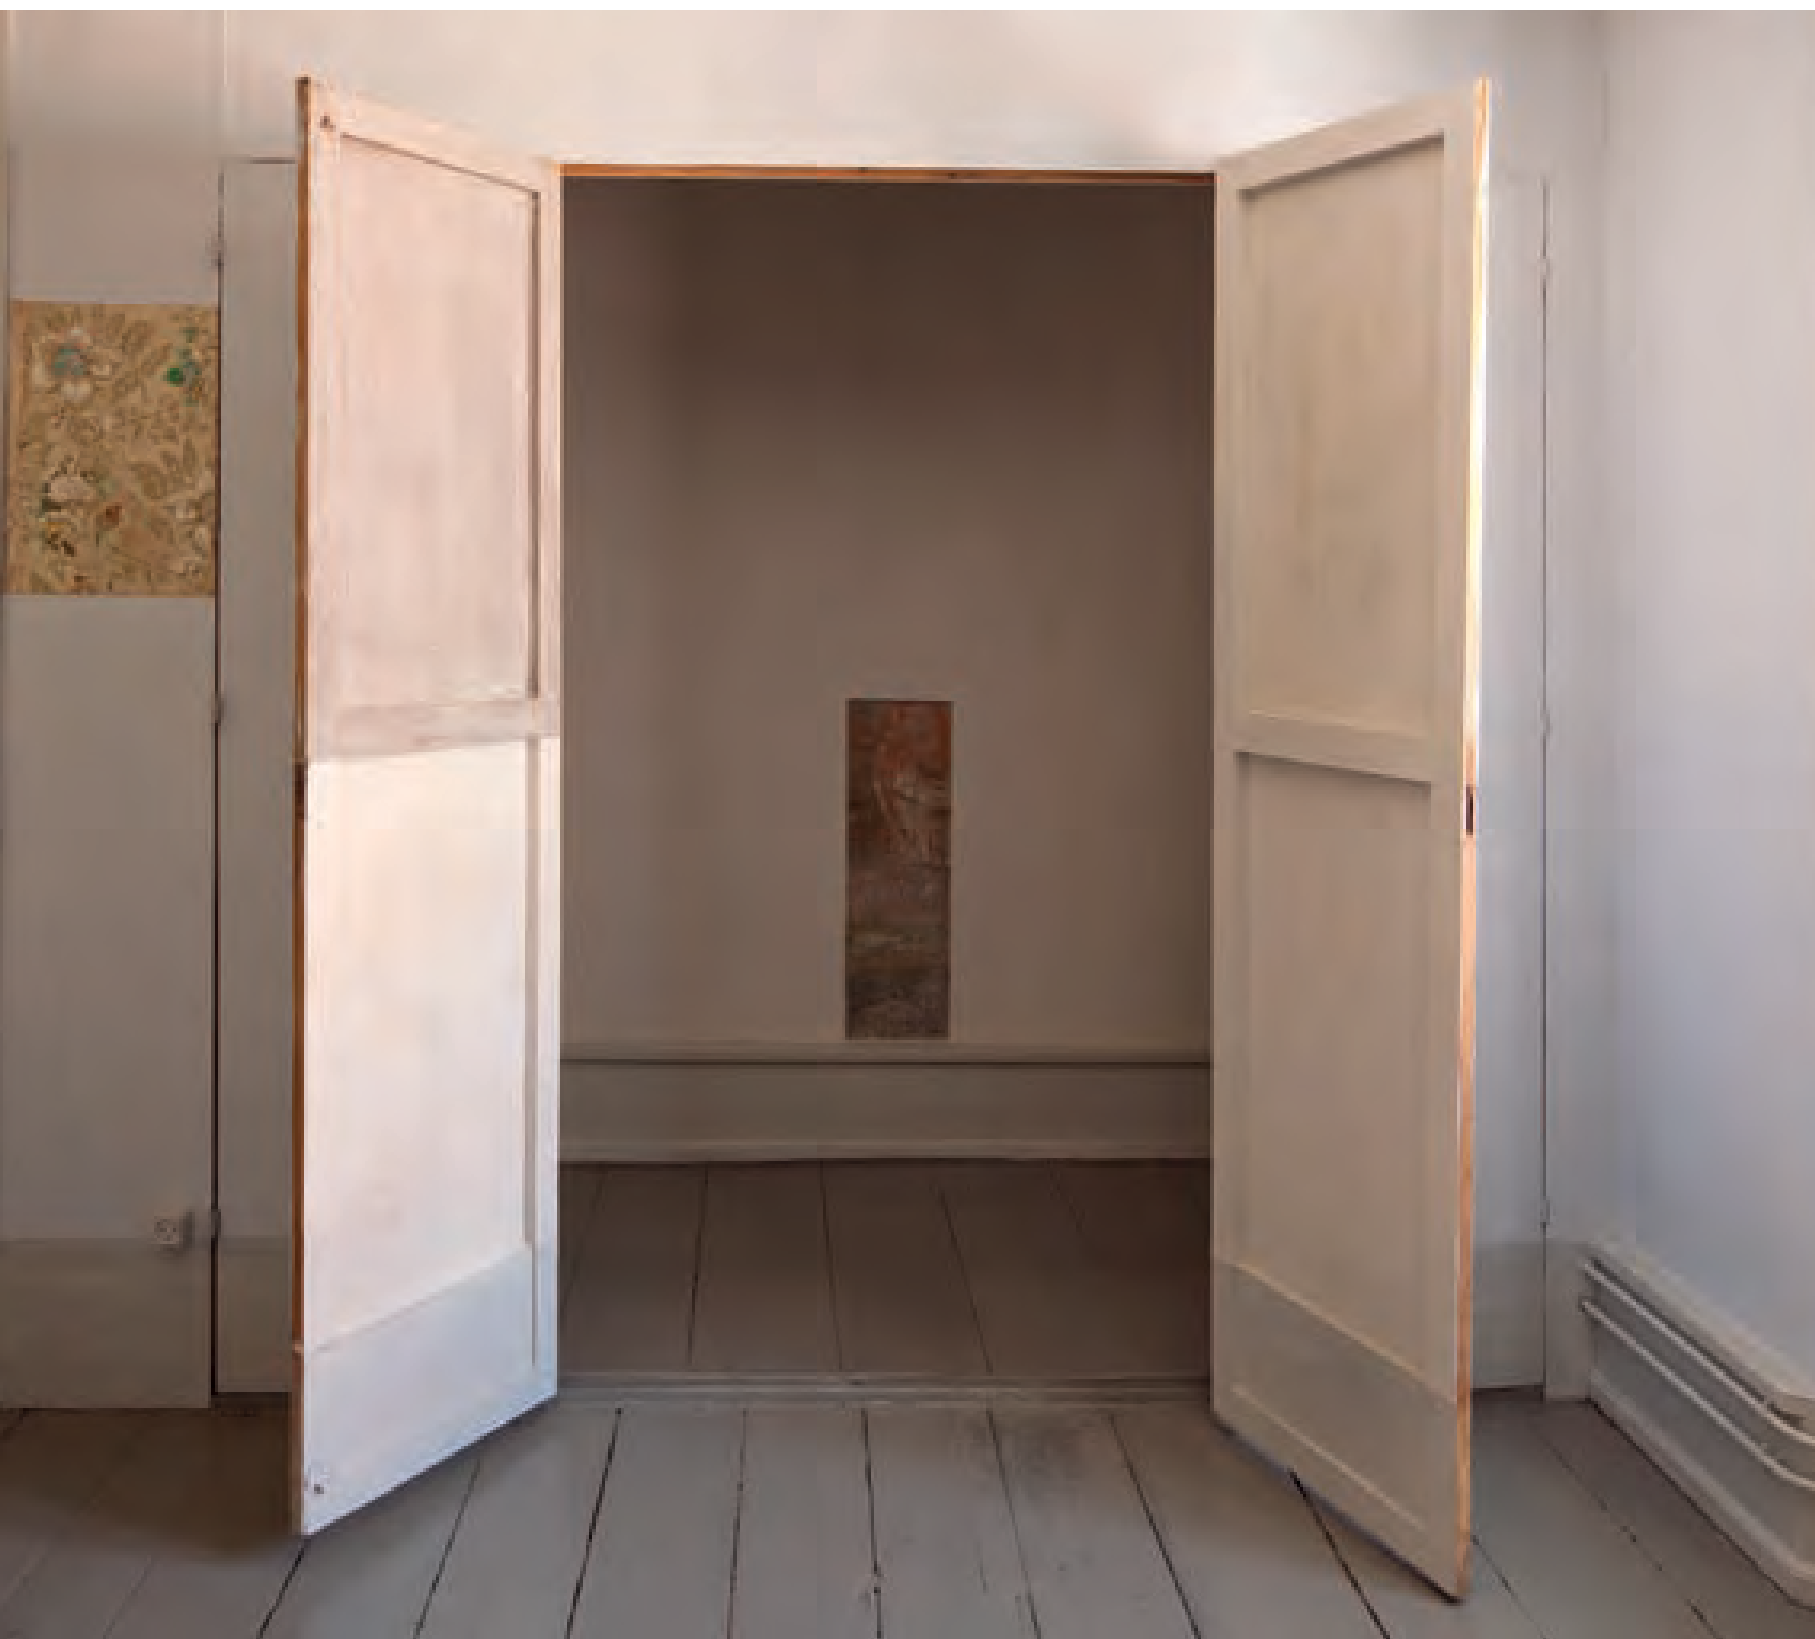
The alcove in 207 was wallpapered both inside and outside with one of the finest wallpapers found in Secular Convent for Noblewomen with an iridescent glimmer. 2013. Photo: Kurt Rodahl Hoppe.

At one point, Miss Løvensøn's bedroom contained within it a room with a four-leaved folding door. This might look like an alcove for servants, such as were often found in castles and country houses – in this case for the lady's maid. But during the restoration it was found that, sometime between 1825 and 1835, the alcove was papered all over with a costly French wallpaper, so maybe it was the lady's diminutive bedchamber.
