The Arcade Room

Restaureringen af Jomfruklosteret

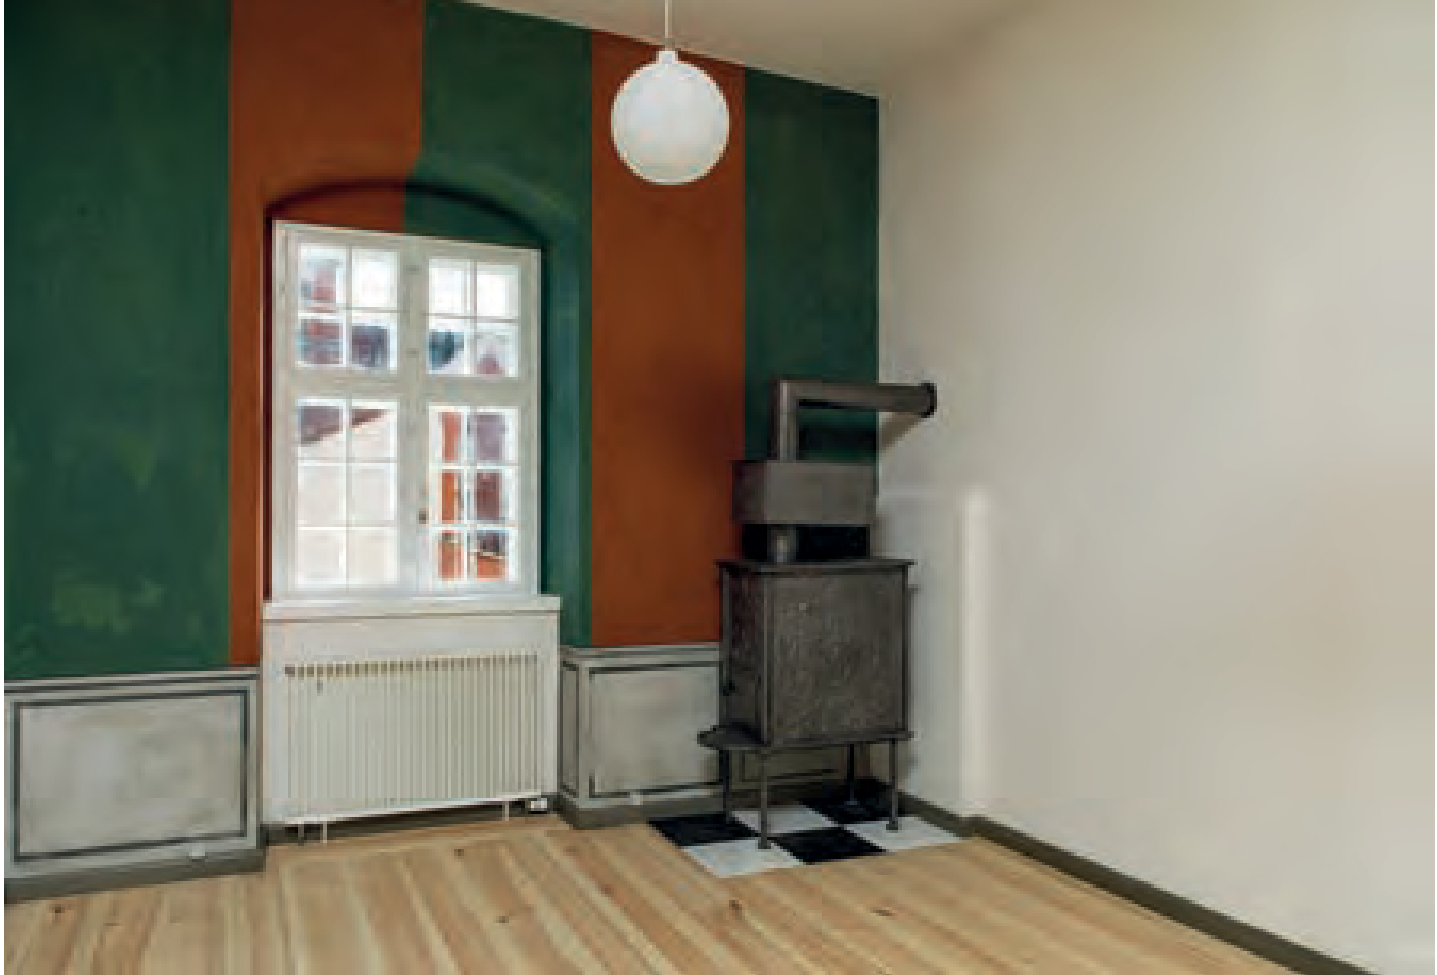
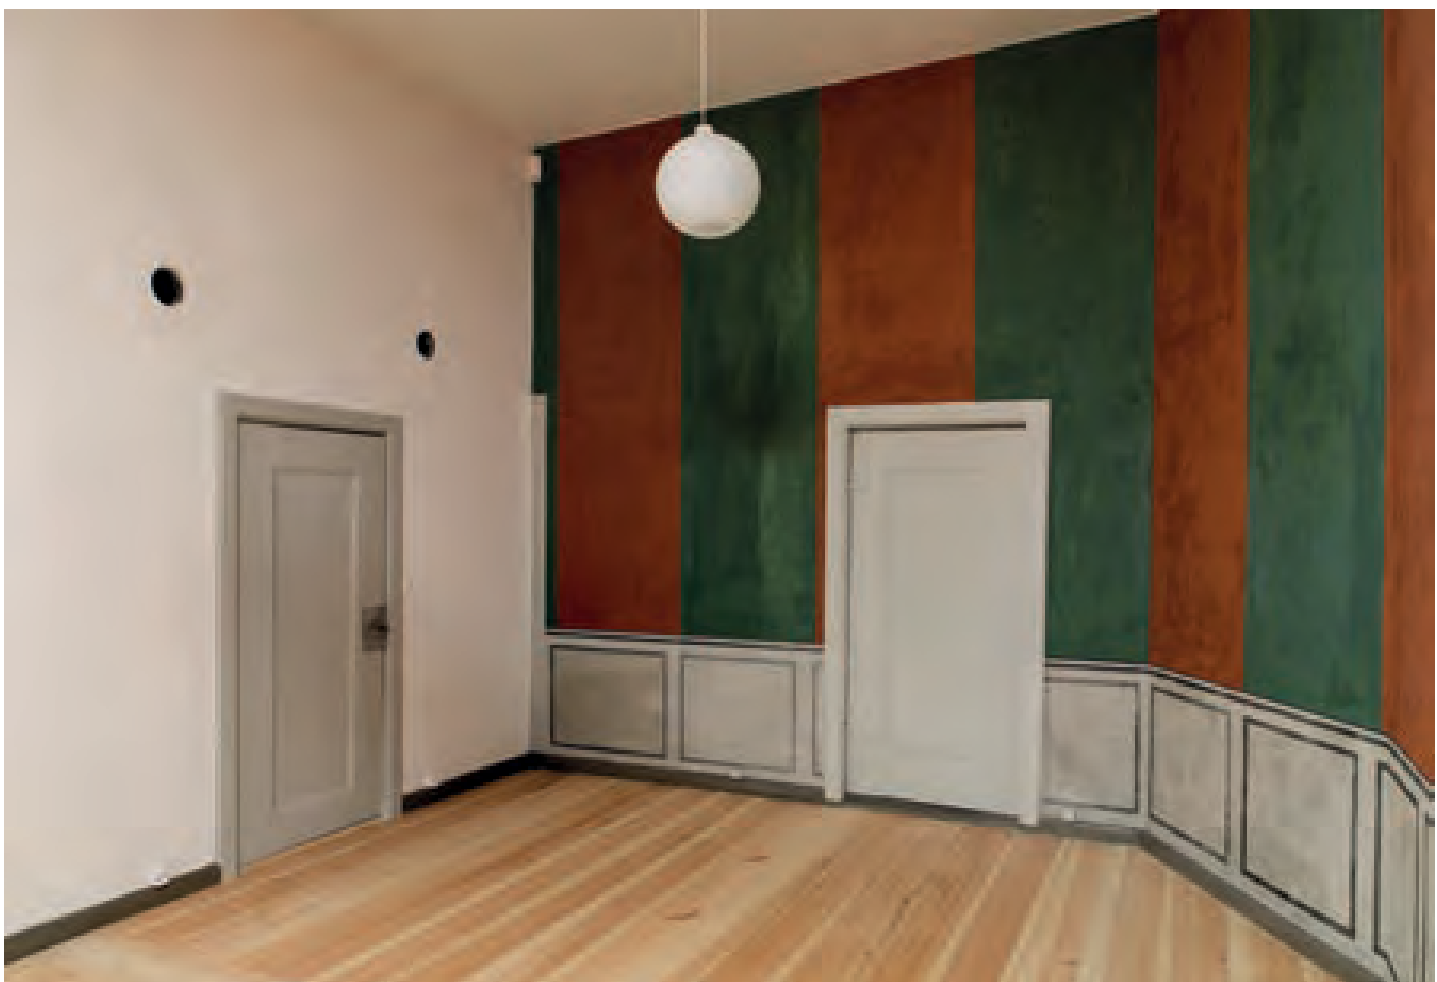
Room 108 was part of the original great hall to the east, enlarged by the 16th century extension of the building. This is the only place in the Convent where partitions have been removed during the restoration, thus partly re-creating the hall. The white wall in the picture below is a remainder of this partition; the red-green striped decor is discontinued here to proceed on the other side of the wall. The door on the end wall is a later addition as well and therefore shut permanently.

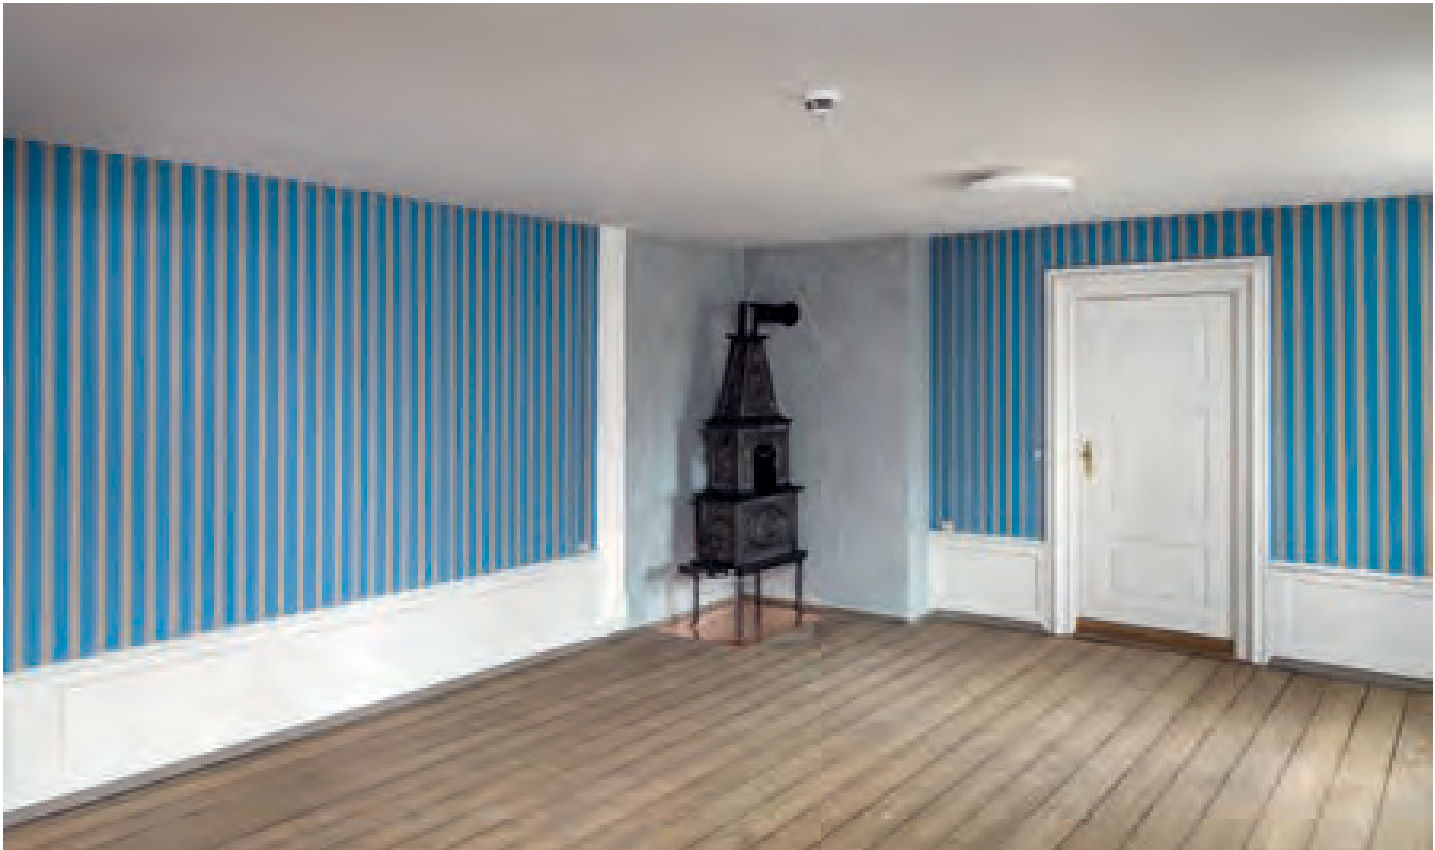
Rum 214 med etageovn, der som type er ældre end cylinderovnene i nogle af de andre rum. 2013. Foto: Roberto Fortuna.

Room 214 with multi-level wood burning stove of the type that is older than the cylinder-shaped stoves in some of the other rooms. 2013. Photo: Roberto Fortuna.

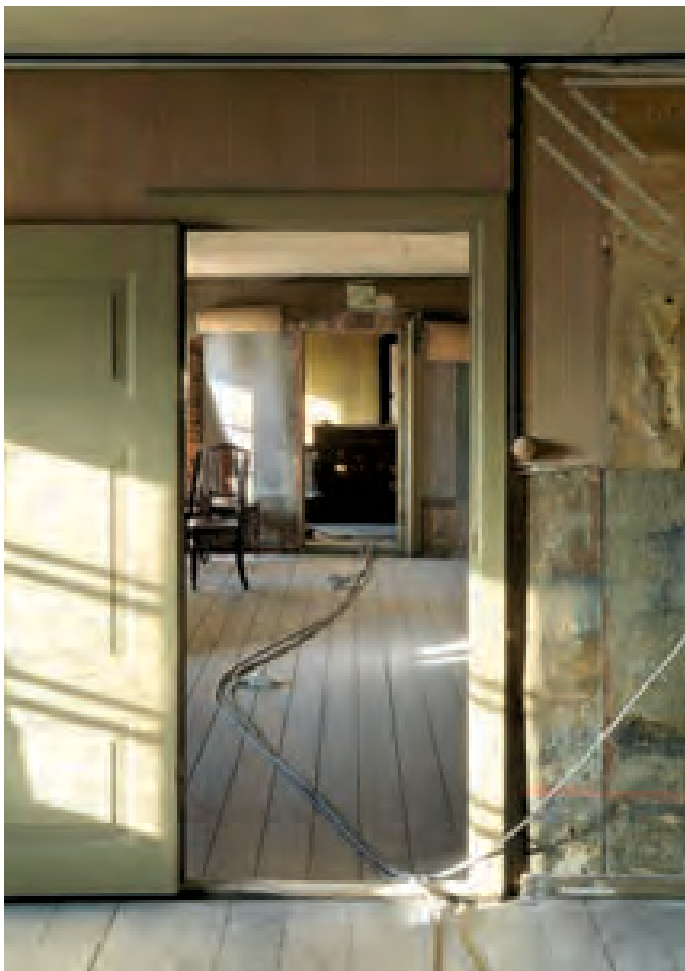
*Rum 213 med kig mod trapperum 215 under restaureringen.
Foto: Roberto Fortuna.*

*Room 213 with view to the staircase 215 during the restoration.
Photo: Roberto Fortuna.*

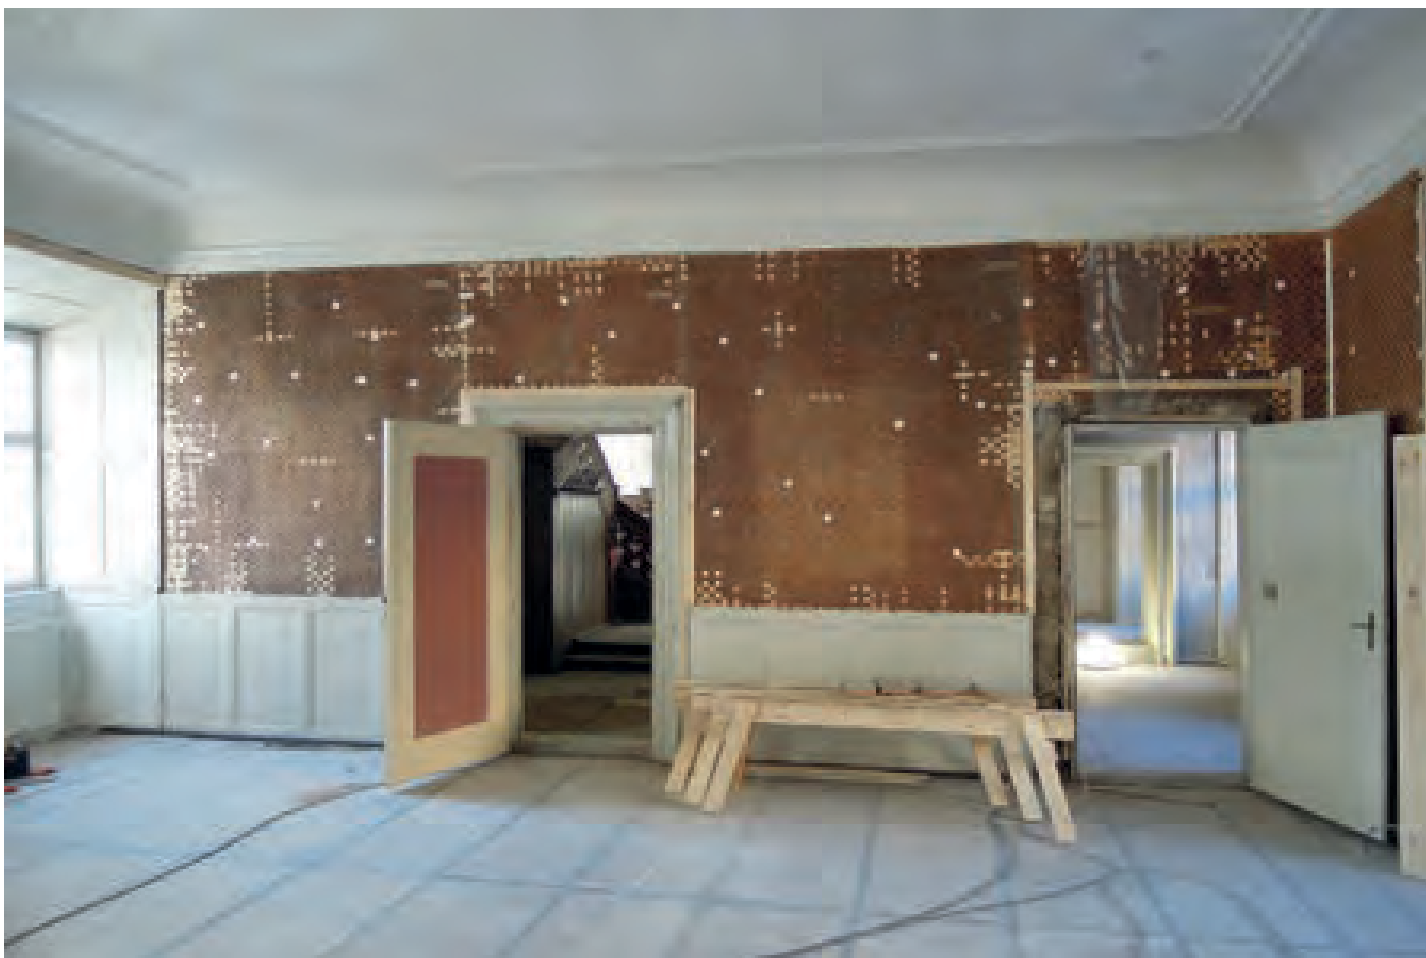
Under væglærrederne blev der fundet spåntapeter fra 1700-tallet. De isolerede, beskyttede de bemalede lærreder mod fugt især på ydervæggene og gav lidt bund, så de stramt udspændte lærreder ikke så nemt fik flænger.

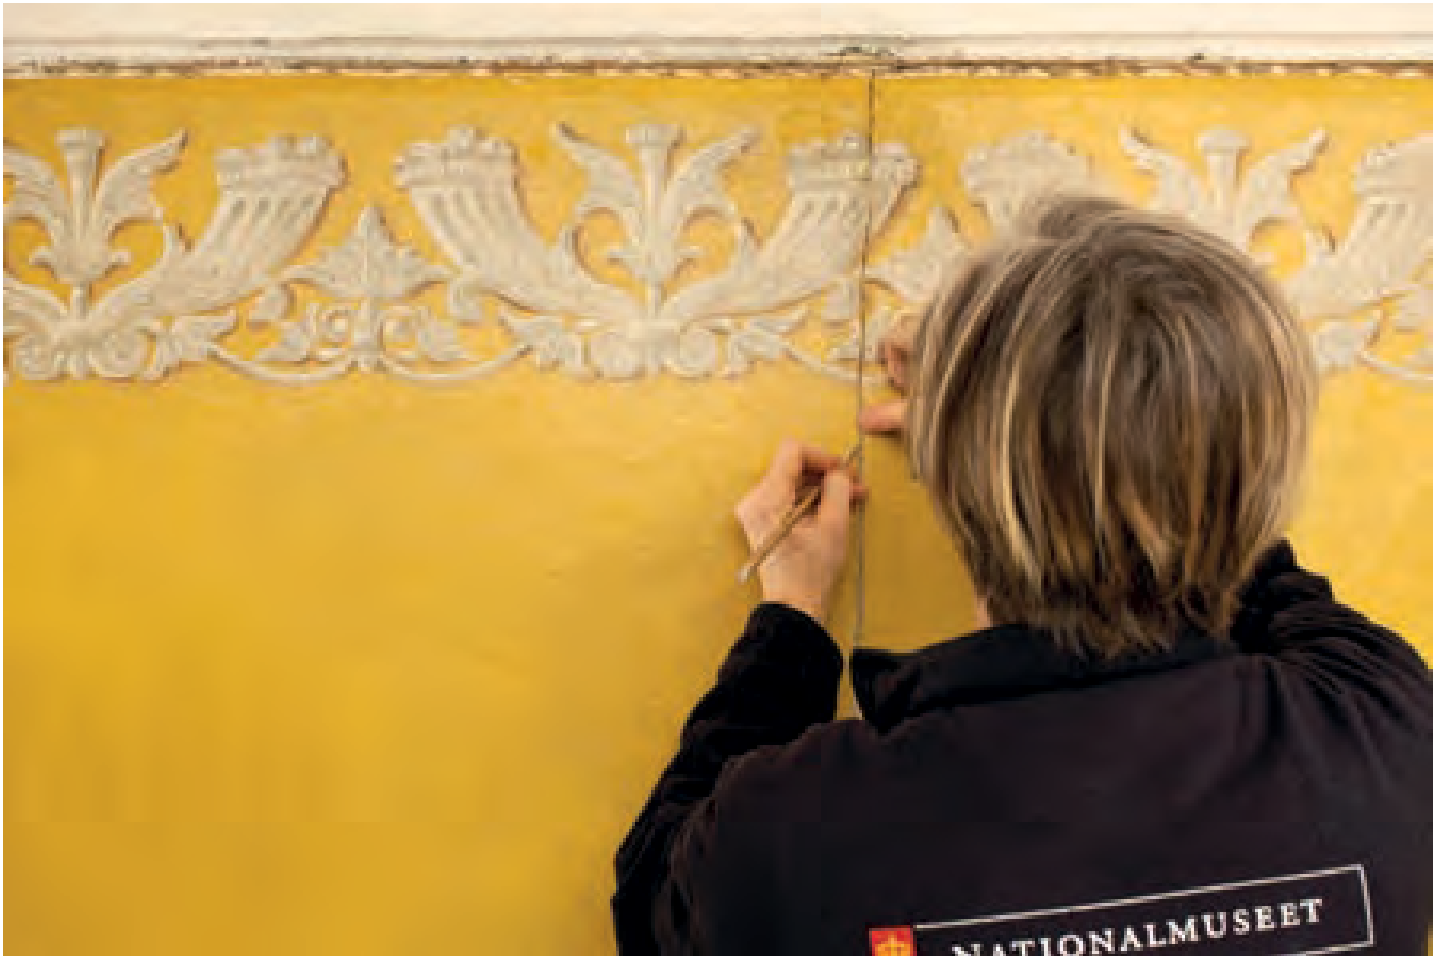
Under lærrederne sad spåntapeter, der var flosset i kanterne; de er repareret af Nationalmuseets Bevaringsafdeling og genopsat under de restaurerede væglærreder.

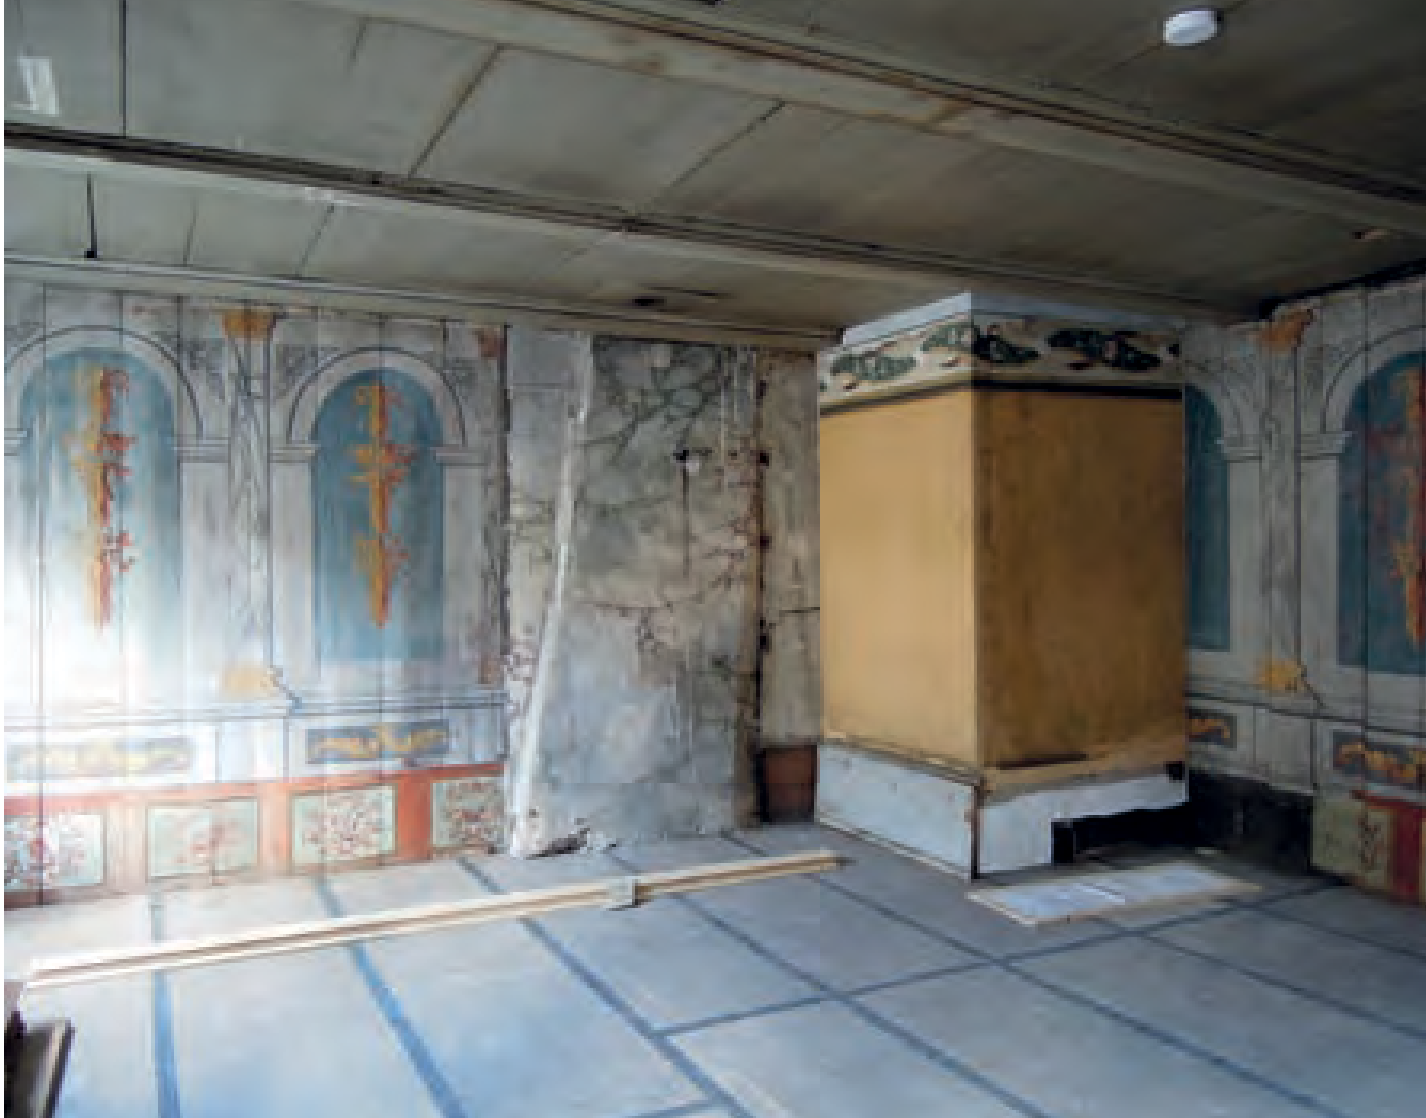
Arkaderummet illustrerer kompleksiteten i valget af hvilket af de mange lag, der skal stå fremme efter istandsættelsen. Det blev besluttet at vise laget oven på den oprindelige bandemaling og forneden det tredje lag, det røde illuderede panel, mens perioden med lærreder vises omkring loftstrappen. Resten af

lærrederne med papirtapet og adskillige senere lag maling er konserverede og opbevares nu i magasin på Jomfruklosterets loft. På skorstenen ses både kvadring og marmorering, opmalet mange gange, så linjerne med tiden blev lidt forskudte. Foto: Lundqvist Tegnastue.

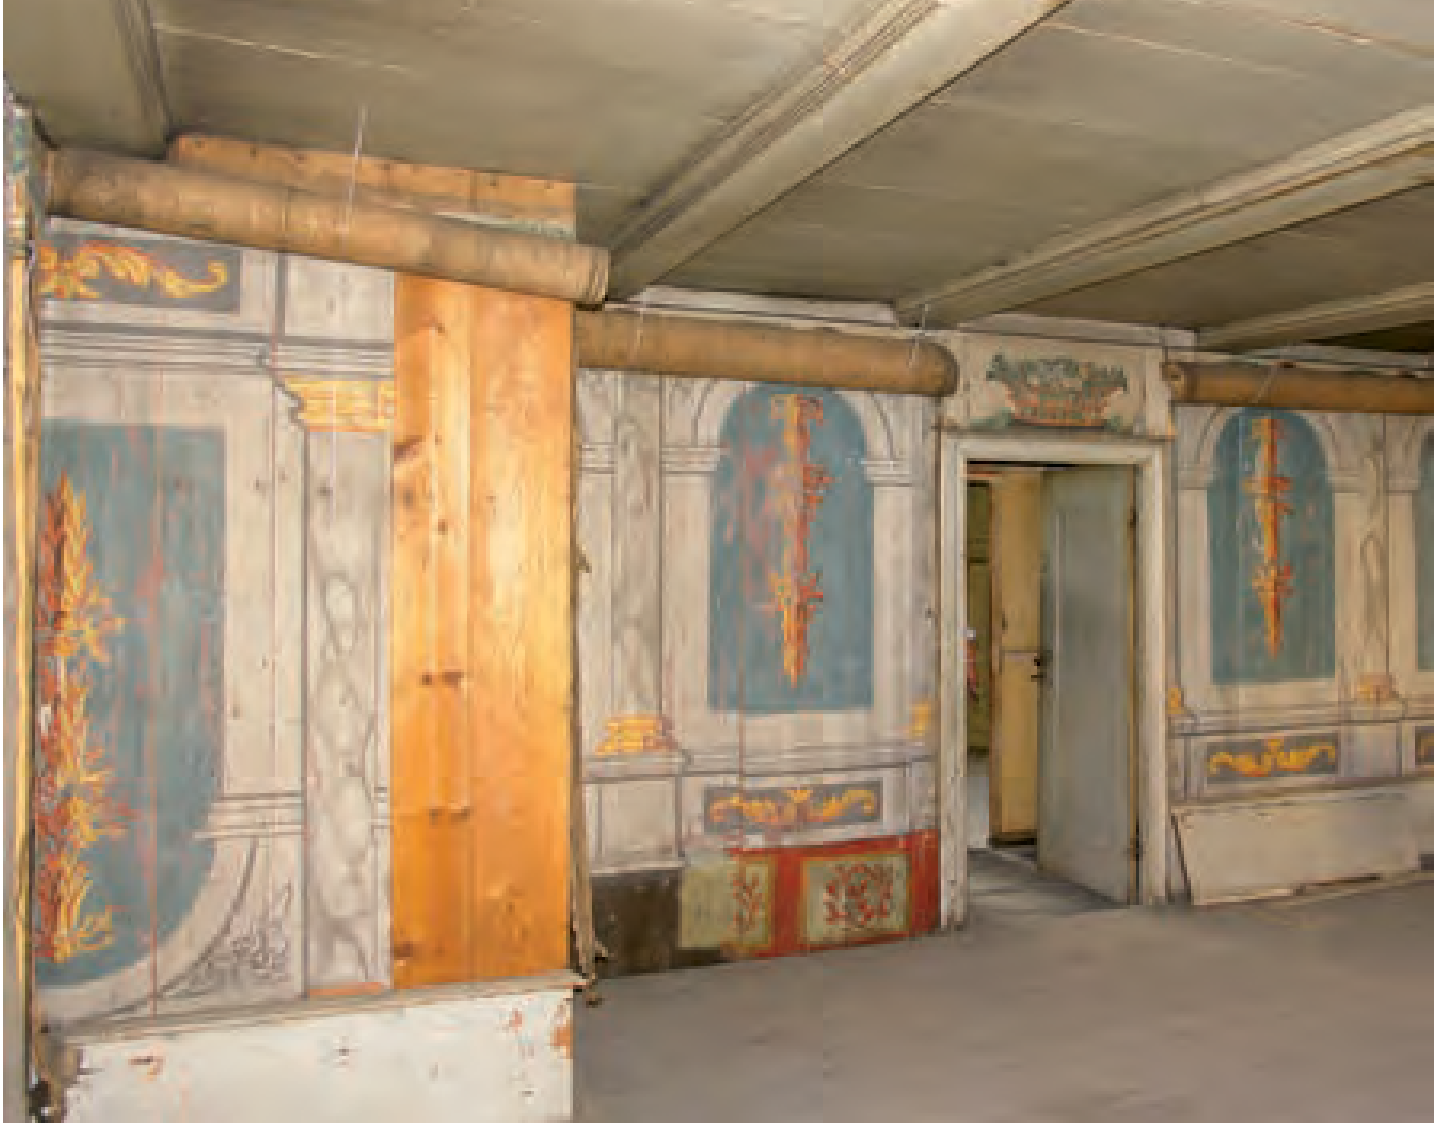
The Arcade Room illustrates the complexity of choosing which of the many layers is to be displayed after restoration. It was decided to show the layer above the original striped painting and, lower down, the third layer, the red trompe l'oeil dado, while the period with canvas is shown round the attic stairs. The rest of the

canvases with wallpaper and several later coats of paint have been conserved and are now appropriately stored in the Jomfruklosteret attic. The chimney shows both imitated stonework and marbling, retouched many times so that the lines have fallen slightly out of alignment over time. Photo: Lundqvist Architects.

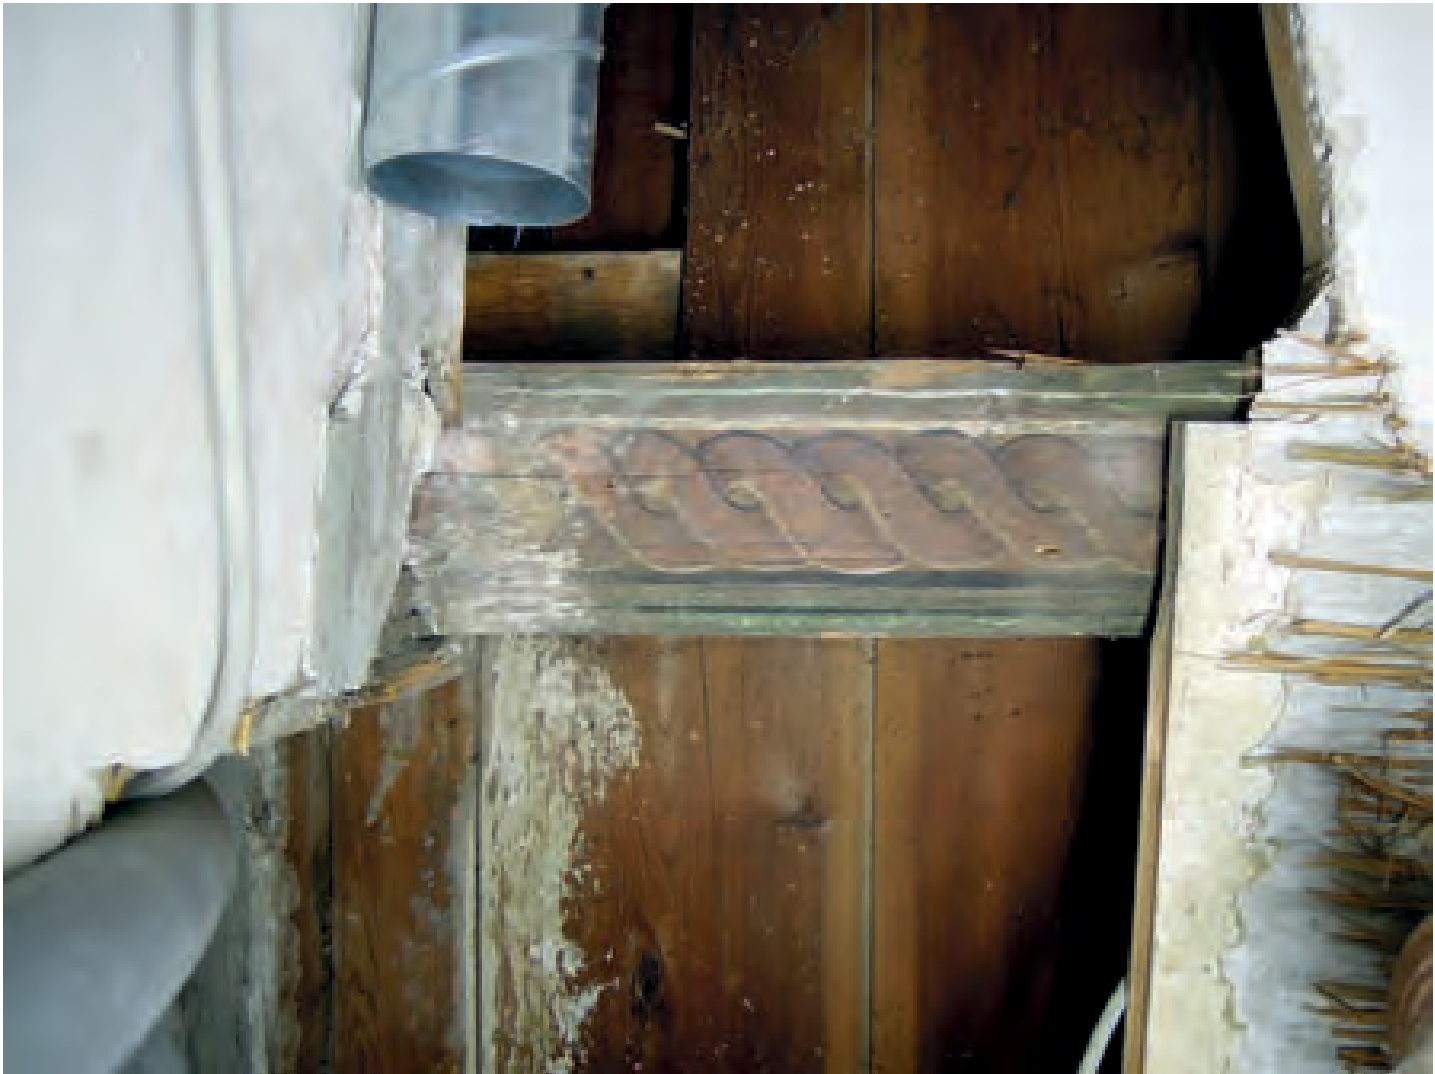
Presumably in Jørgen Brahe's time, the first half of the 17th century, this room has been given painted ceiling beams with strapwork ornamentation on the sides and a complicated border on the lower surface, all with refined shadow effects. The decoration was found to continue under a later suspended ceiling in an adjacent room, showing that a large continuous room was later sub-divided.

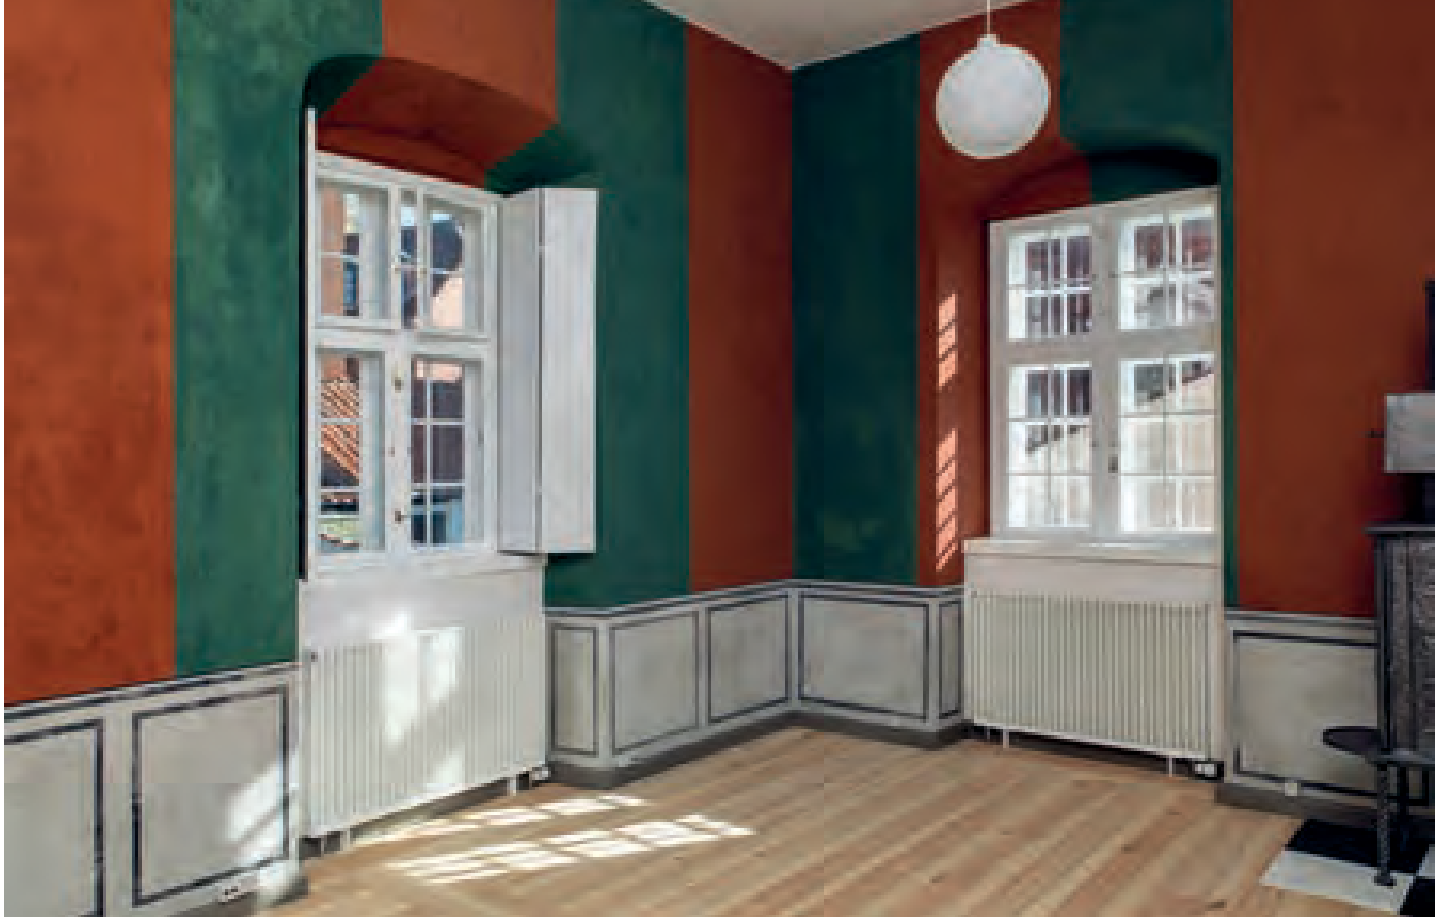
De malede bander, lodrette bånd af to vekslende farver, er efterligninger af opspændte tekstiler, som oftest af uld. De kom på mode midt i 1600-tallet som afløsere for de draperede vægtæpper, der havde været brugt siden middelalderen. Kombinationen rød-grøn er den mest almindelige, men på Jomfruklosterets førstesal, hvor otte rum er bandemalede, er der flere andre farvekombinationer. Banderne gik af mode i første halvdel af 1700-tallet og afløstes af malede lærreder, opspændt med profilerede lister. Foto: Roberto Fortuna.

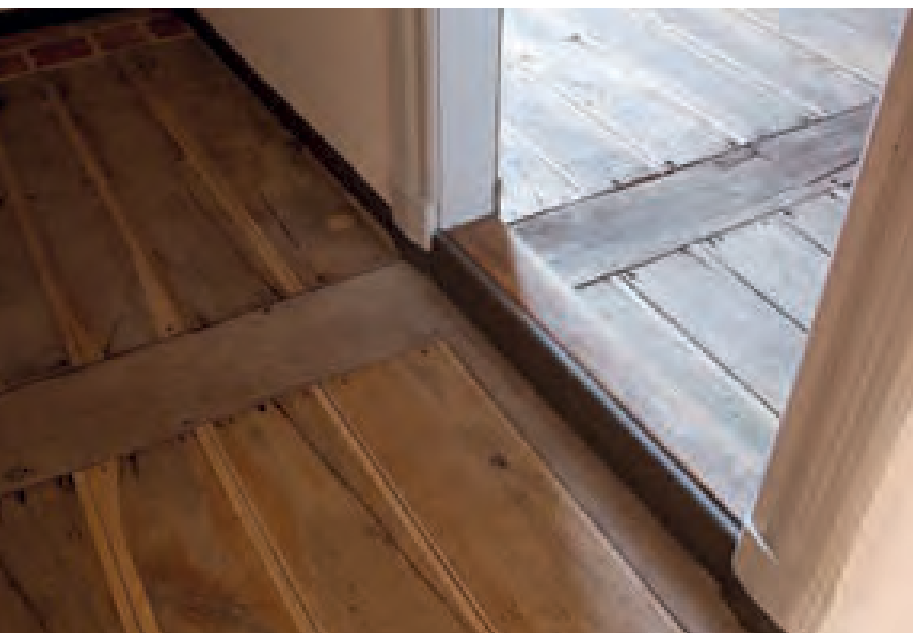
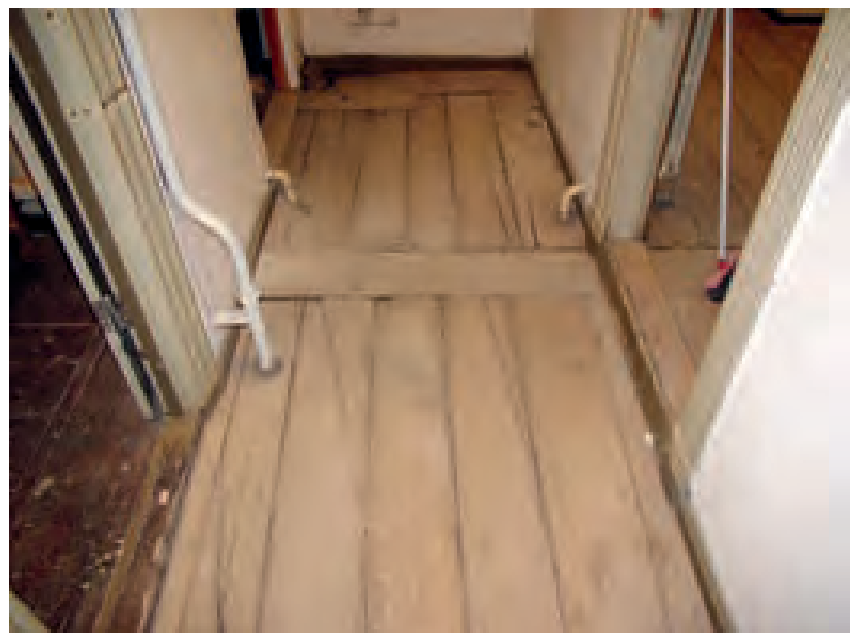
I korridoren mod østgavlen ligger landets måske ældste bevarede egetræsgulv, lagt da trægulve af komfortensyn afløste Bispegaardens flisegulve. Disse gulve er sjældne, da egetræ ganske vist tåler slid, men let sprækker, og snart gik man over til næsten udelukkende at lave gulve af fyrretræ. Den tværgående guldplanke markerer forlængelsen af hovedbygningen i anden halvdel af 1500-årene. Under restaureringen blev gulvet taget op og repareret, hvorefter de enkelte guldplanker blev lagt tilbage på deres oprindelige plads. Foto tv.: Kurt Rodahl Hoppe. th. Lundqvist Tegnestue.

In the corridor towards the east gable end is what is perhaps the oldest preserved oak floor in Denmark, laid down at a time when, for reasons of comfort, wooden floors replaced the former flagstone floors in the Bishop's Palace. These floors are rare, as although oak is hard-wearing, it splits easily, and very soon, floors began to be made solely from pine. The transverse floorboards mark the extension of the main building in the second half of the 16th century. During restoration, the floor was taken up and repaired, after which the individual boards were relaid in their original position. Photo left: Kurt Rodahl Hoppe. right: Lundqvist Architects.

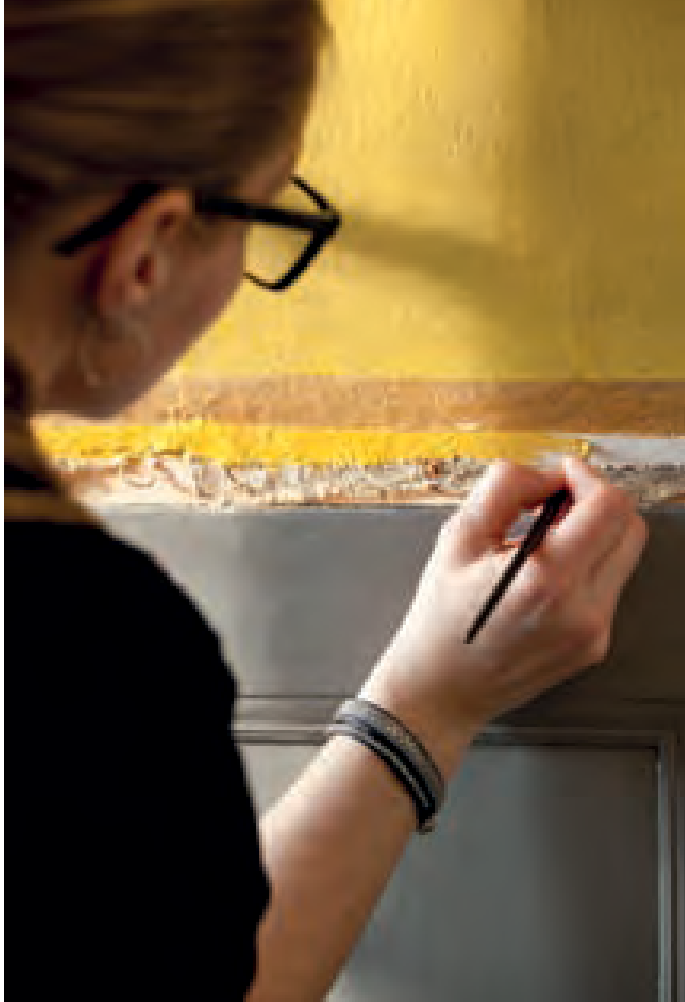
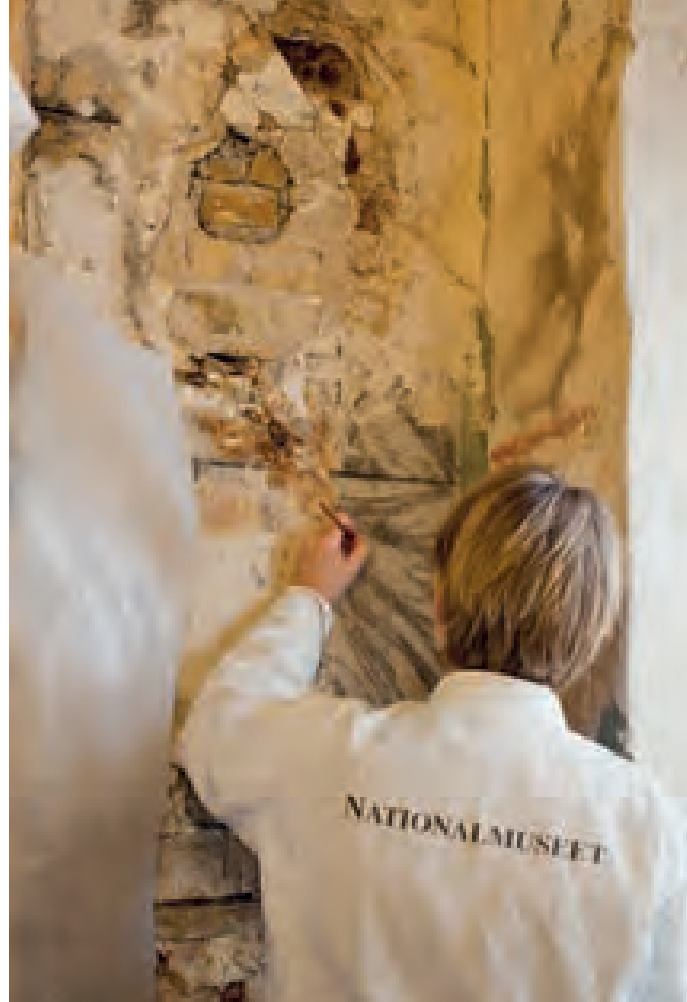
På skillevæggen nord for Salens kakkelovn ses den oprindelige bemaling, som den antagelig har været i hele rummet: gul, dodenkop, sort – formentlig en midlertidig sørgebemaling – dernæst kvadrering med en lidt ubehjælpssom marmorering og endelig hvidtekalk som sidste lag før spåntapet og lærreder. Foto: Kurt Rodahl Hoppe.

On the partition wall north of the stove in the Hall the original paintwork appeared. It presumably covered the whole room: Yellow, caput mortuum, black – supposedly a temporary mourning paint scheme – then imitation stonework with a rather clumsy marbling effect, and finally limewash as the final layer before the wooden wallcovering and the canvas. Photo: Kurt Rodahl Hoppe.

of the hall was later subdivided several times, and in the early 1800's this was done with partitions made of recycled boards. The end-wall fireplace was now at the end of a corridor and was blocked off.

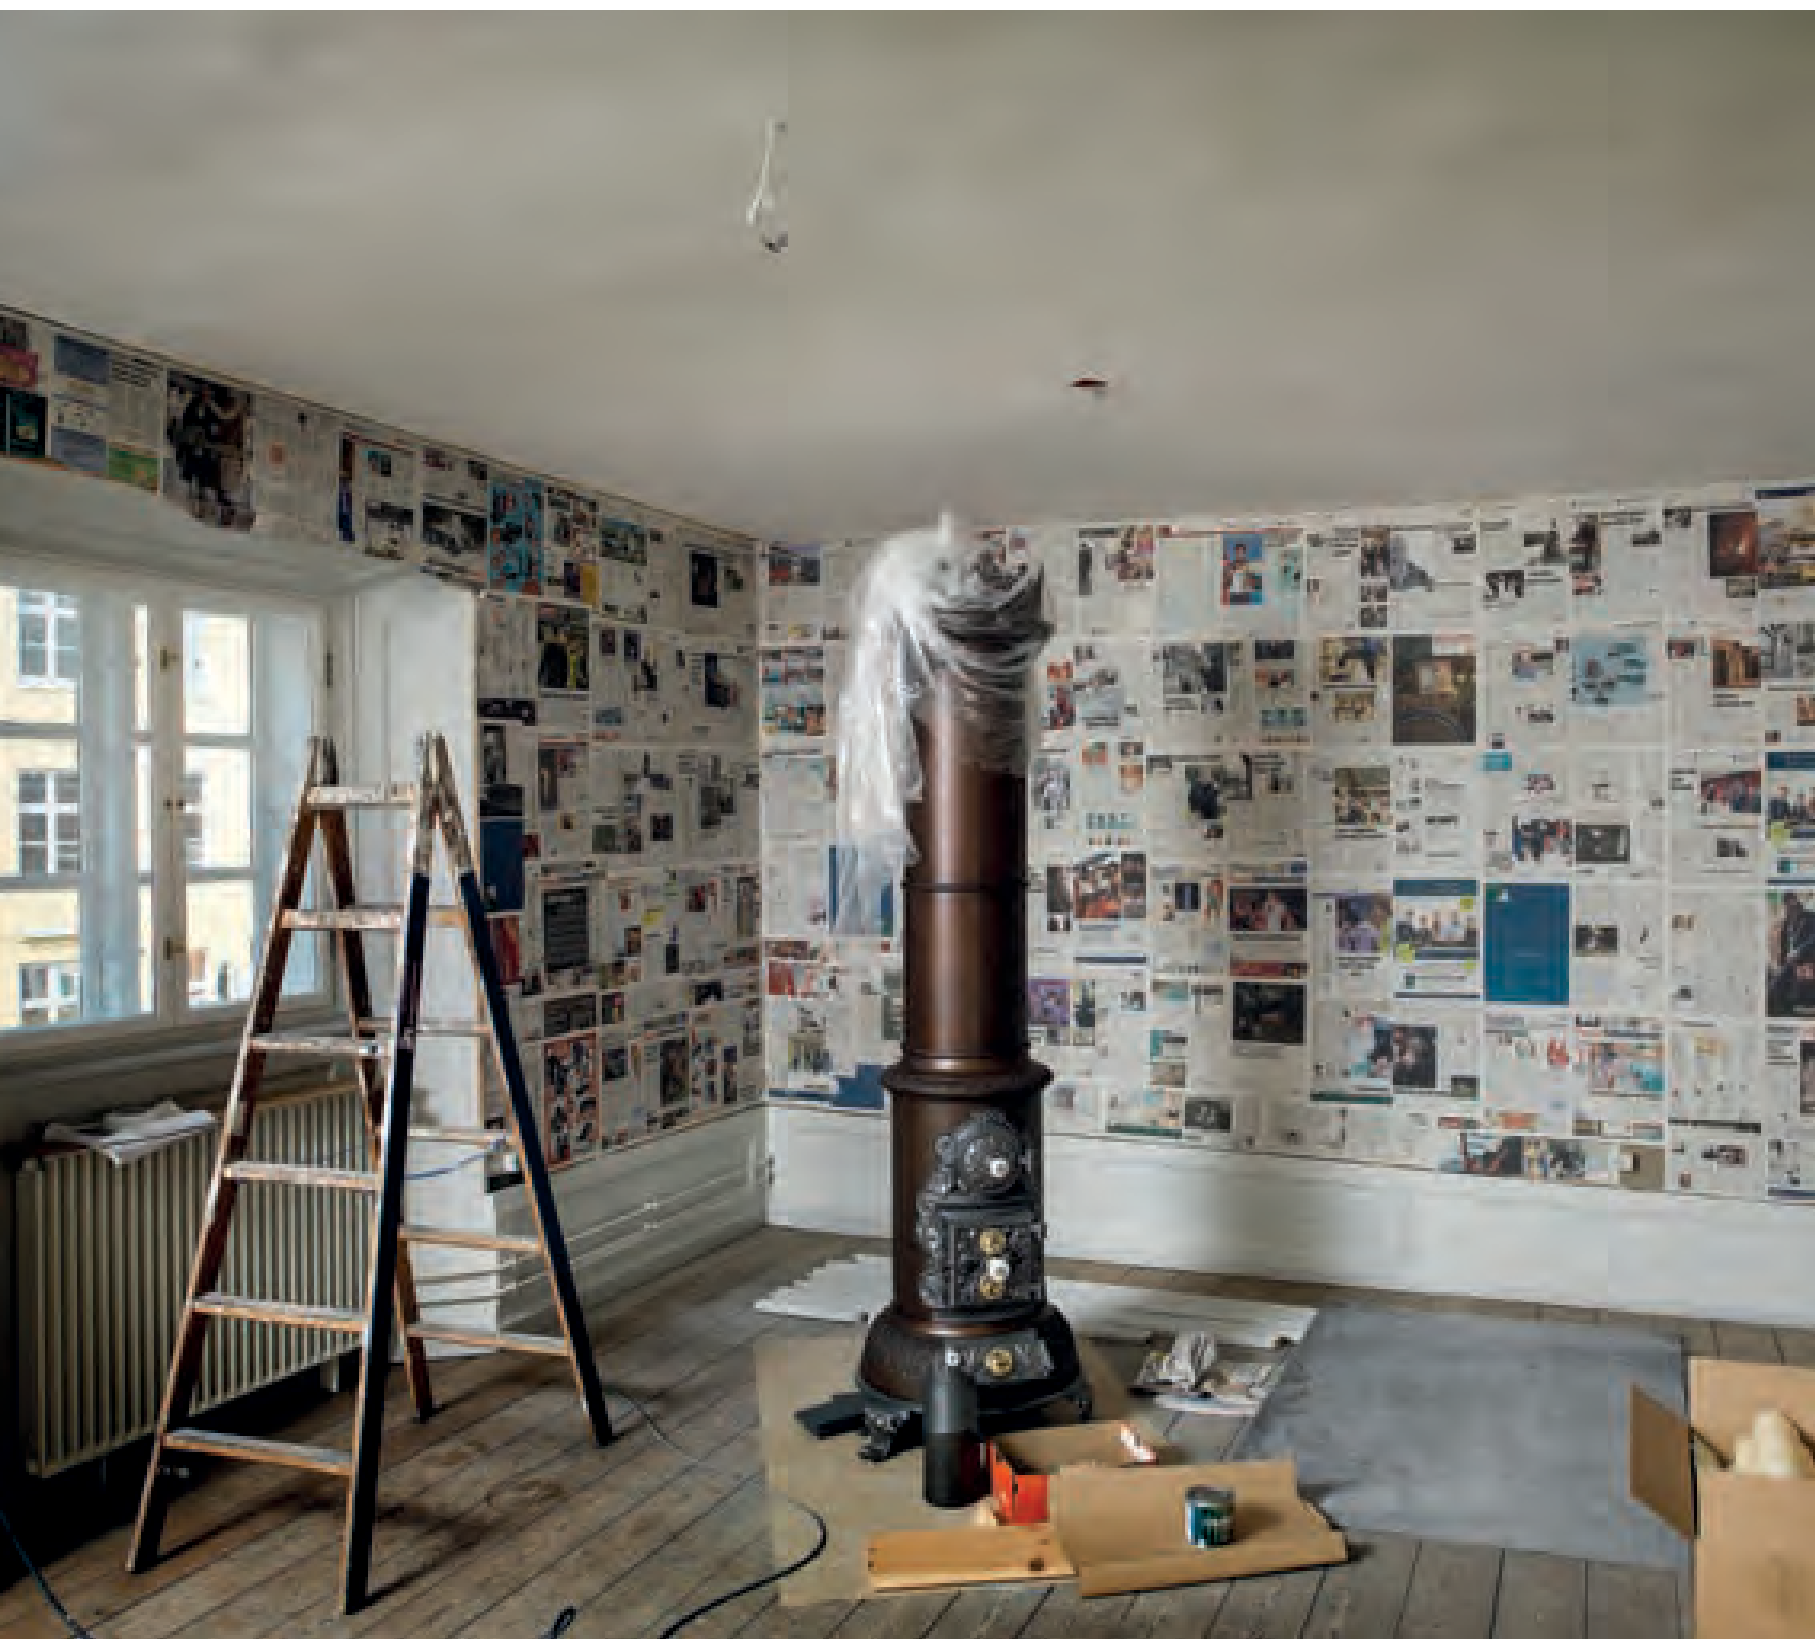
Der er ikke fjernet noget under restaureringen af klosteret, der lægges i stedet nye lag på alle de foregående, så alt er bevaret indenunder. Når konservatorerne har sikret de oprindelige lag på væggene, opsættes der grundpapir uden lim og derefter lærred på en træramme. Lærredet tapetseres med avispapir, idet det kan glattes fuldstændigt – og det skal være med tryk. Herefter tapetseres med endnu et lag grundpapir, og herefter er væggen parat til bemaling med limfarve eller opsætning af det endelige tapet. Foto: Roberto Fortuna.

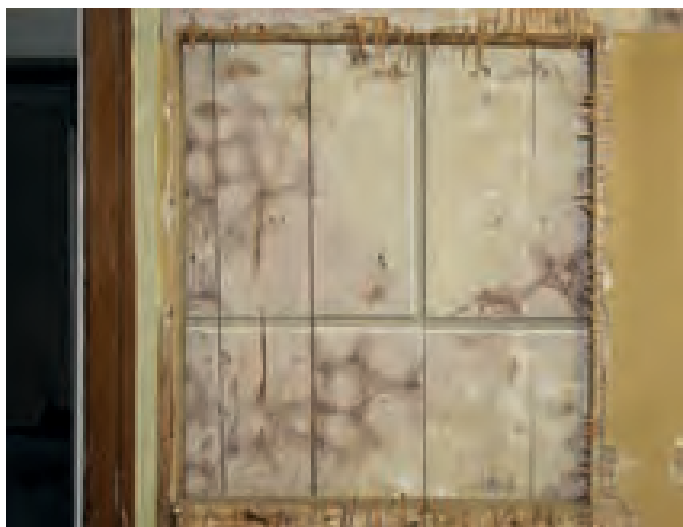
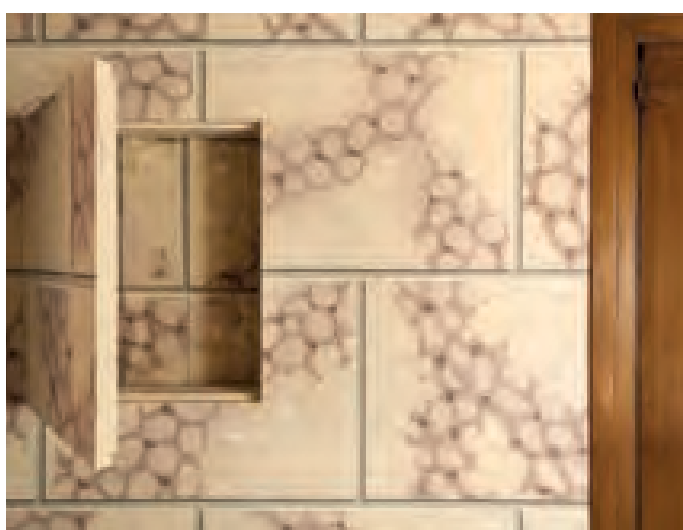
During the restoration, original marbling was found by chance on the back side of a board wall between the west staircase, 215, and room 214, and then it was also found near the other staircase. The marbling has now been restored in the two staircases, 109+211 and 112+215. A door has been made in room 215 so that the original pattern can be seen. Photo: top: Lundqvist Architects. Others: Kurt Rodahl Hoppe.

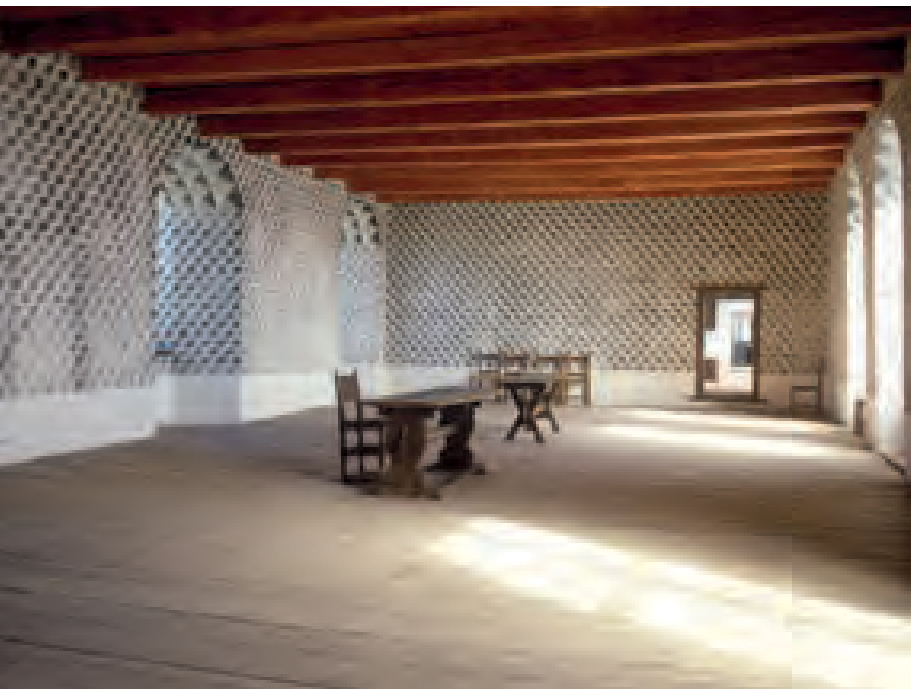
Nyborg Castle. Hall with lime-painted geometric wall decoration in black, white and grey. The pigment was likely carbon black. Painted in the 1520's. Photo: Roberto Fortuna, 1990's.
