The Arcade Room

Restaureringen af Jomfruklosteret

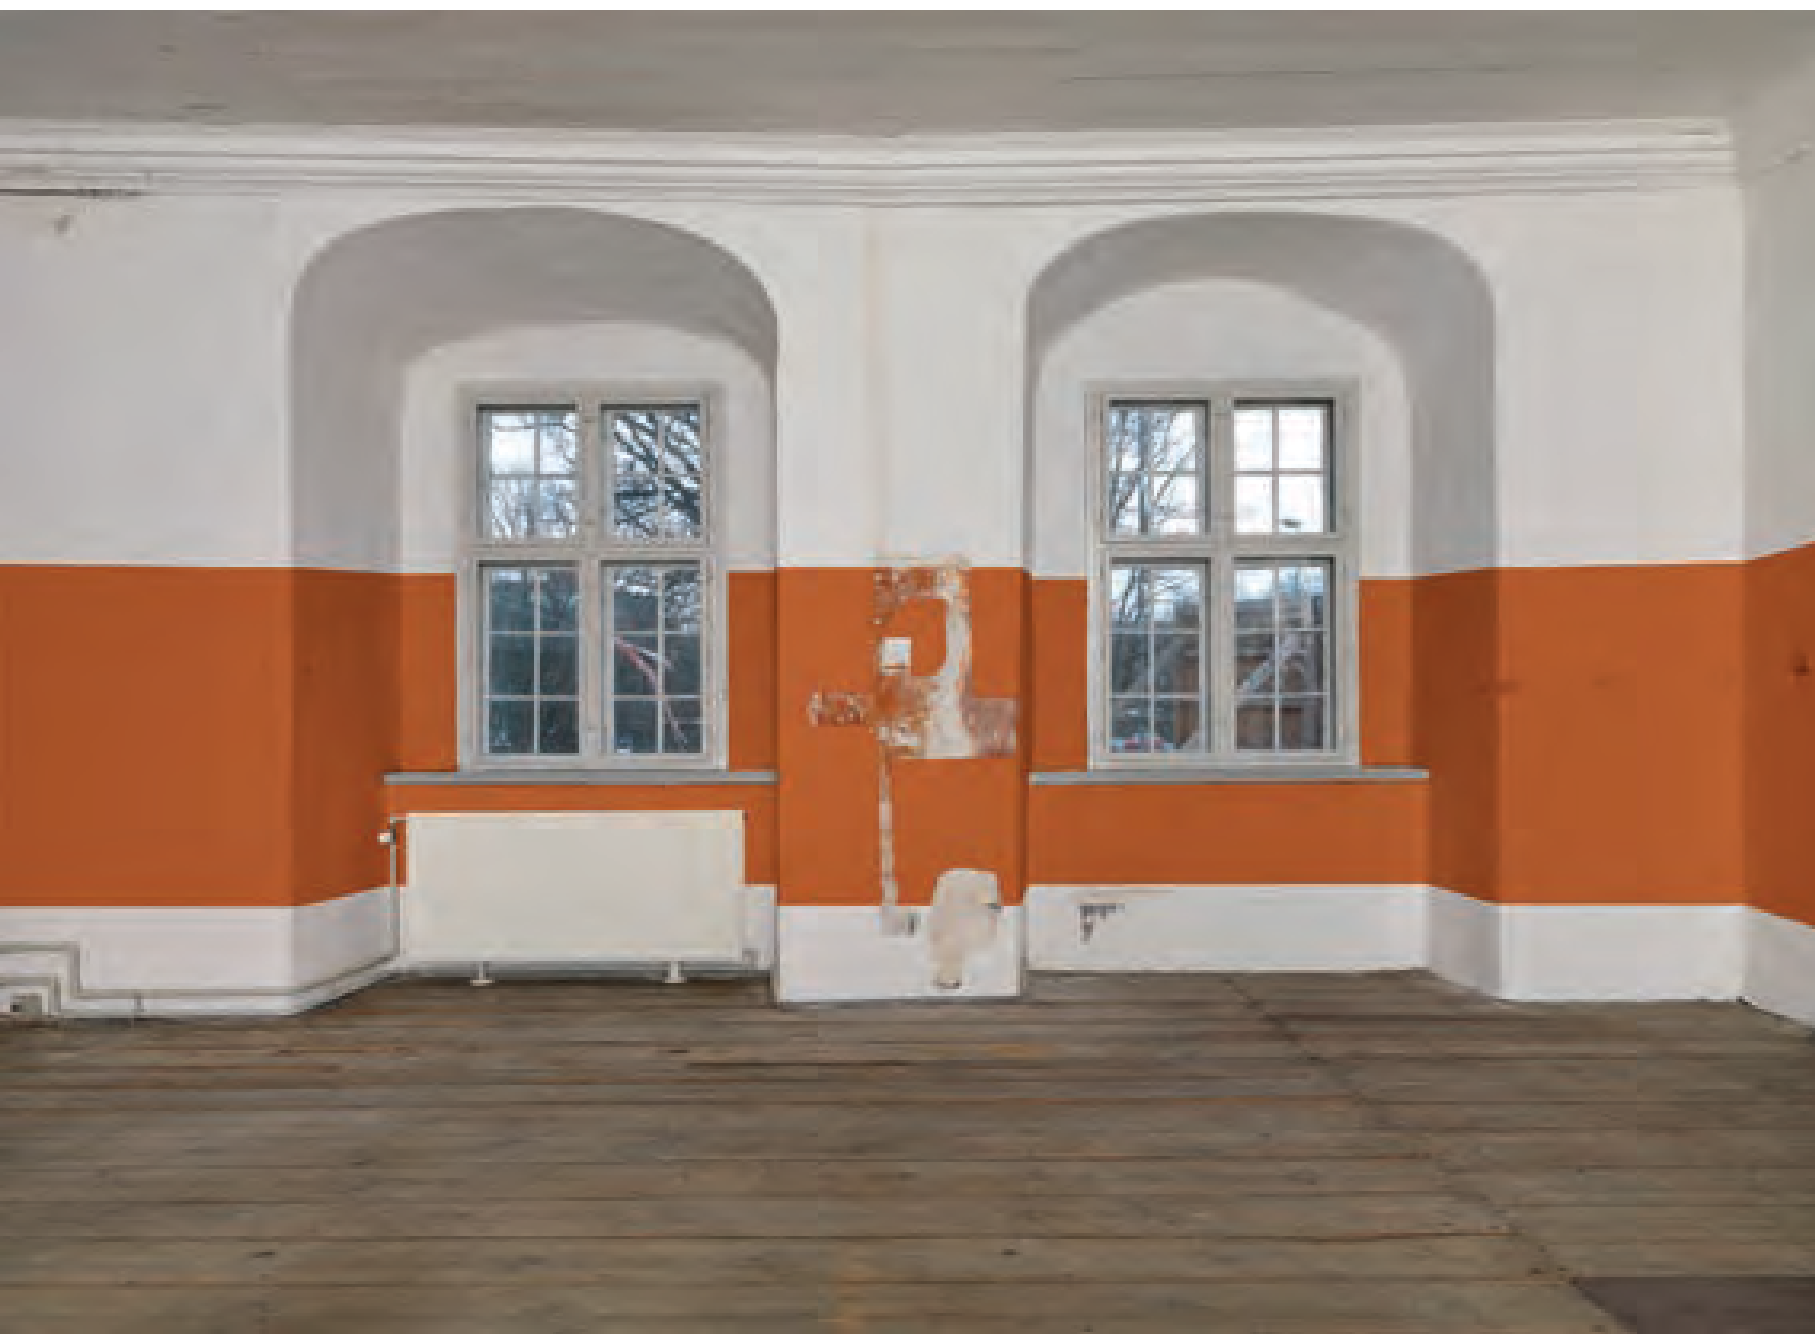
The Odense Secular Convent for Noblewomen. In the building's original medieval hall around the year 1508, a nearly 1.5 metre high red stripe was painted around the entire room, probably in distemper. This imitation of hanging carpets showed the building's wealth by using the expensive red lead pigment. Digitally reconstructed photo. Photo: Roberto Fortuna, 2011.

Painted imitation textiles are also seen at other manors, such as Gl. Estrup in Djursland. The imitation here was more realistic, since the rug was painted with folds in the fabric, as opposed to the one from the bishop's palace, which was only painted as a flat surface. However, the pigment used in the hall of the bishop's palace was red lead, an exclusive pigment at the time.

The ceilings in the halls of the bishop's palace were also painted with red lead and also decorated with painted imitations of decorative carvings along the beams, painted in shades of grey to give the appearance of light and shadows. In the same way, whitewashed beams with green-painted ornaments from the Middle Ages were found in other rooms, and walls in less important rooms were lime-washed in white, ochre, caput mortuum (violet) and grey. Cheap earth pigments were used here, which shows that the rooms had a lower status than the fine red lead-painted halls.

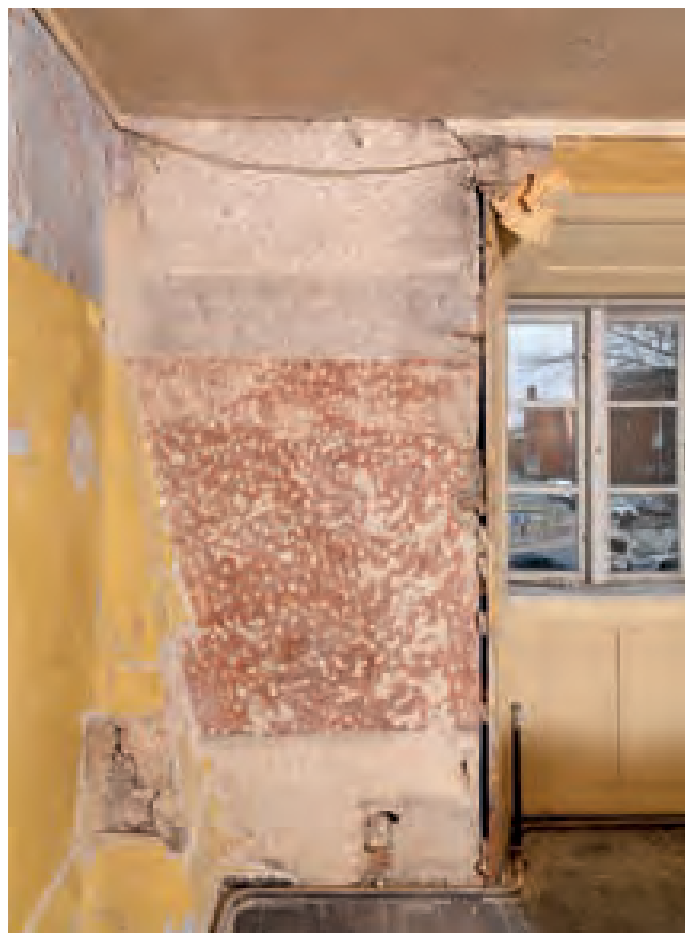
The Odense Secular Convent for Noblewomen. Around the year 1600, the top floor's hall was decorated with a painted imitation textile and imitations of coated stucco profiles, painted in distemper with the less expensive pigments iron oxide red and carbon black. Photo: Roberto Fortuna, 2011.

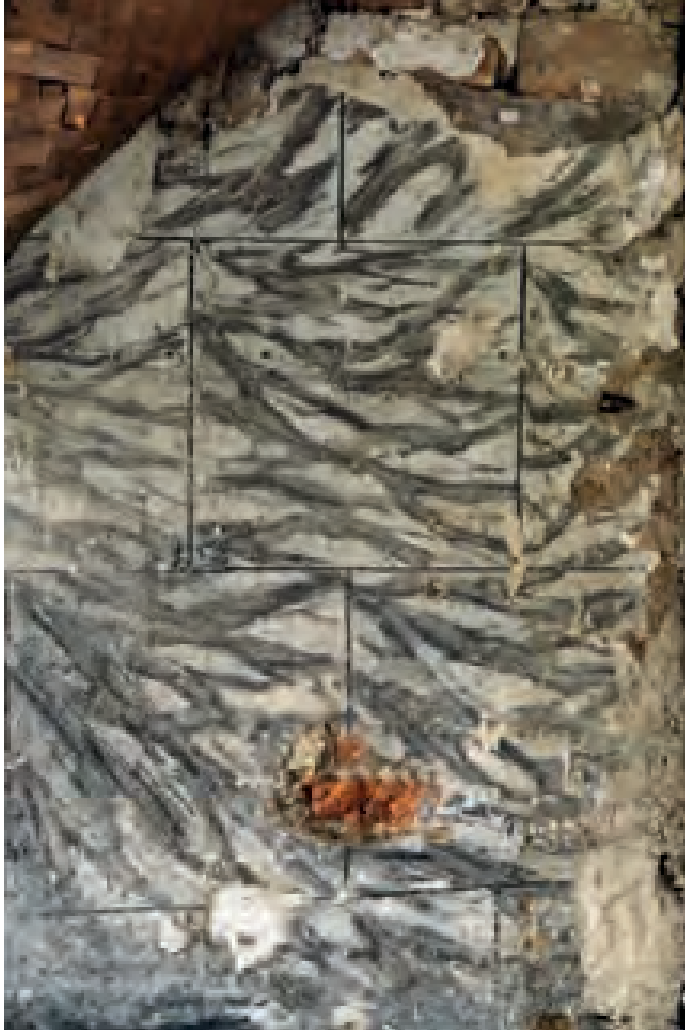
The Odense Secular Convent for Noblewomen. Black and grey marbling on a white base, divided into ashlars that were designed to resemble marble blocks. The decoration filled the walls of the hall in the middle of the building and was done in the late 1600's, presumably using distemper and carbon black pigment. Photo: Roberto Fortuna, 2011.

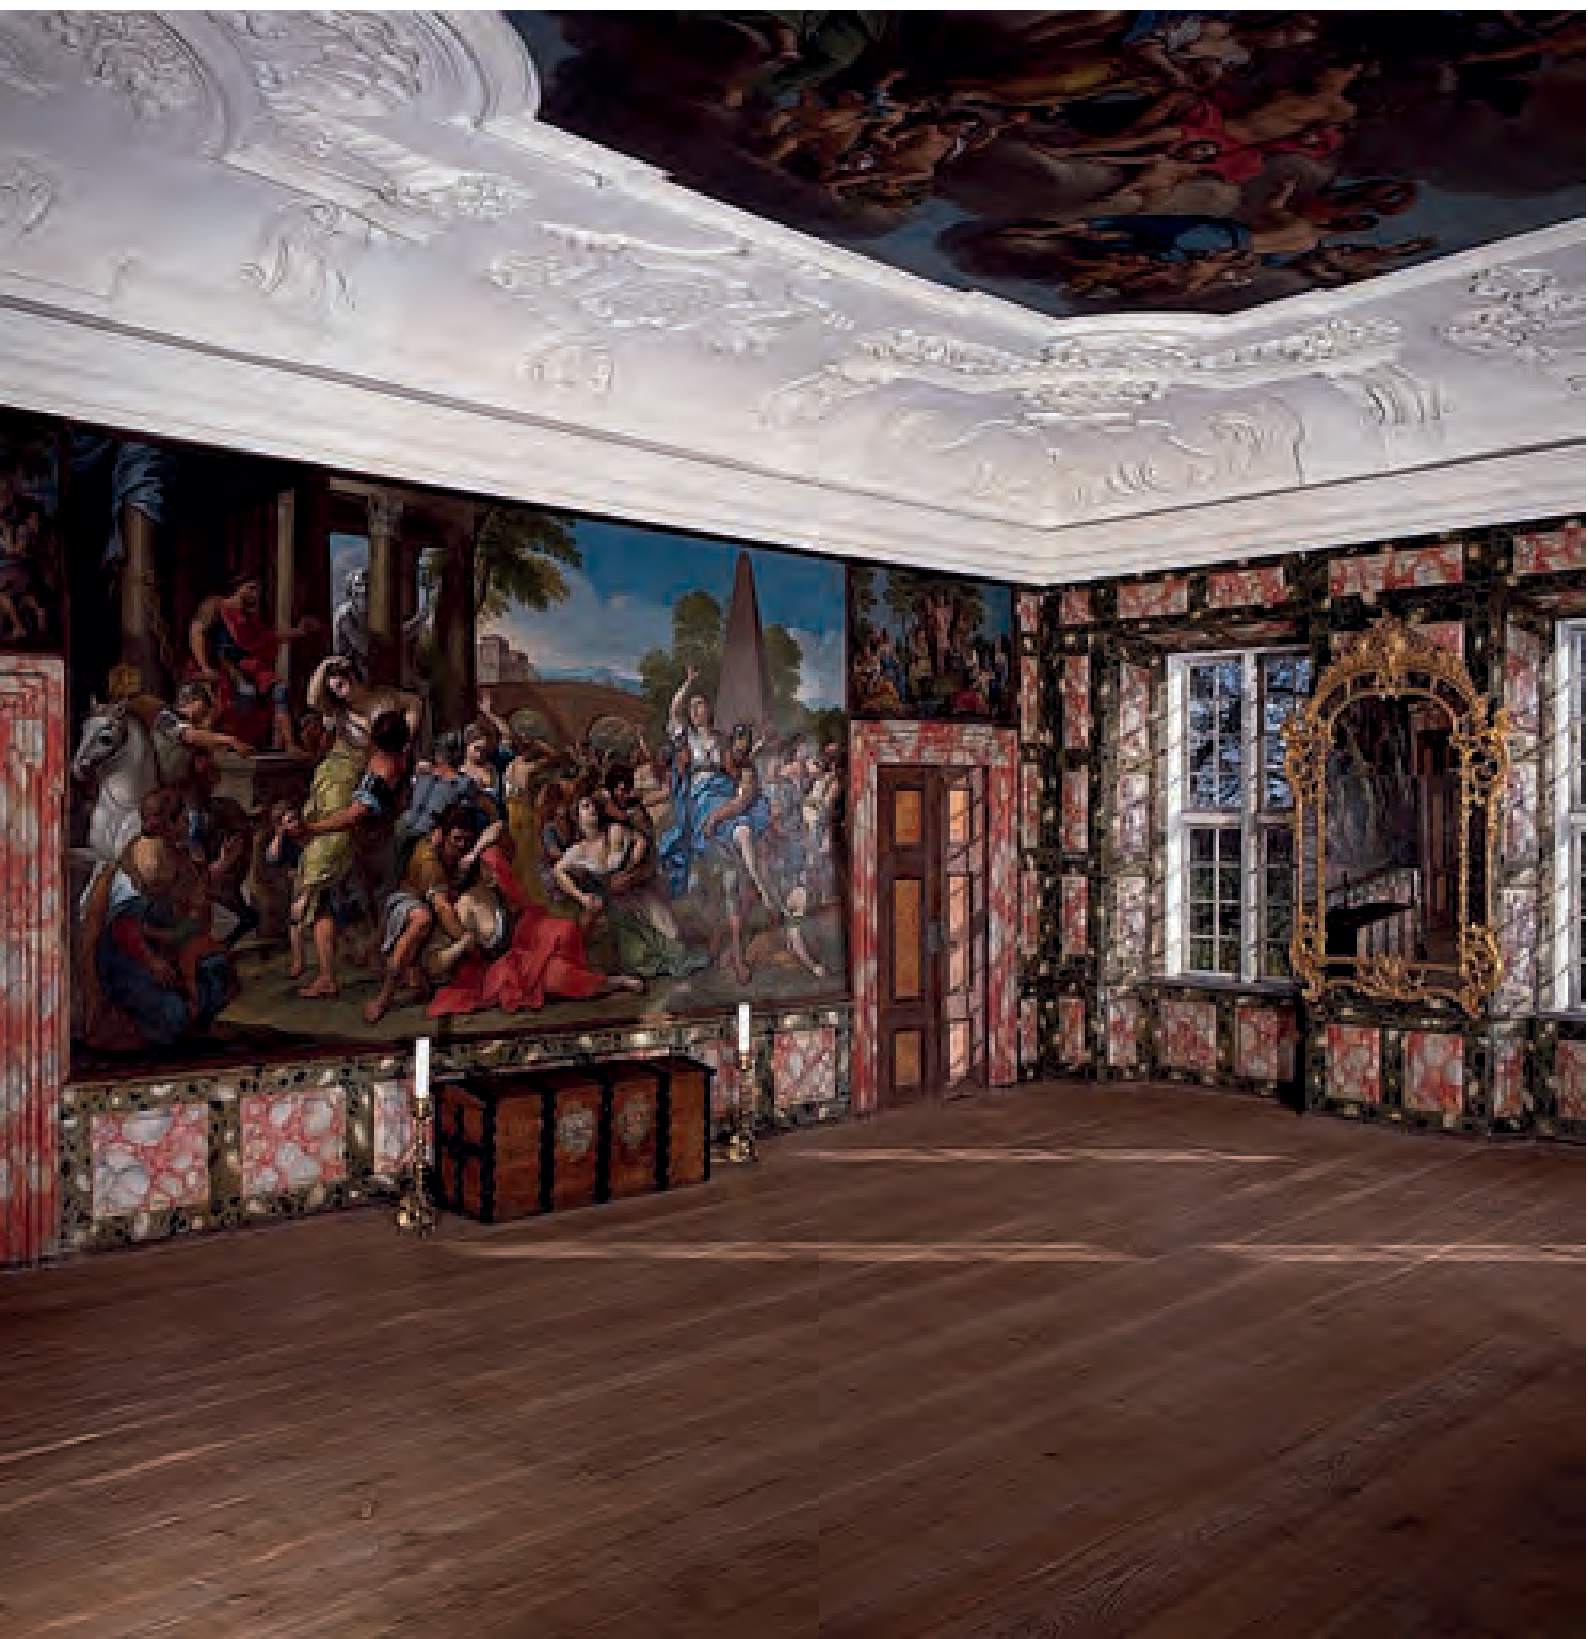
Selsø, Hornsherred. At the time of the building's construction in the 1730's, the great hall was decorated with marbled woodwork and figurative paintings by Hendrik Krock on stretched canvases, hung on the ceiling and walls. The popular stucco ornaments of the Baroque period can be seen around the ceiling painting. Photo: Roberto Fortuna, 1990's.

During this period, figural painted motifs or decorations with garlands and ornaments were used on the walls. One example of such a hall is found at the Selsø manor in Hornsherred. The woodwork in the rooms was painted with decorative marbling, while painted wall canvasses by the artist Hendrik Krock were hung on the hall. Yet another feature of this period were paintings in the middle part of stucco ceiling, known as ceiling paintings, as seen at Selsø. Such decorated ceilings were not found at the Secular Convent for Noblewomen, but rather more simple rooms with white-painted wooden ceilings and red line decoration, white- and grey-painted plastered walls, and unpainted or grey-painted woodwork. Karen Brahe's library was arranged in the hall in the west end of the building and here the walls and ceilings

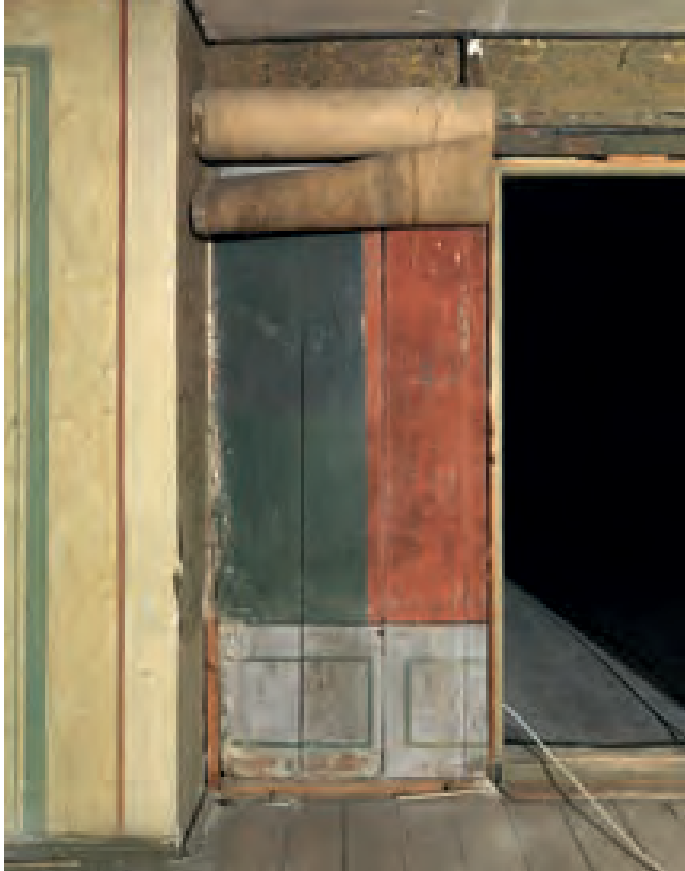
The Odense Secular Convent for Noblewomen. Living quarters for the "noble virgins" (unmarried ladies of rank) were decorated with stripe decorations, meaning painted imitations of textile stripes hung on the walls above an illusionary painted dado. Likely painted in distemper during the first half of the 1700's. Photo: Roberto Fortuna, 2011.

We have never before found such extensive use of stripe decoration in Denmark. It appears that this was a quick and inexpensive way to decorate a room and make it look proper. We have yet to find such decoration in the Danish manors. The increasing application of paint on all surfaces was a part of the desire for comfort. A painted surface is typically smoother and easier to clean than an unpainted plaster or wooden surface, while the painted decorations also graced the interiors.

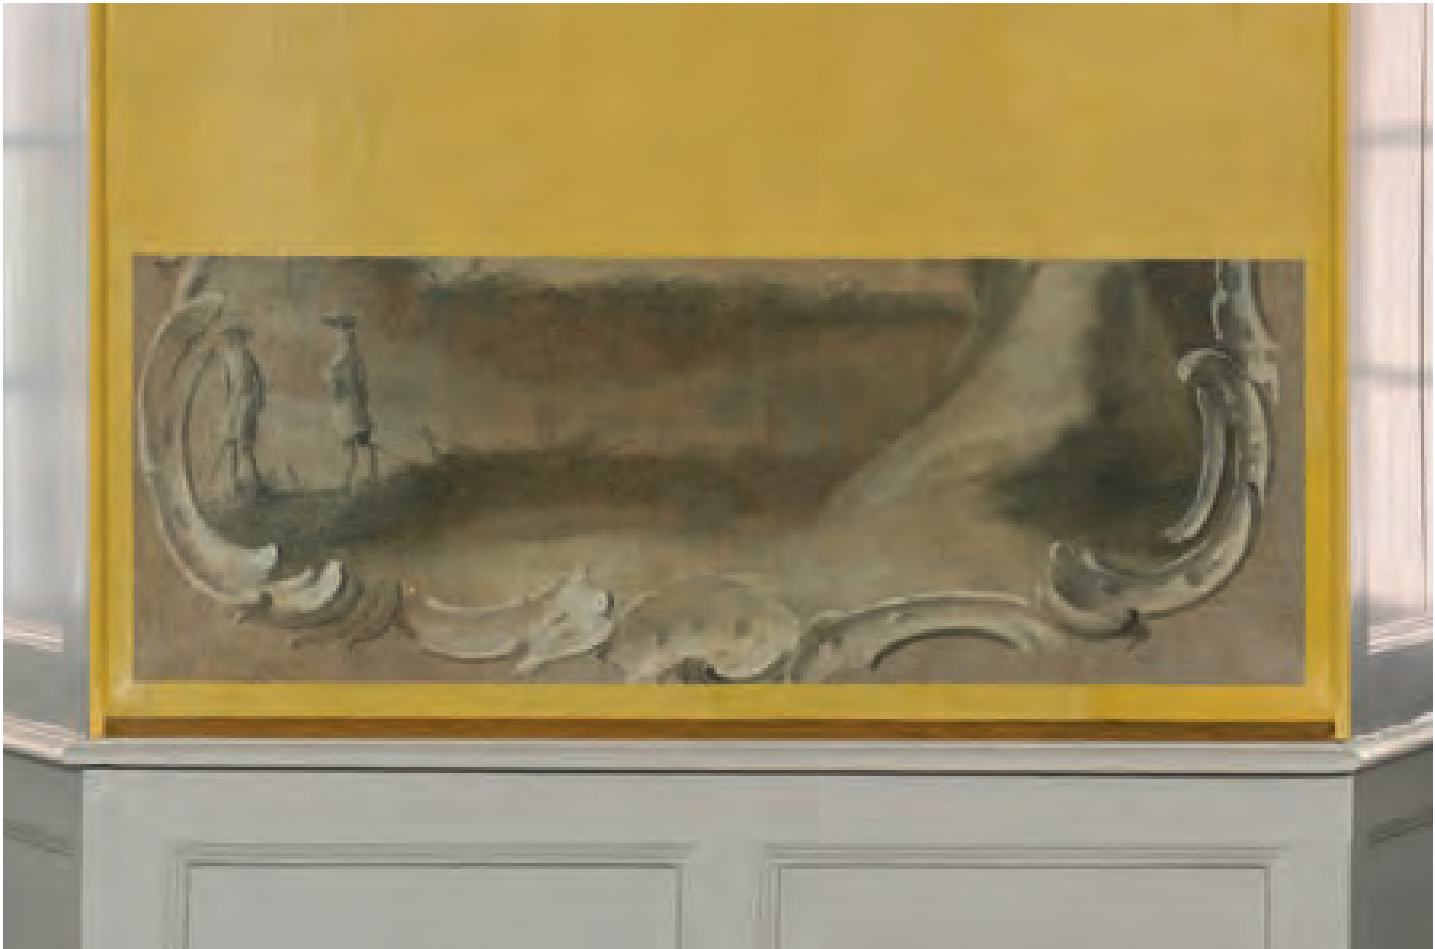
The Odense Secular Convent for Noblewomen. Rococo decoration painted on the wall canvases in the hall, portraying people and ornamentation. Done in shades of grey with oil paint. Photo: Roberto Fortuna, 2013.

The walls are decorated with canvases on the upper sections of walls and wood panelling on the lower sections. Wall silks are used like oil-painted canvases, with painted artistic motifs or with rocaille. On the middle floor of the Secular Convent for Noblewomen, we have found wall canvases with figural motifs framed in rocaille-painted frames. And at the Eremitage Castle, the painted wall canvases were decorated with hunting scenes.

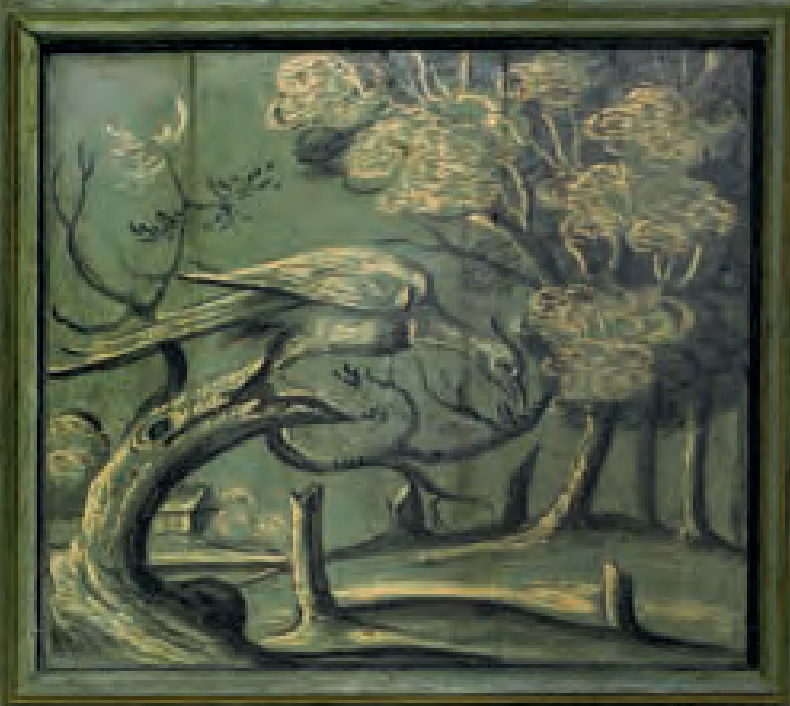
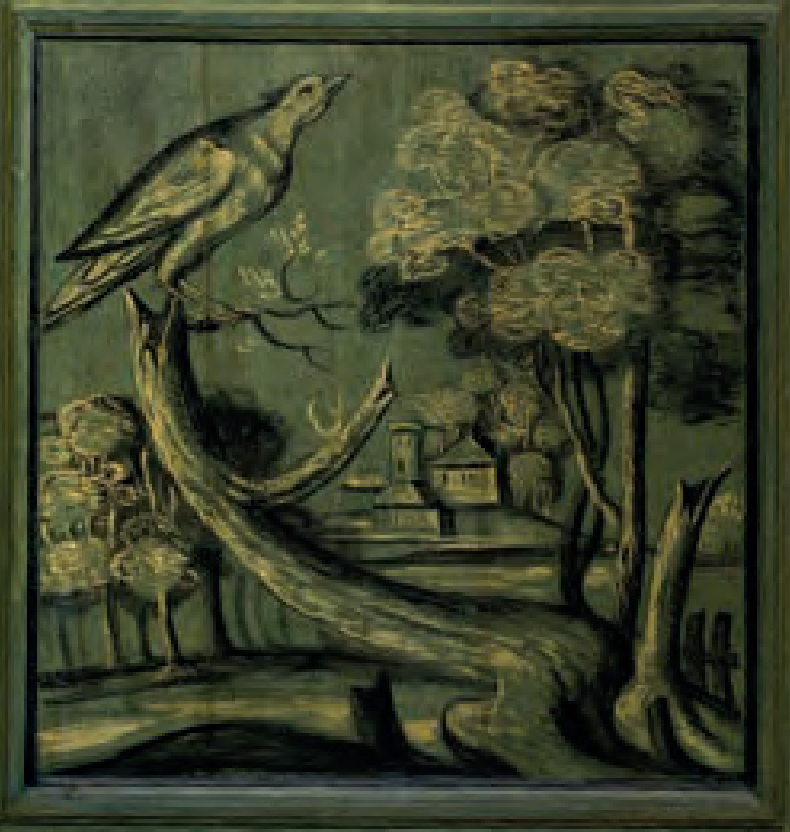
The Odense Secular Convent for Noblewomen. Door with bird motif on Prussian blue base from the mid-1700's. Prussian blue was introduced in the 1720's and became the most popular pigment of its time, in part because this period prized Chinese blue and white porcelain. Photo: Roberto Fortuna.

grey, corresponding to the strong interest in Chinese porcelain. It was also during this period that the synthetic pigment Prussian blue was invented. It was also inexpensive. This enabled the use of the blue and white colours for decorative purposes. At the Secular Convent for Noblewomen, we found a door decorated with a bird motif in precisely this very blue and light grey. Another room had blue decorative elements in freehand with columns and arches painted as arcades with a view to blue skies. Prussian blue is the main colour in this room. Walls are painted very simply with a single colour in light grey or other light distemper.

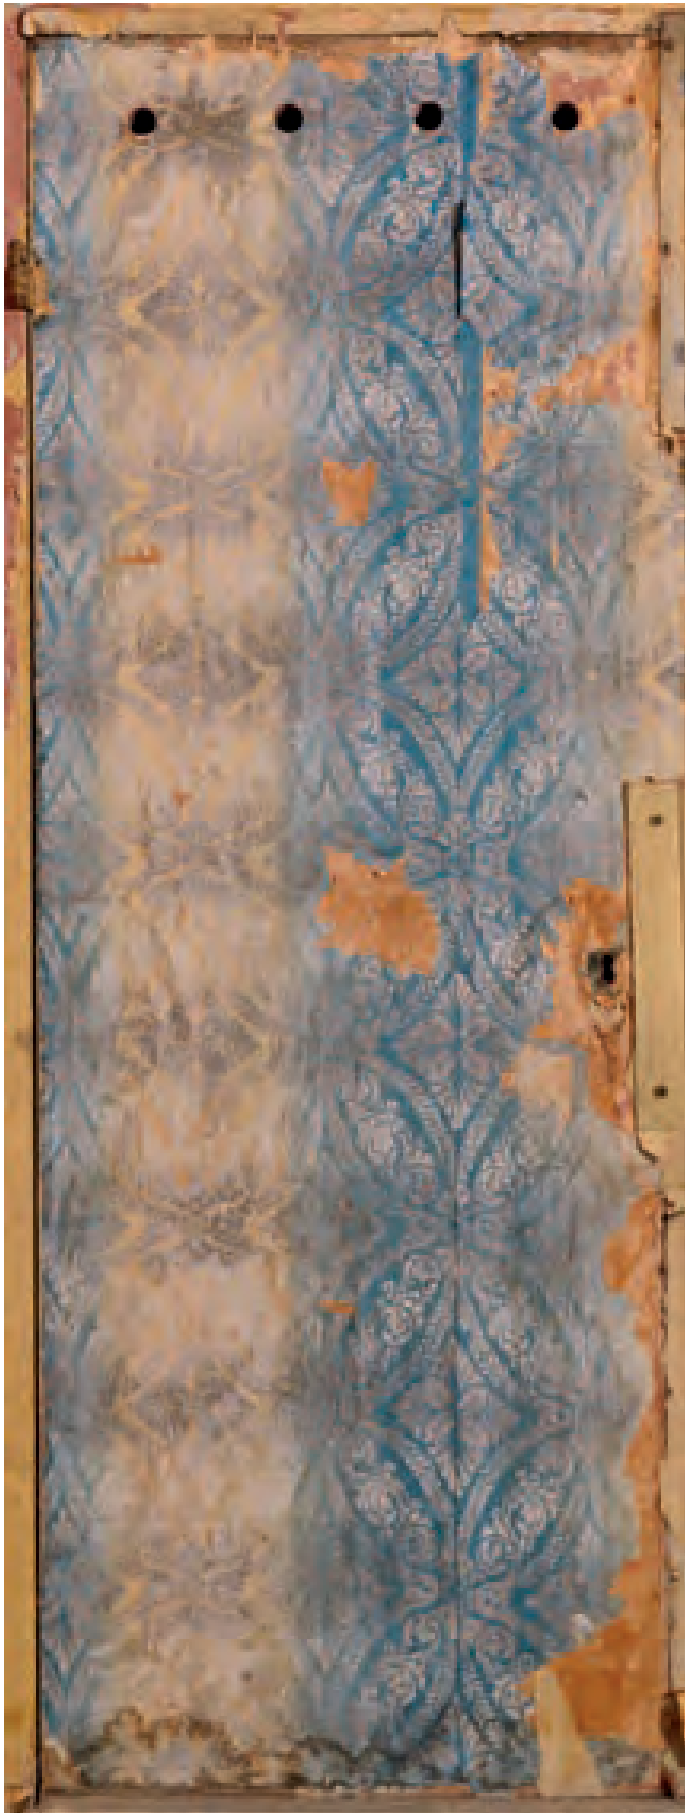
The Odense Secular Convent for Noblewomen. In the late 1700's, wallpaper became very popular in interior design. In the beginning, wallpaper typically featured printed imitations of the wall silks of earlier times, so the print is designed to resemble a wavy textile. Photo: Roberto Fortuna, 2011.

At the Secular Convent for Noblewomen, we found walls with wallpaper that was printed in sheets. The endless paper roll had not yet been invented, so the individual paper sheets were printed with a wallpaper pattern, whereupon the sheets were glued together into strips. We have found remnants of striped and floral wallpaper, as well as wallpaper with silk imitations. The wall silks of earlier times were outdated; however, imitating them with printed wallpaper was at the height of fashion. These wallpapers were printed in distemper, as this was the most suitable paint for printing.

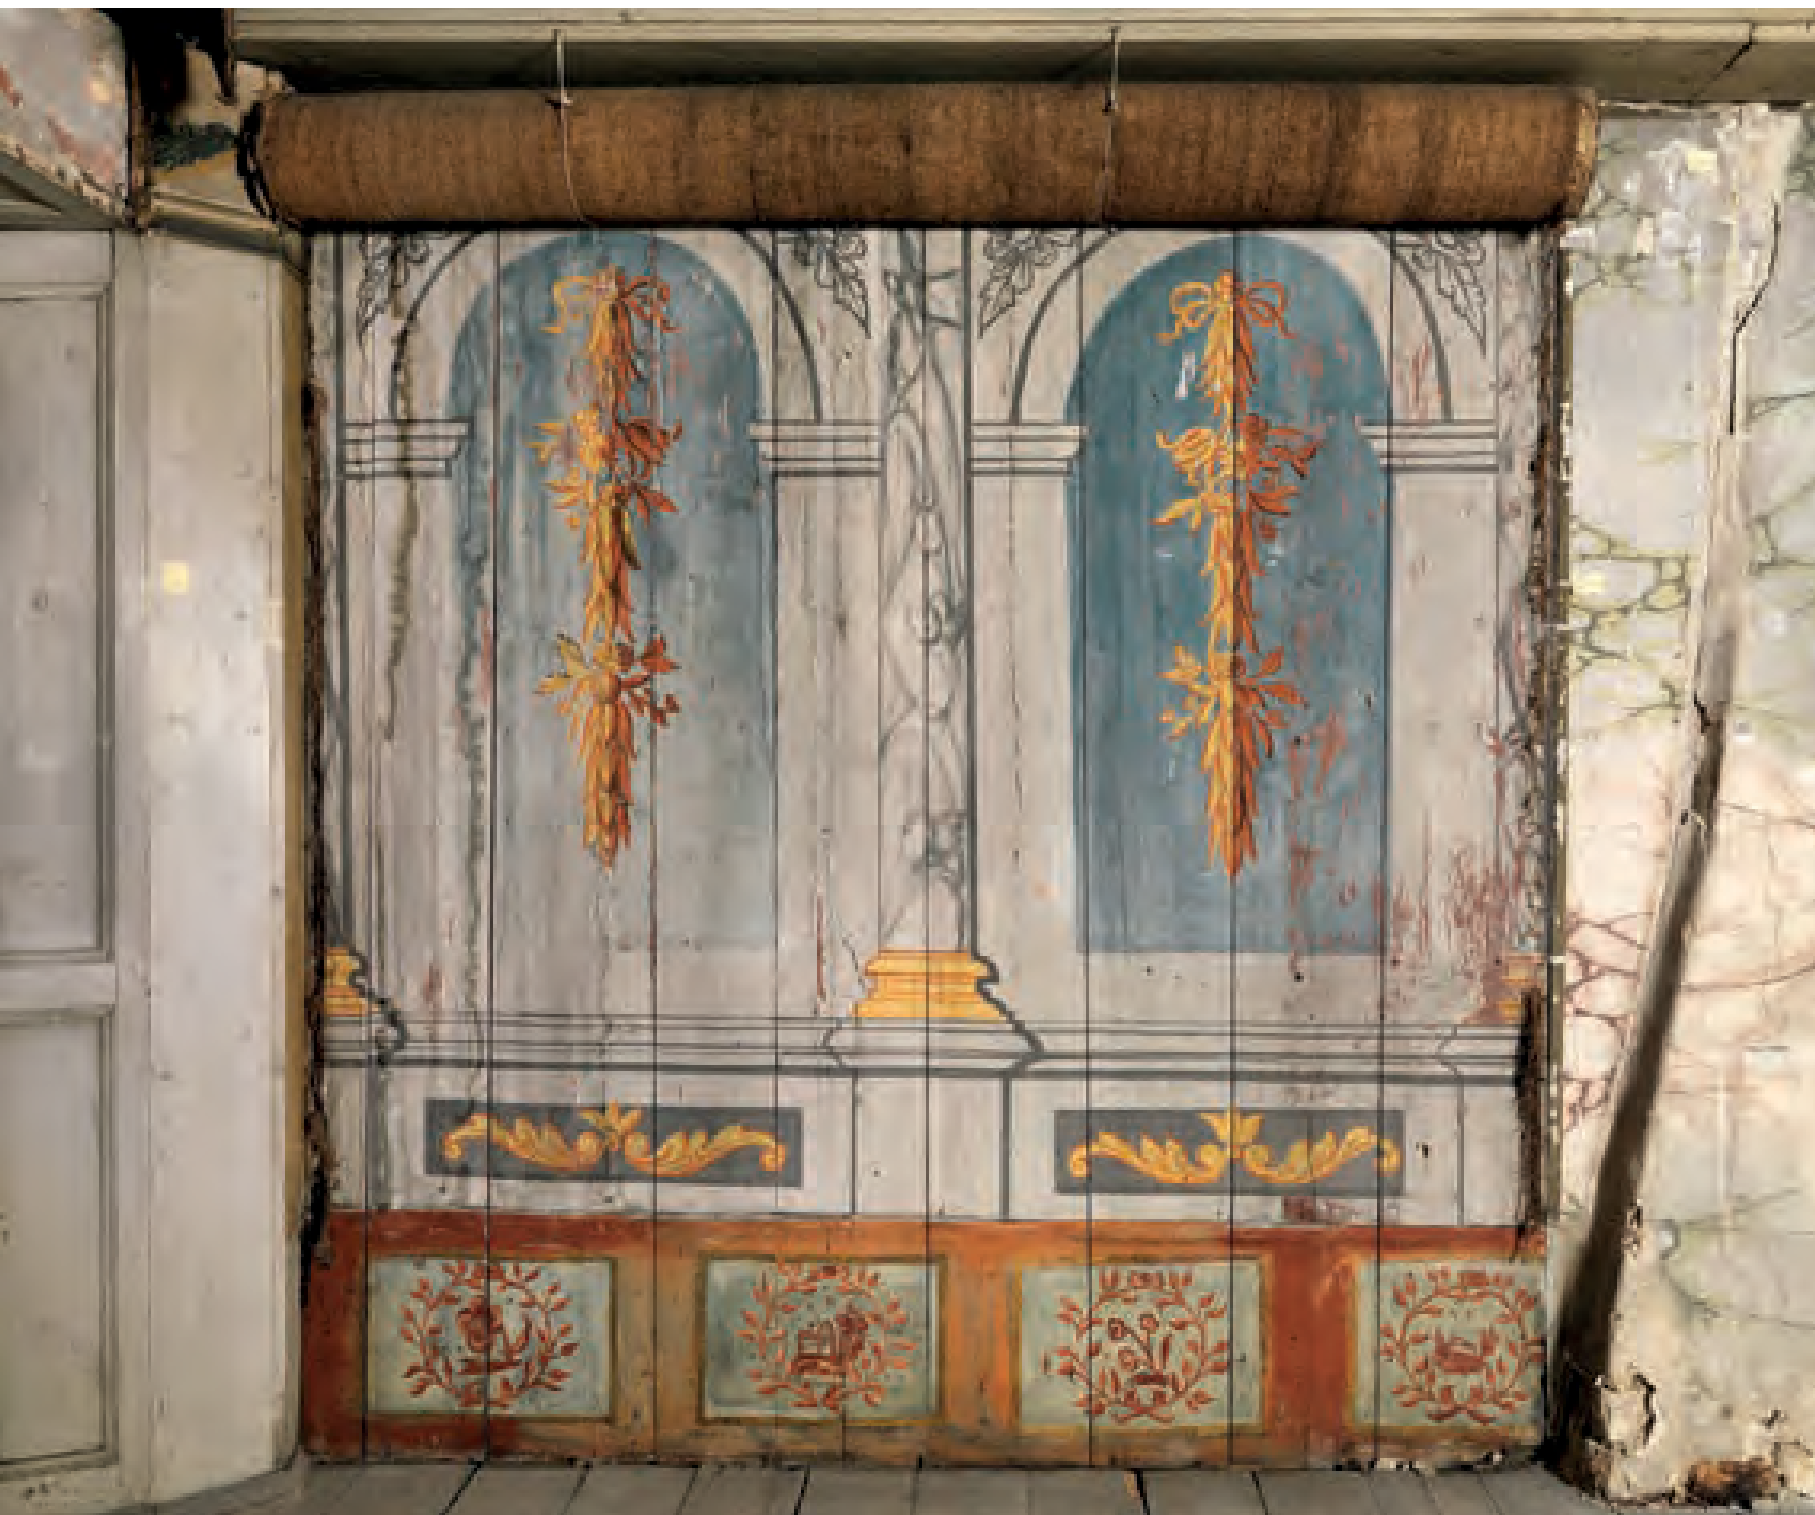
The Odense Secular Convent for Noblewomen. The living quarters were decorated to varying degrees. In the mid-1700's, one of the rooms was painted to create an illusion of marble columns and arcade arches, with a view to the sky. All of this was likely painted in distemper. Photo: Roberto Fortuna, 2011.

In one of the former living quarters on the first floor, the late Baroque decorations were preserved under wall canvases that were hung at a later time. These wall canvases have now been removed and stored in the attic, revealing decoration imitating arcade arches and garlands. Everything was originally done in distemper, which is vulnerable to wear and fluctuating humidity. Here it was necessary to glue all of the loose paint in place and then retouch damage in the paint.

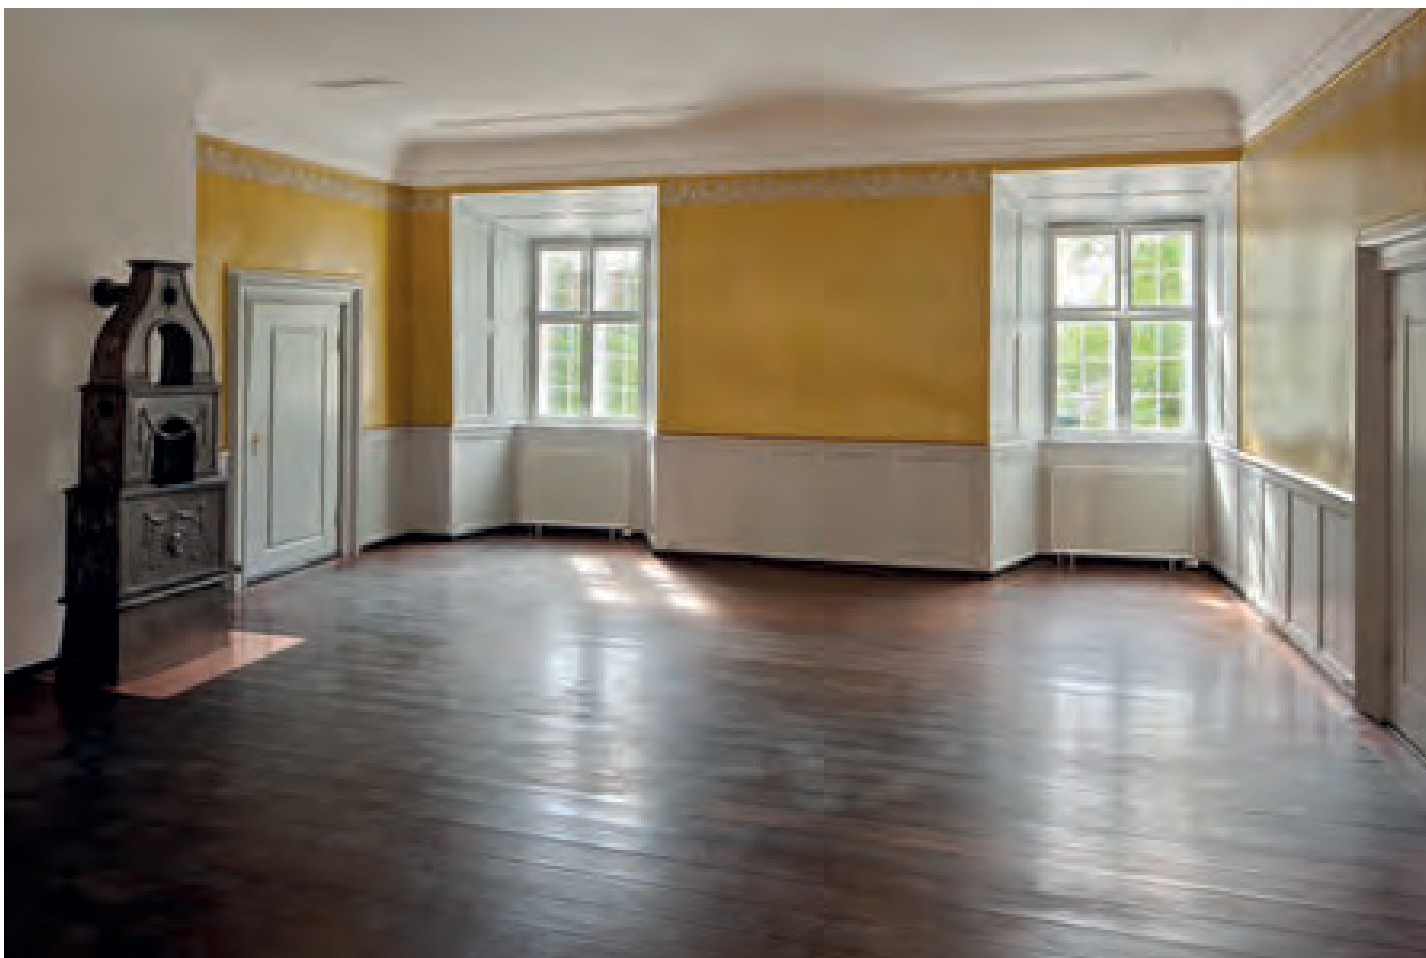
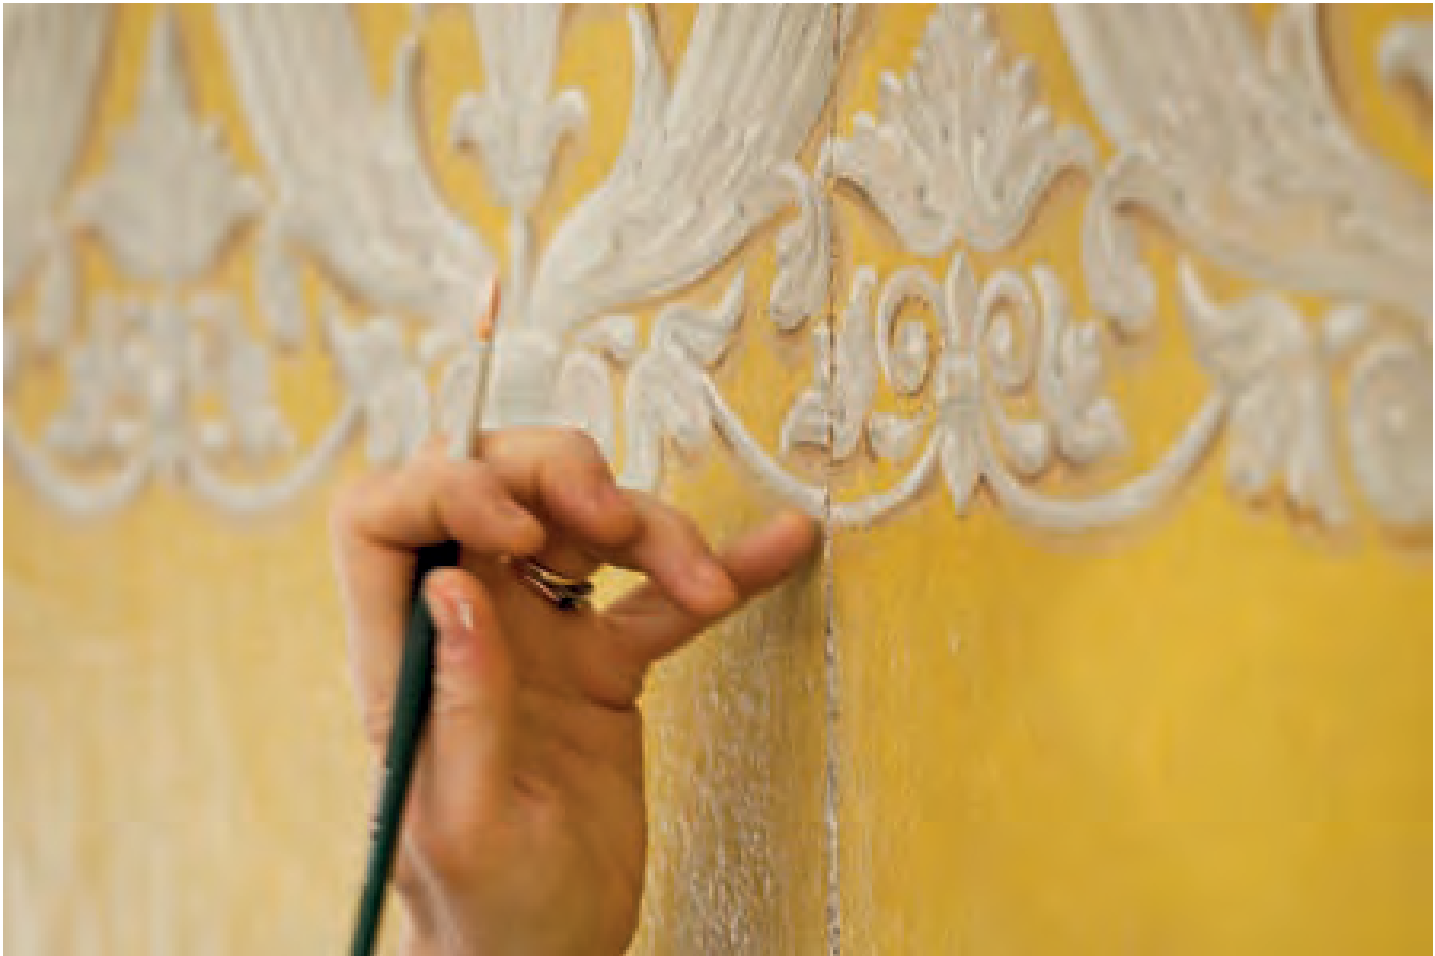
The Odense Secular Convent for Noblewomen. During the Rococo period, the hall in the middle of the building was decorated with stretched wall canvases featuring figurative motifs (see page 317). During the Neoclassical period, when it became outdated, the motifs were painted with yellow wall paint and a white ceiling frieze painted with a template. Painted in linseed oil paint in patent yellow and white. Photo: Kurt Rodahl Hoppe.

Walls were still covered with canvas above dados, reusing the canvases of the Baroque and Rococo periods. Thus, around the year 1800, the hall's rococo decorations were painted in accordance with the new, Neoclassical fashion. The walls were painted yellow with a stenciled border under the ceiling with white ornaments that may have been an attempt to imitate

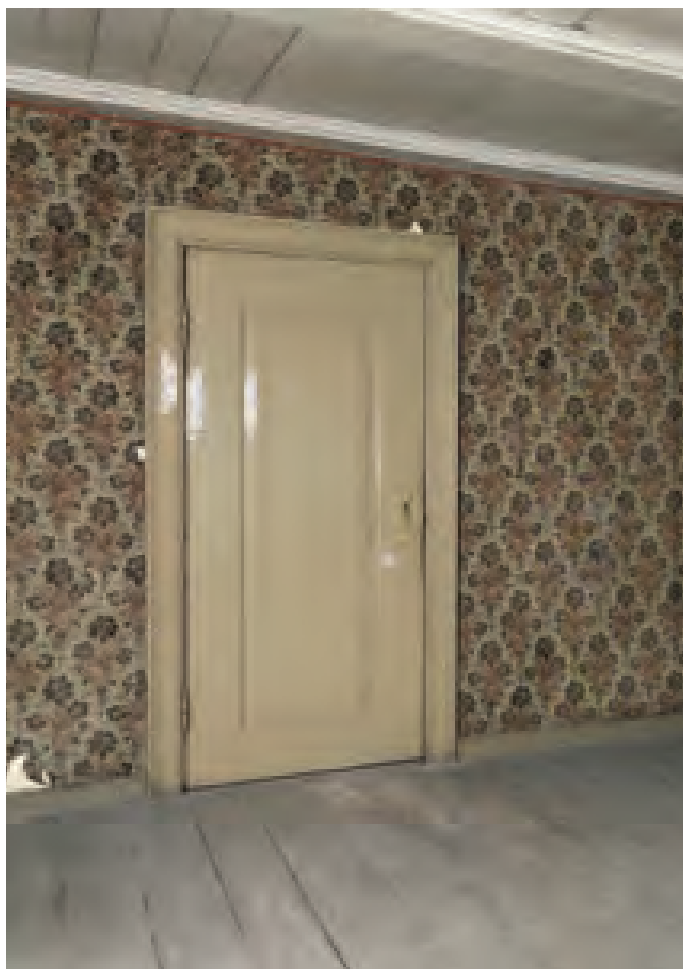
The Odense Secular Convent for Noblewomen. The living quarters' interiors were renovated over time. Beginning in the mid-1800's, many of the rooms were decorated with wallpaper, which had become much easier to manufacture at this time. However, the door's white paint came at a later date. When the wallpaper was installed, the woodwork was typically painted to resemble oak. Photo: Roberto Fortuna, 2011.

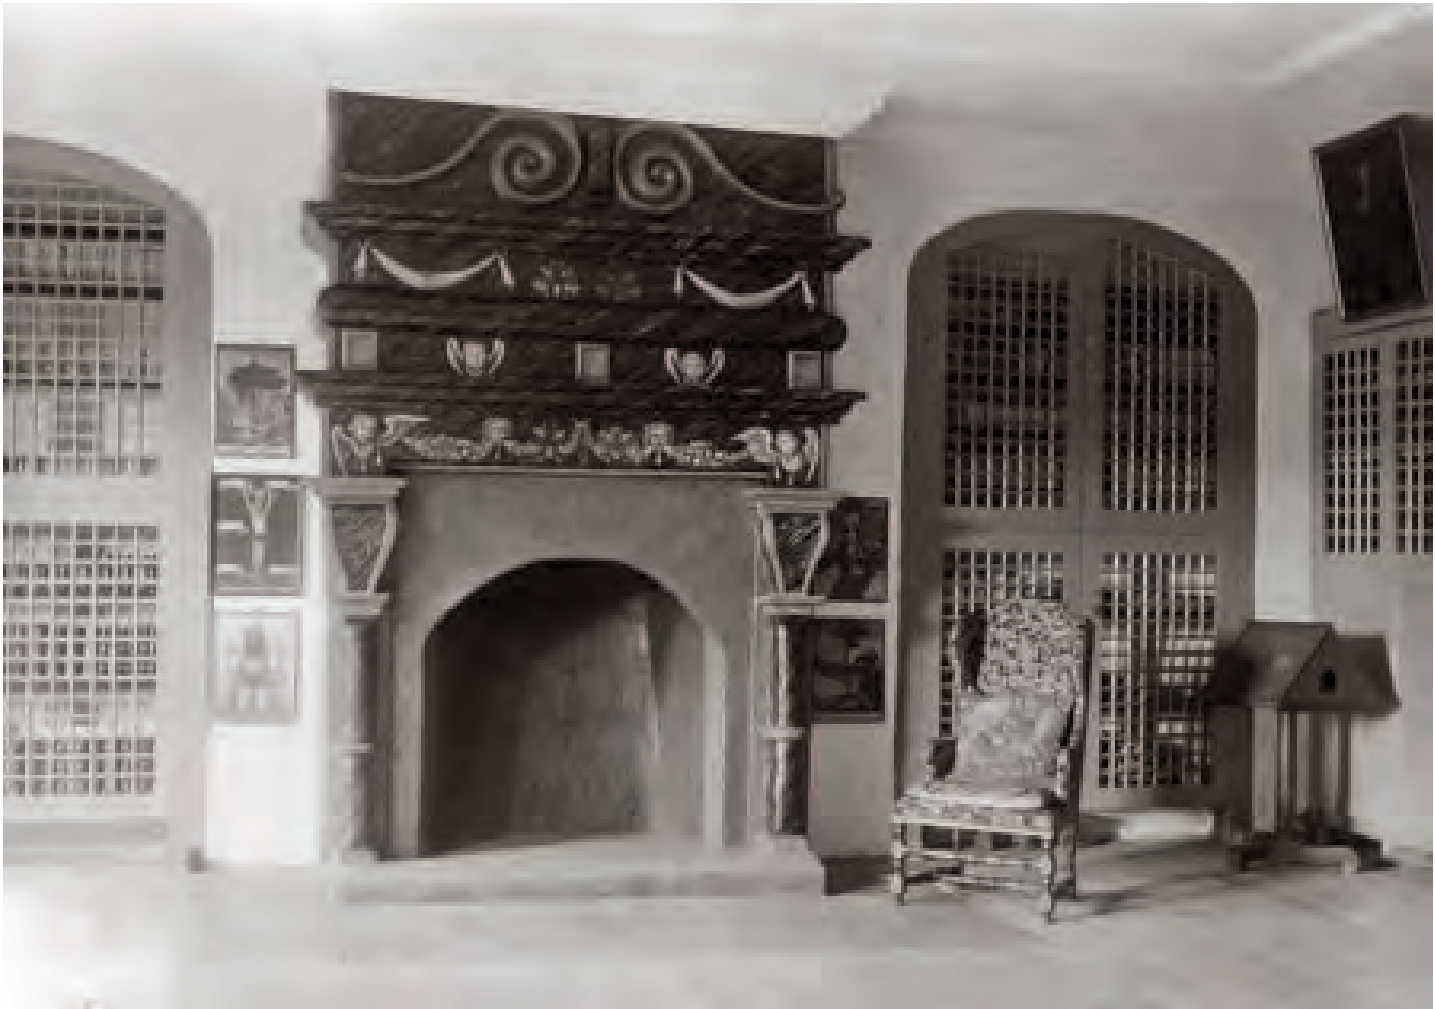
The library at Jomfruklosteret, 1901. The collection fills a total of 104 shelf metres, of which the manuscripts fill approx. 11 metres.¹³ The books had always been stored in the closed book cabinets attached to the walls; two of these cabinets have been preserved. It must have been humid in the cabinets, because in the mid-1880's the books were moved to free-standing racks with open shelves in the middle of the room.¹⁴ They may have been moved to an adjacent room when this photo was taken.

The moisture was likely from the bricked-up windows behind the library’s book cabinets. In the 1880’s, most of the books were therefore placed on free-standing shelves and all of the doors, apart from the two doors in the west gable, were taken down and stored in the basement.
