The Arcade Room

Restaureringen af Jomfruklosteret

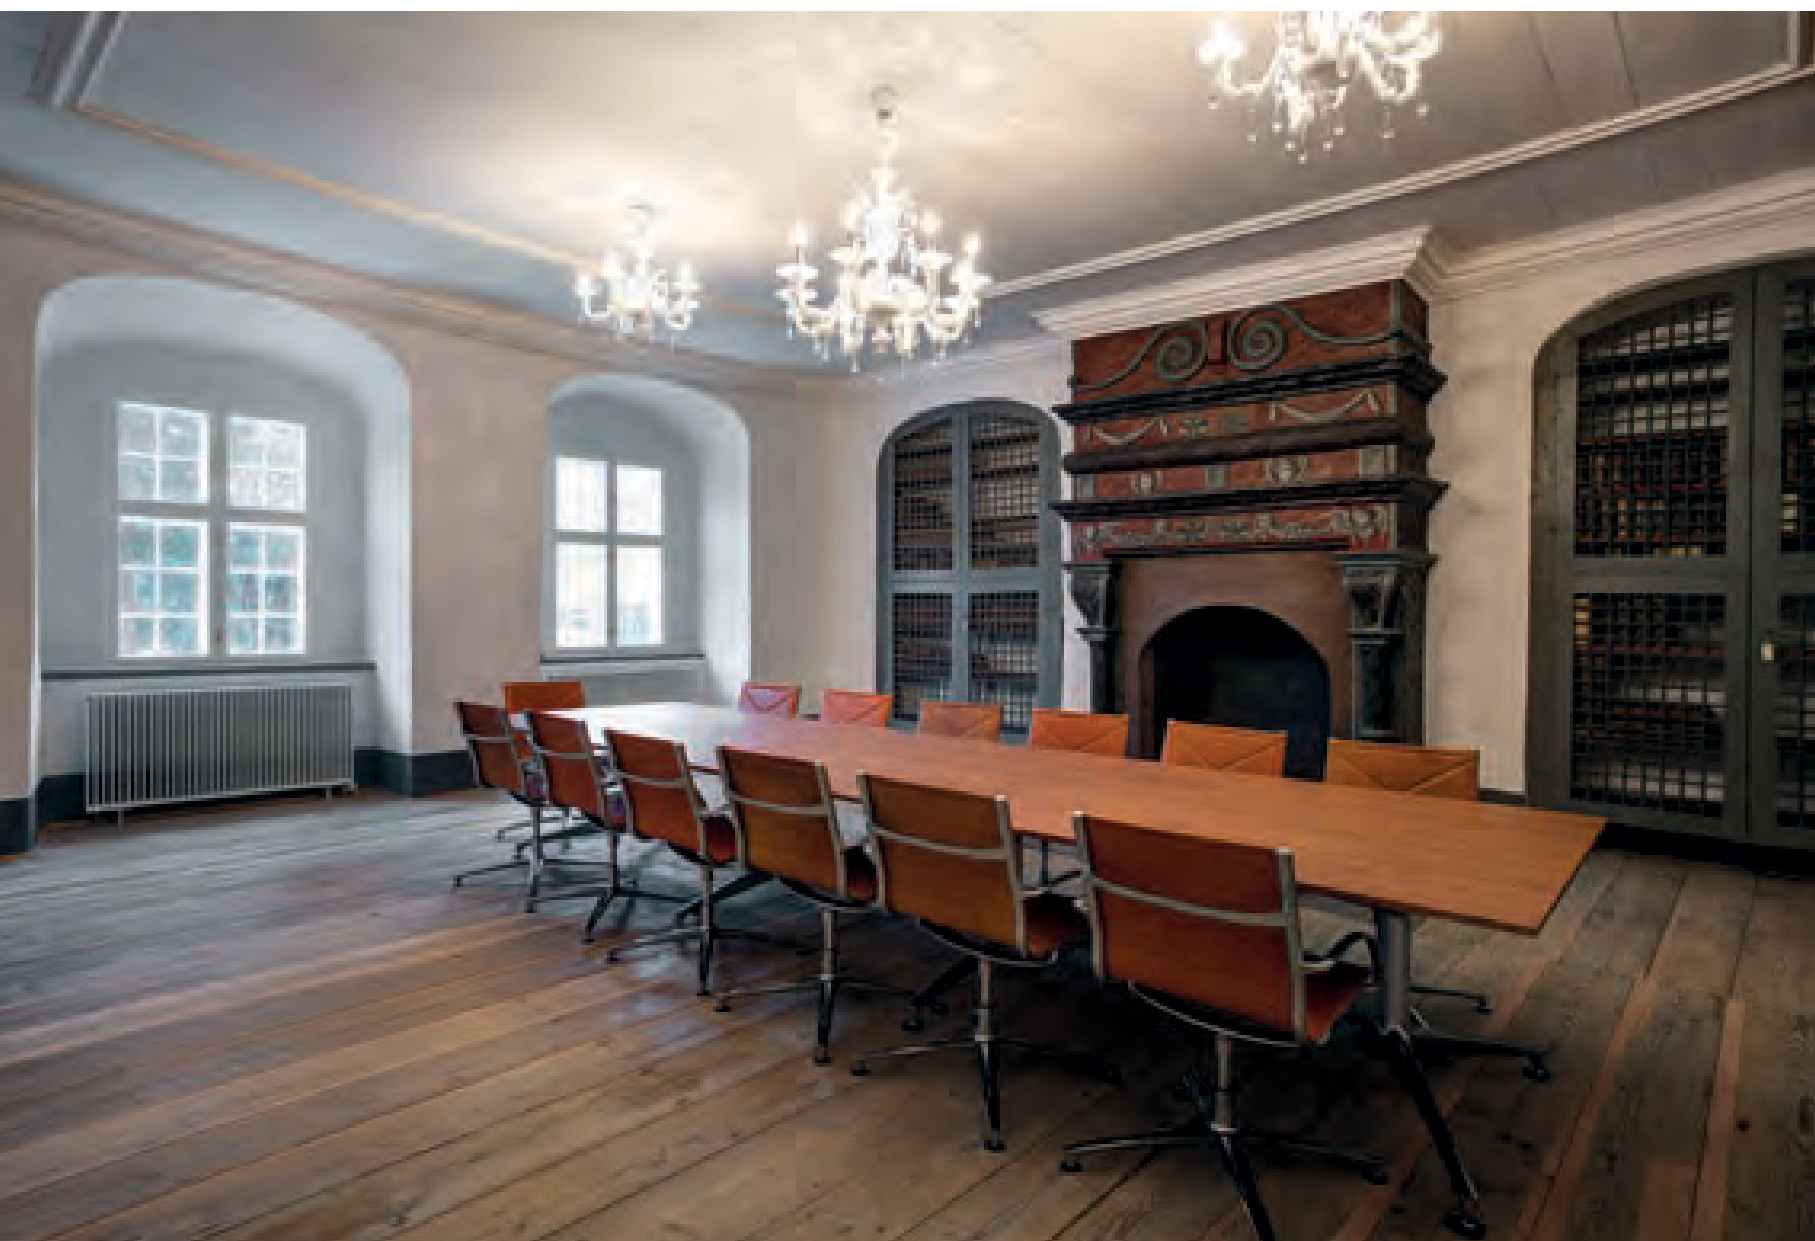
The Library, room 101, before the restoration. The room was given its current size after a smaller room was separated, most likely in the beginning of the 18th century, and has basically been untouched ever since. Only the colours have changed through the ages. Photo: Roberto Fortuna.

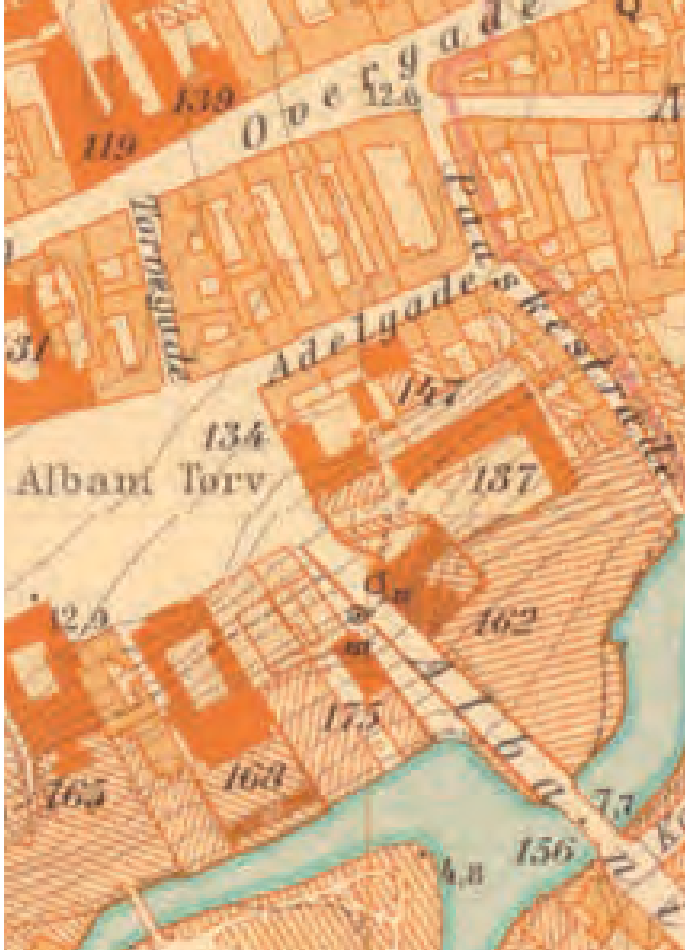
Contour map 1904: Ordnance map of Odense from 1904 shows the differences in height before the building of Albani Church and Thomas B. Thriges Gade. North of the main building, the terrain rises steeply to Adelgade, while Paaskestræde clearly follows a hollow with a gentler gradient. City of Odense Museums.

The ground conditions in the investigated area are currently characterised by a steep gradient from north to south, falling towards the river. In the middle ages, this gradient was presumably even more marked, as a certain amount of levelling has probably since taken place. The subsoil consists of a moraine deposit of mainly yellow clay, currently cut into distinct terraces with no traces of original surfaces.²

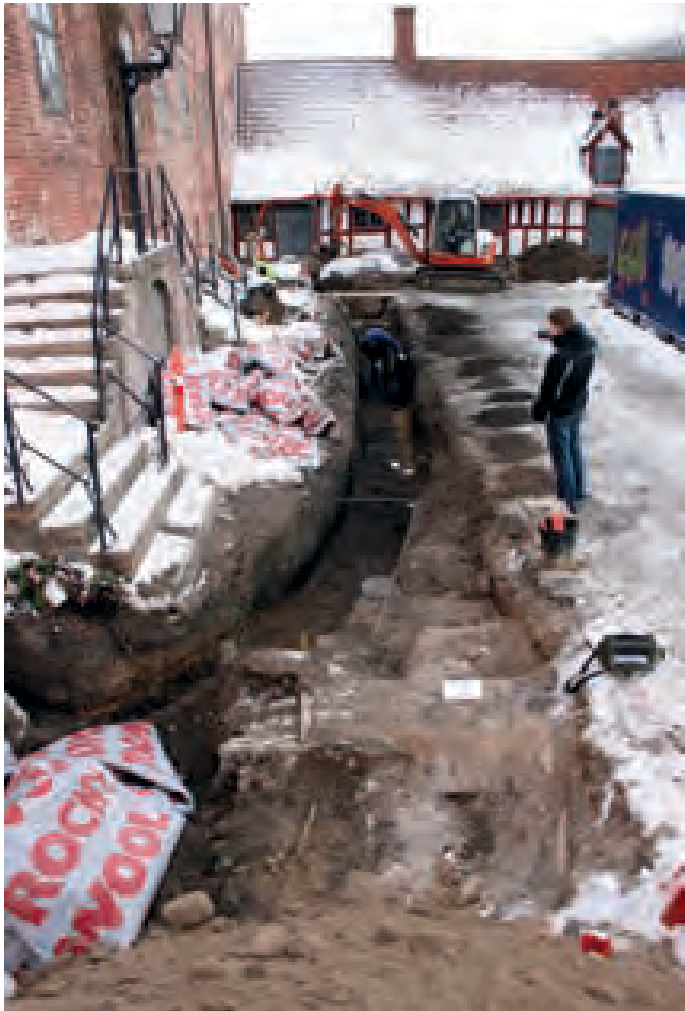
Investigation of the east-west trench in the courtyard. The archaeologist is recording one of the dark pits containing smithy waste, while the client's consultant is recording the archaeologist. City of Odense Museums.

Of more interest were a couple of pits half way along the main building, in which the infill was almost black. These contained large amounts of charcoal and smithy slag – waste from smithing activity and other rubbish. Among this were several grey fragments of the Middle Ages' everyday earthenware, dating the contents to the period 1250-1450. The pits themselves must represent a clearance of the area, the holes being dug to dispose of the refuse. Of the actual smithy, no traces were found. Presumably the ground levels were drastically altered when the present buildings were constructed. Even so, the very fact that the location was used for smithing, a source of both smoke and fire risk, would seem to indicate that the main bishop's palace building prior to 1450 did not lie in the same location as Beldenak's.

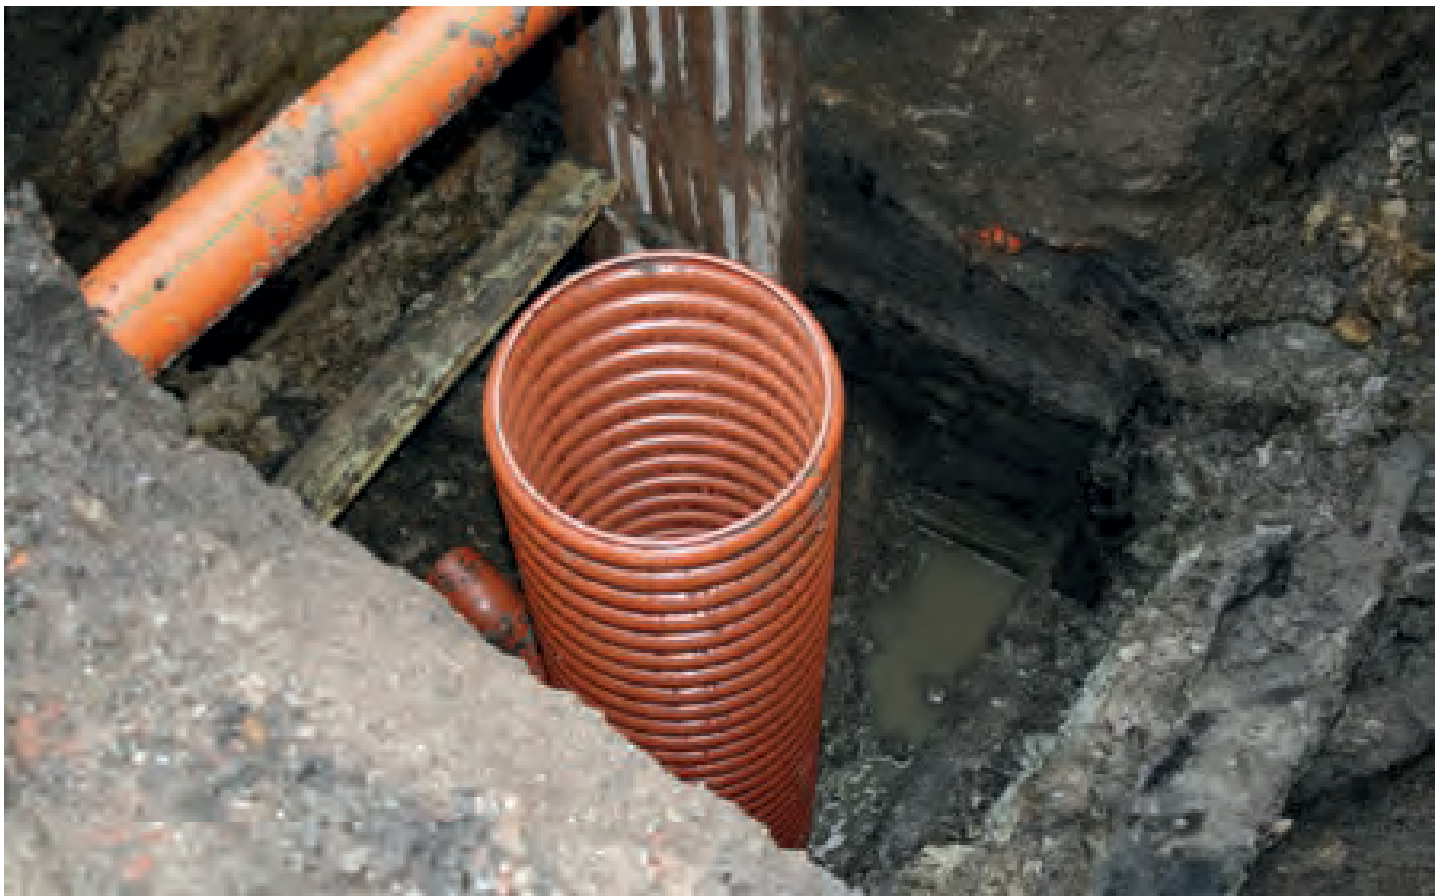
Ny i gammel. Den moderne brønd blev ved et tilfælde sat lige ned i den gamle, som det lykkedes at bevare. Odense Bys Museer.

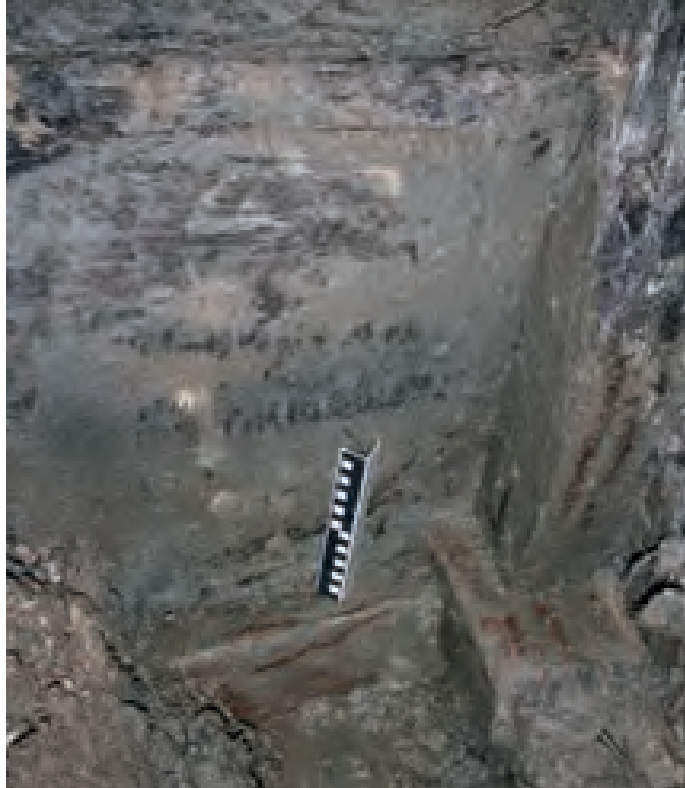
Den ældre brønd fra o. 1300 var utrolig velbygget med fodremme og øverst i billedet tværstivere mellem stolperne. Siderne bestod af kløvede egeplanker. Odense Bys Museer.

The older well from about 1300 was extremely well-built with sill beams and, at the top of the photo, bracing between the posts. The sides consisted of split oak planks. City of Odense Museums.

His building was the first on the site, but a solidly built well from about the year 1300 just to the north indicates that prior to this the main buildings of the bishop's palace may have lain immediately to the north, facing Adelgade.

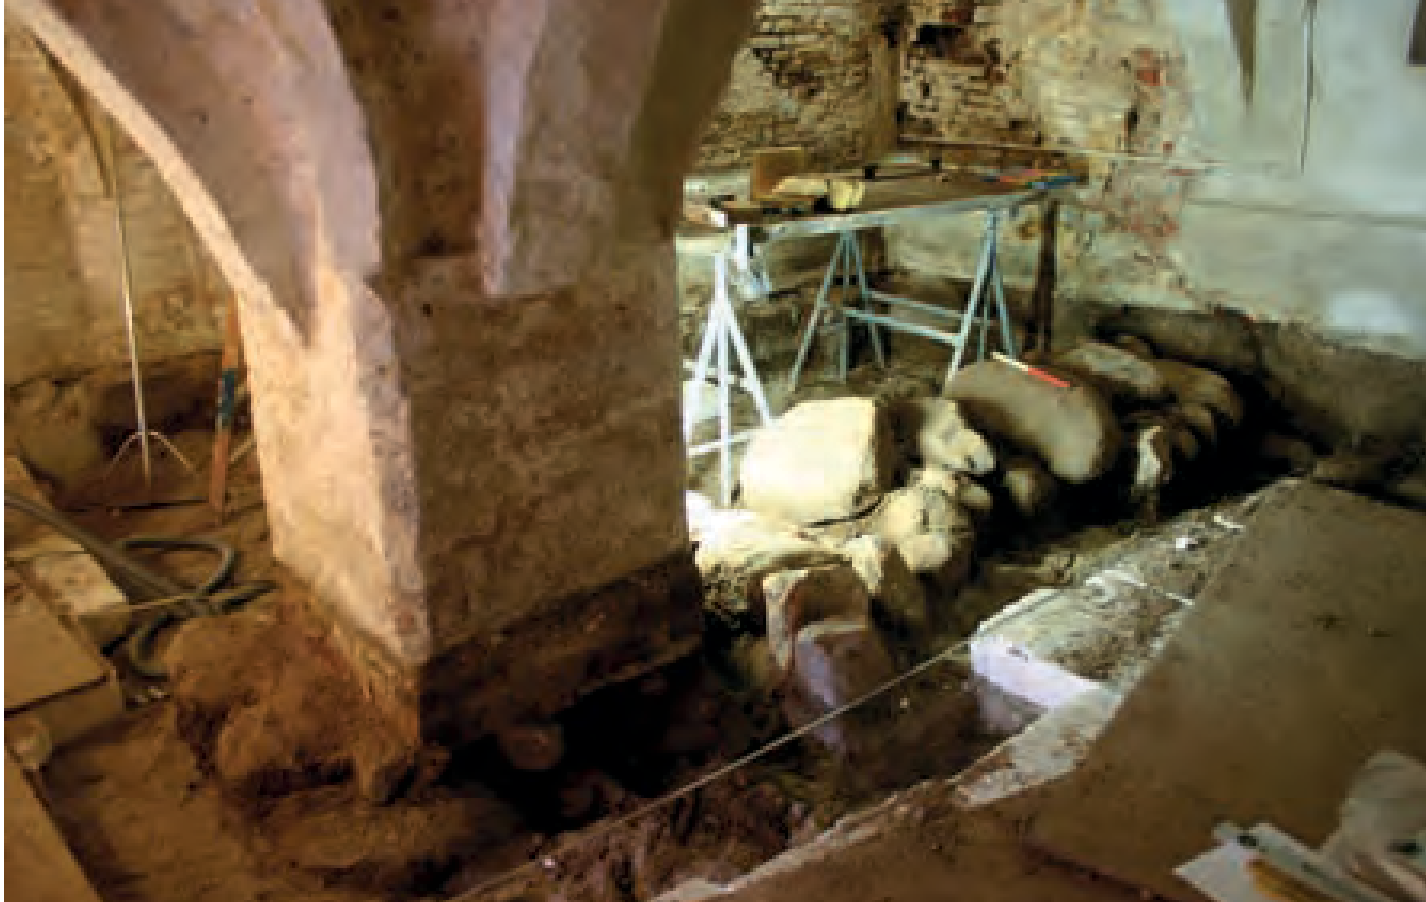
I det mindre kælderrum stod hvælpillen på et regulært fundament. Det tilstødende fundament stammer formentlig fra et stort ildsted i tilknytning til skorstenen, som er under reparation bagest. Odense Bys Museer.

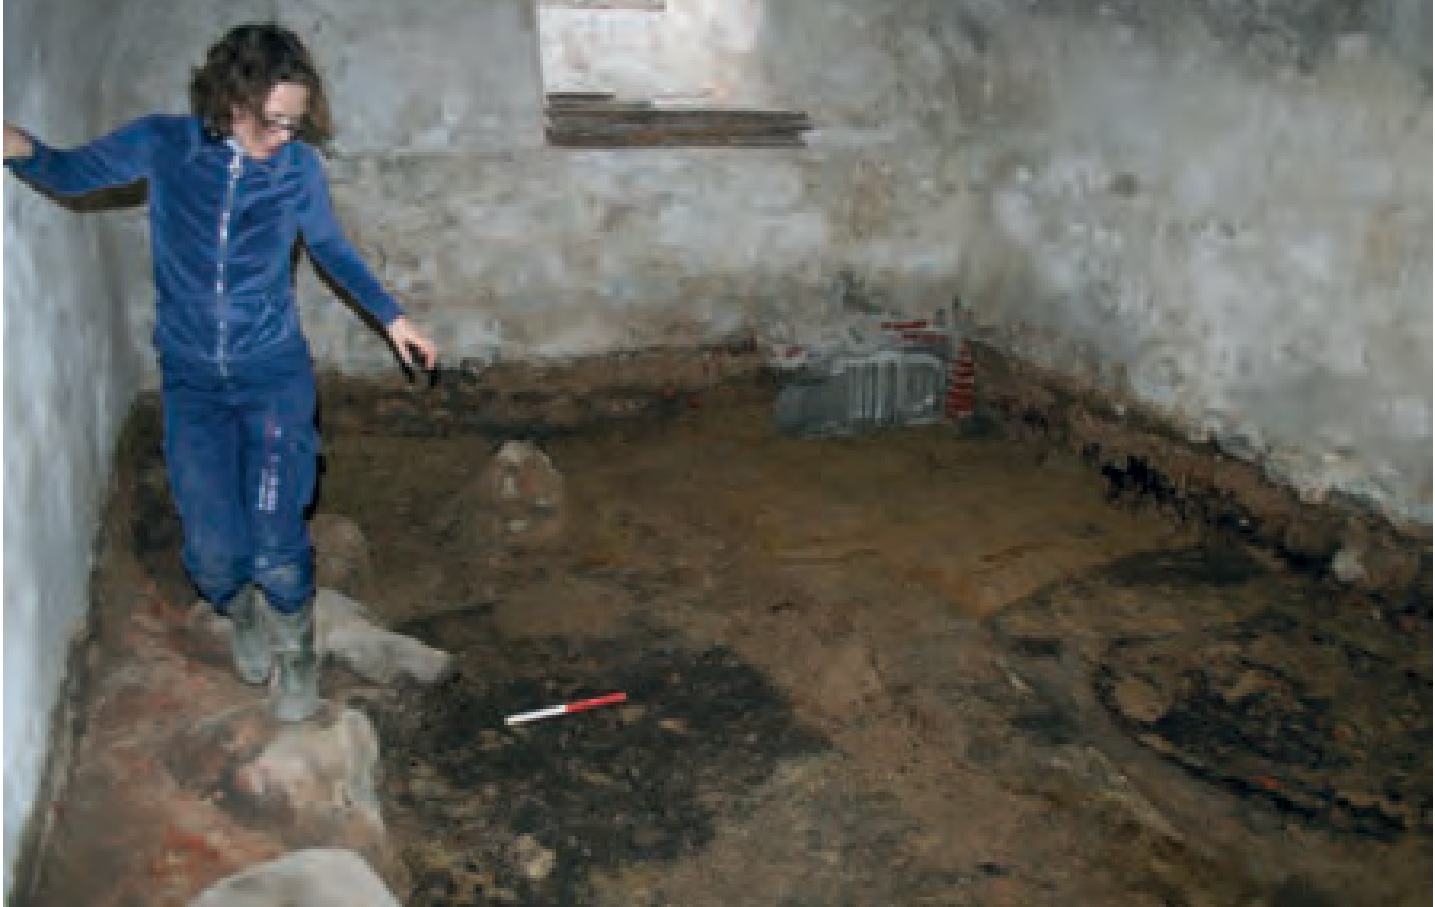
Arkæologen balancerer på fundamentstenene fra den oprindelige østgavl for at undgå at træde på de ældre nedgravninger med den mørke fyld i det tidligere anretterkøkken. Odense Bys Museer.

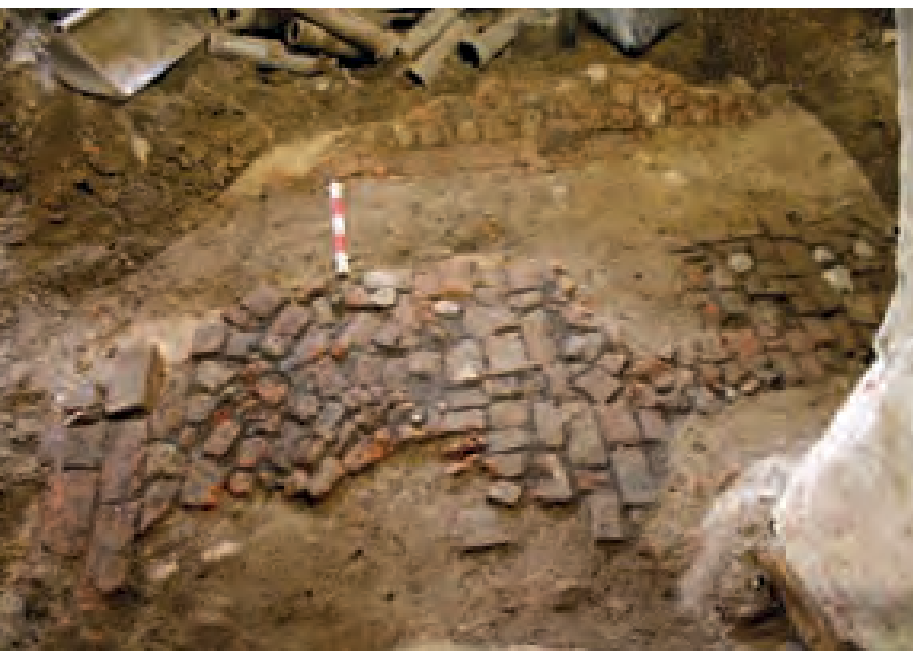
*Detalje af teglstensgulvet med to render af hele sten.
Odense Bys Museer.*

*Detail of brick floor with two gutters in whole bricks.
City of Odense Museums.*

But, in fact the floor proved to be *older* than the surrounding house from 1504-1508! The brick floor and underlying sand layer had clearly been cut through by the excavations for the foundations for the vault pillar and the partition wall. As the floor could scarcely have been outdoor paving, the floor must stem from an older building. Unfortunately, no datable finds were present in the humus layer above the floor or in the underlying sand layer. The floor is dated to the 14th or 15th century and is probably a remnant of Mogens Krafse's bishop's palace mentioned in 1466.

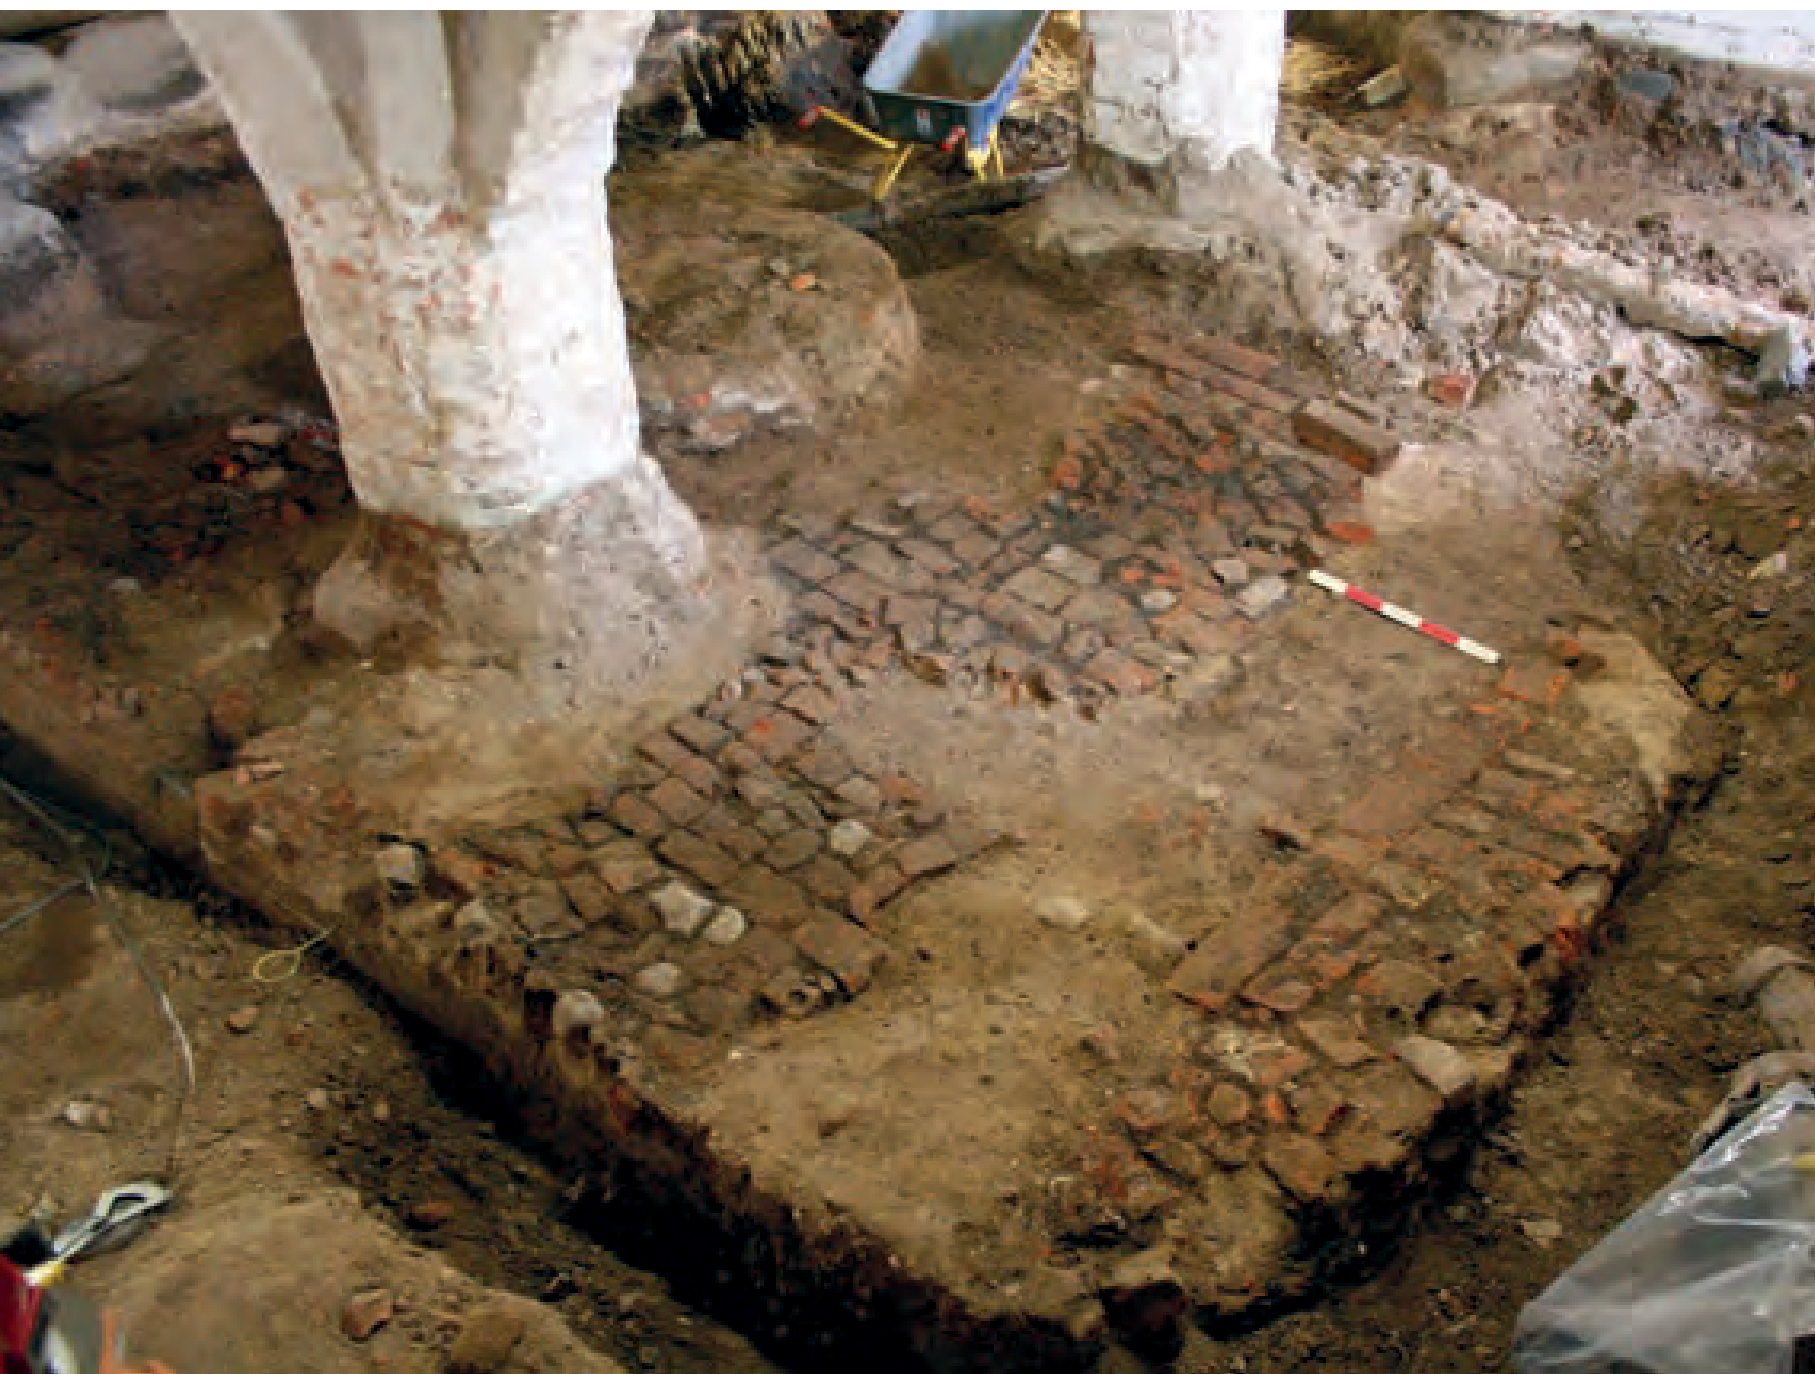
Teglstensgulvet fra den nedrevne bygning. De manglende teglsten under målestokken skyldes en nyere nedgravning til rør. Den højre kant af brolægningen afgrænser den plyndrede fundamentsgrøft fra den tilhørende bygning. Odense Bys Museer.

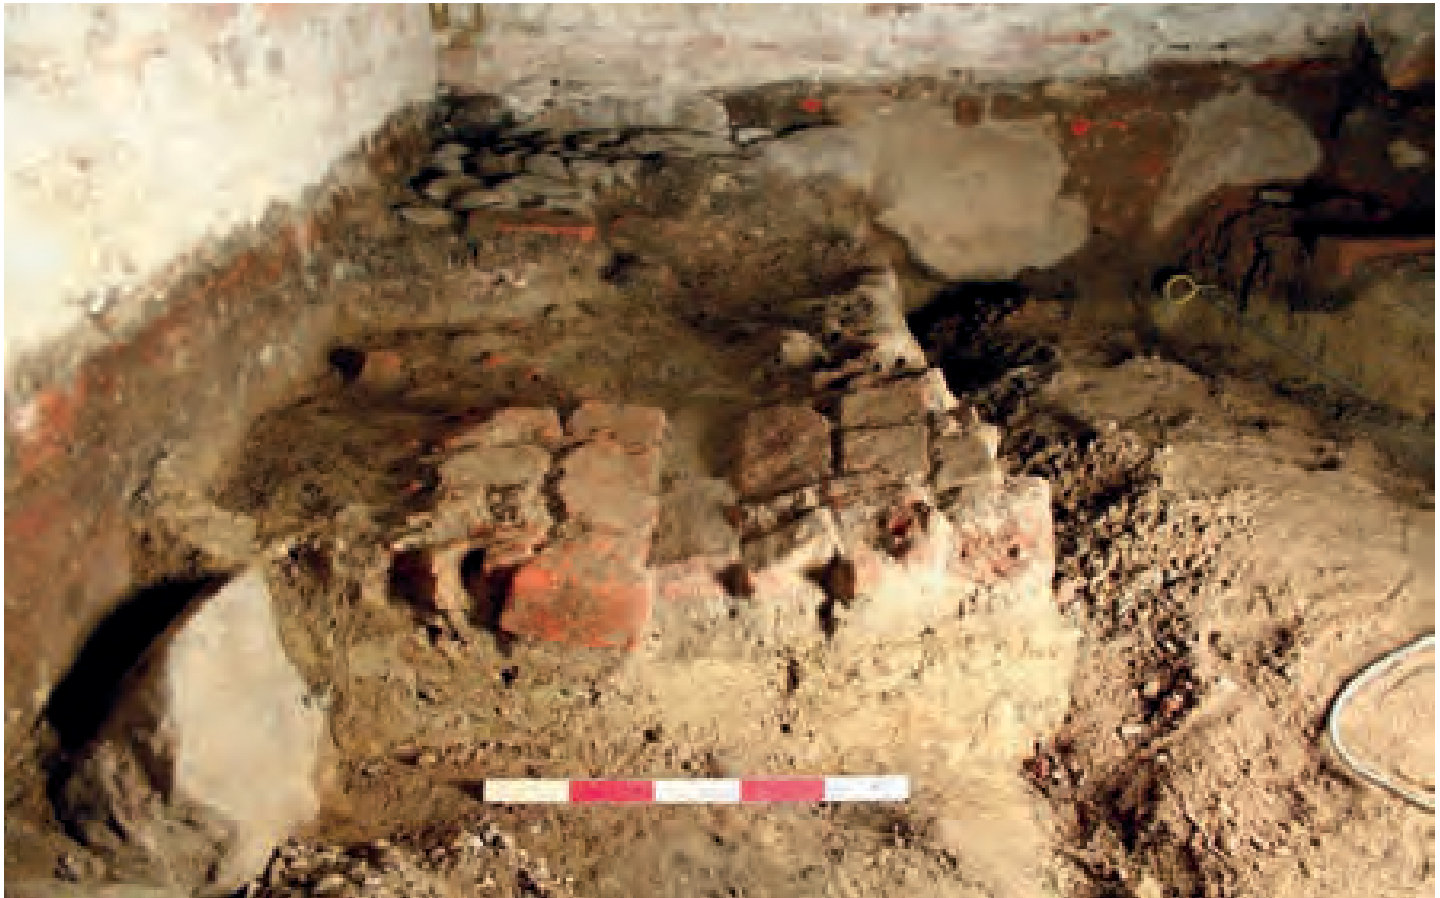
To kældergulve – to bygninger. Snit gennem det ældste kældergulv. Når gulvet stopper lidt fra væggen, skyldes det, at den og fundamentstenen er gravet ned igennem det ældre gulv, som det ses omkring hovedet af sømmet. Op ad bagvæggen ses en rest af den brolægning, som hører til den stående bygning. Odense Bys Museer.

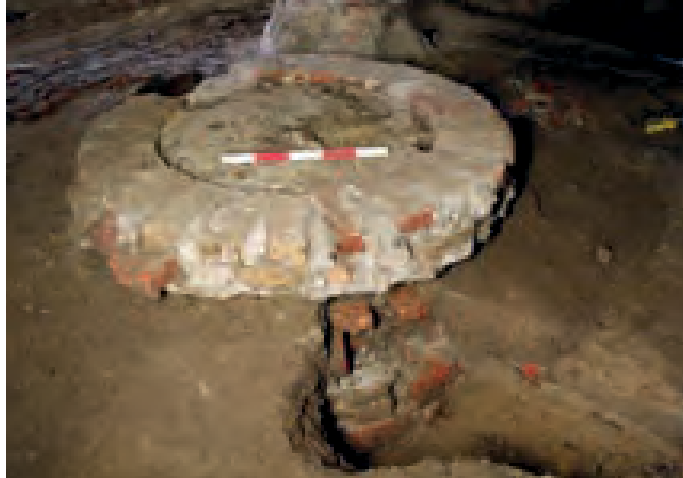
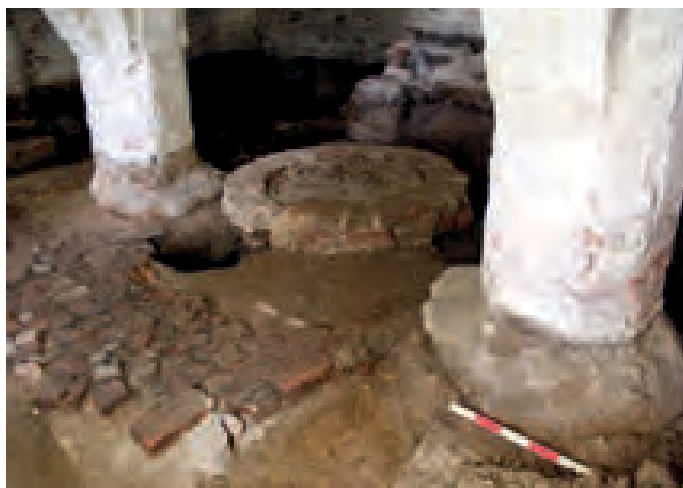
Øverst: Brønden i kælderen stammer formentlig også fra den ældre bygning. Den oprindelige middelalderlige brøndkarm i røde sten ses nederst. Nederst: Teglstensgulvet og brønden fra den ældre bygning. De fritstående hvælvpiller hviler hver på én stor kampesten. Odense Bys Museer.

Top: The well in the cellar is presumably also from Krafse's older building. The original medieval red-brick well curb can be seen at the bottom. Bottom: Brick floor and well from Bishop Mogens Krafse's older building. The free-standing vault pillars each rest on a single large boulder. City of Odense Museums.

The location very close to the foundation of one of the cross vault pillars (about 10 cm), could indicate that the well was established prior to the erection of the vaulting, and thus presumably belongs to the older building with the brick floor.

The infill in the well was sand and gravel at the top, but drilling showed that it was more organic and moist at the base, which lies a minimum of 170 cm below the top of the well curb. As with the brick floor, the well was also preserved, and is now visible in the form of a ring of bricks in the newly laid tiled floor.

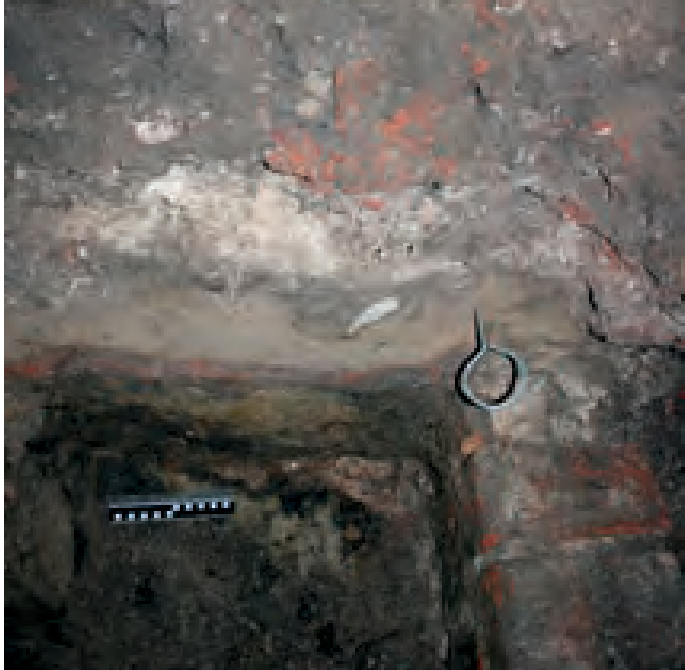
Østfløjens østmur set indefra. Under metaløjet ses det første i muren. Til venstre og over det ses et sandlag fra den plyndrede kælderbrolægning og her over igen kraftige nedbrydningslag med mørtel og teglstumper. Odense Bys Museer.

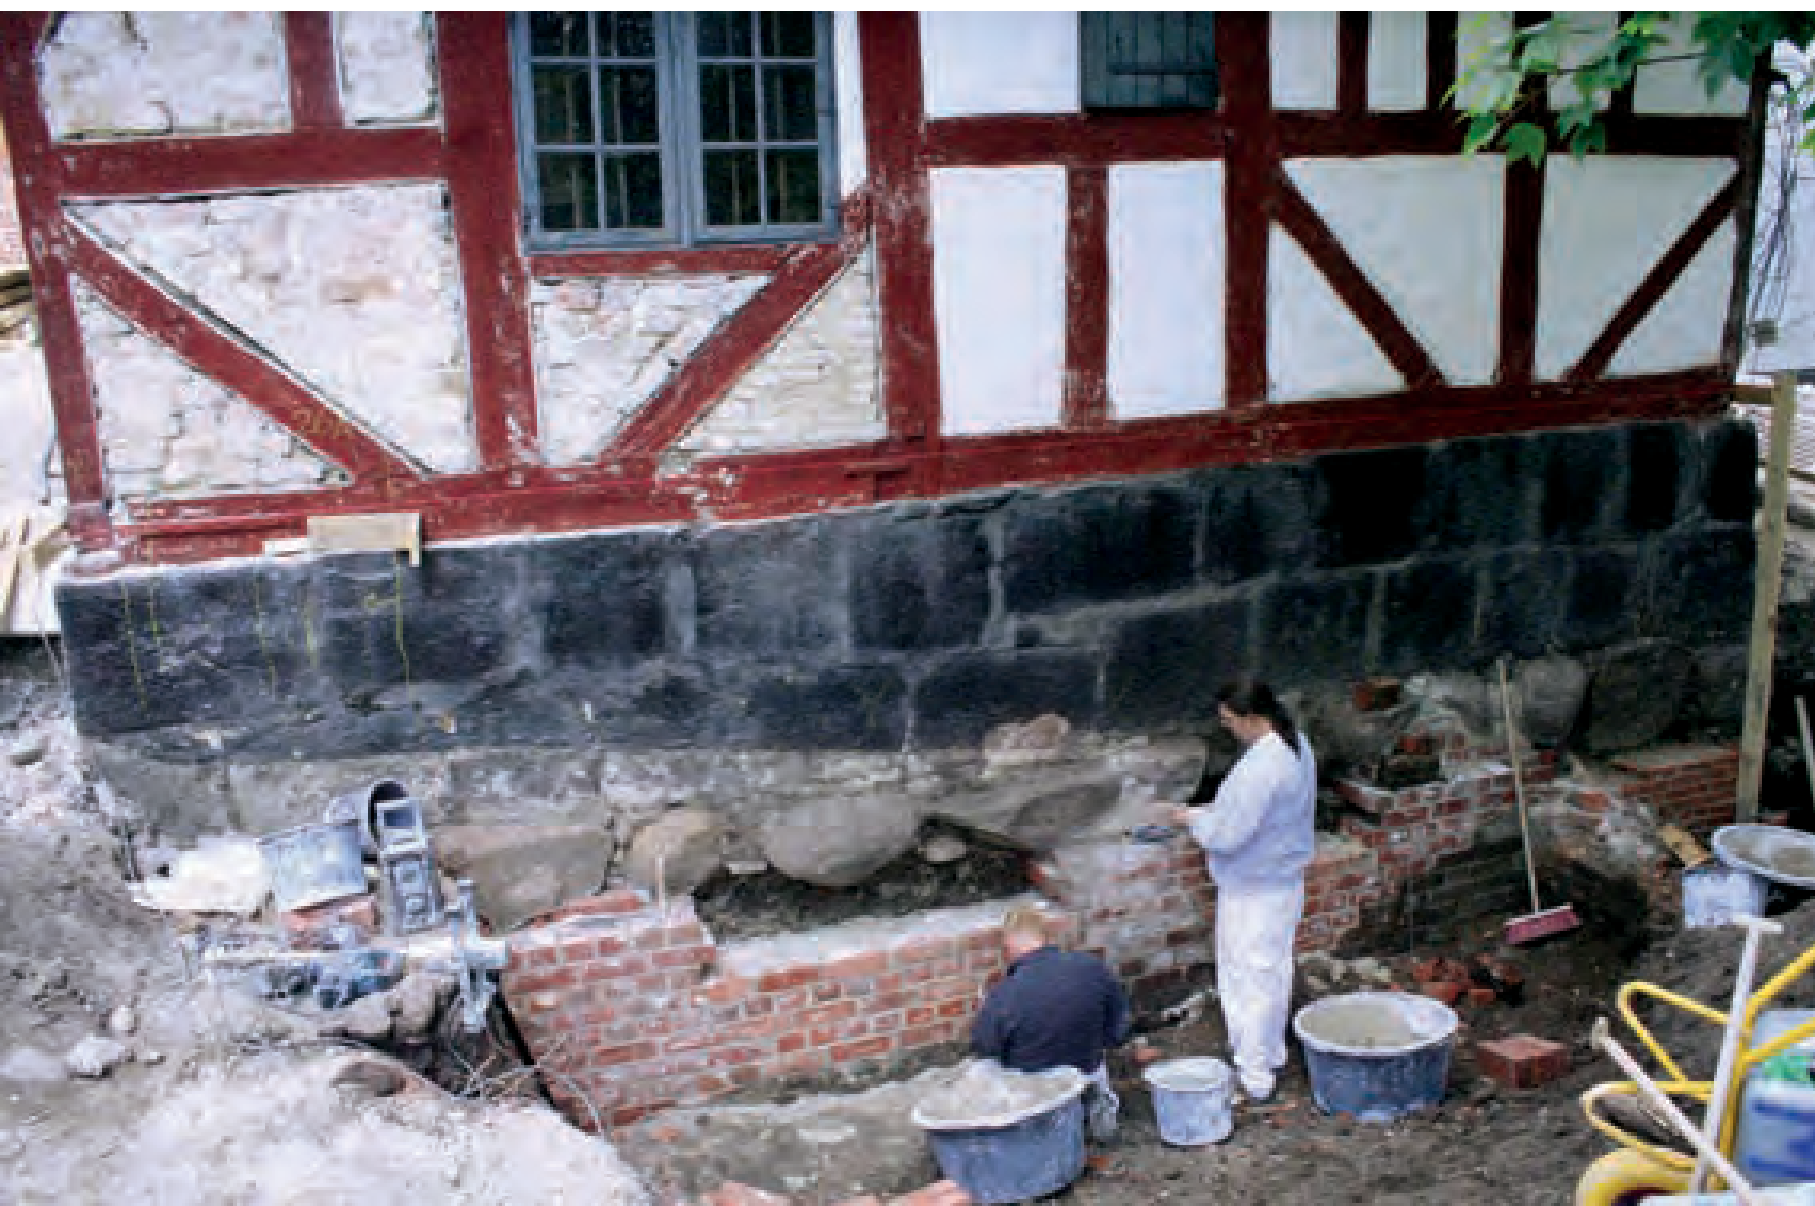
Den velbevarede mur i sydgavlen betød, at man i stedet for at understøbe den valgte at mure op fra den middelalderlige gavl. Et stykke af den ses som et mørkere stykke mur bag kosten. Odense Bys Museer.

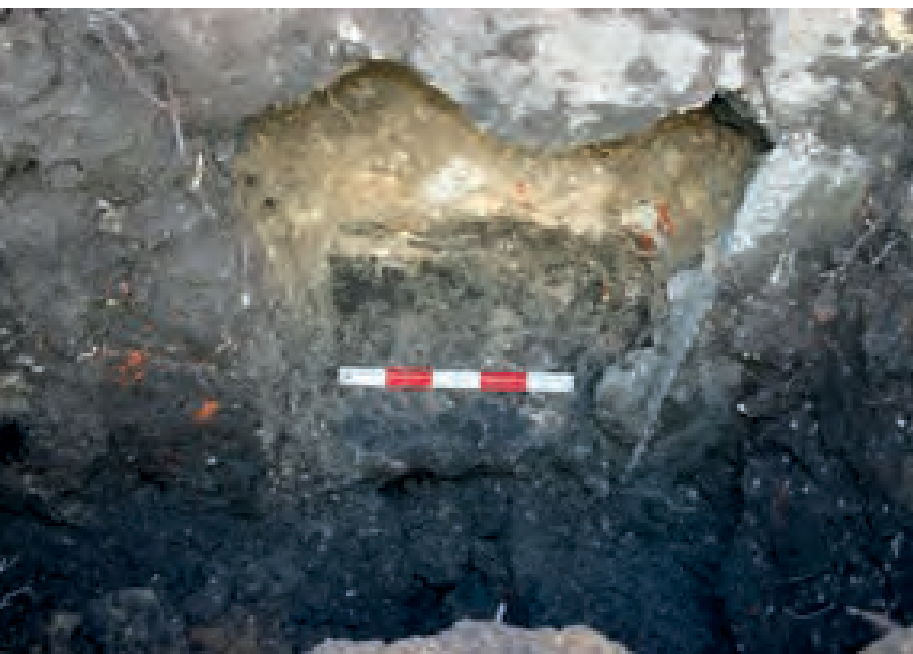
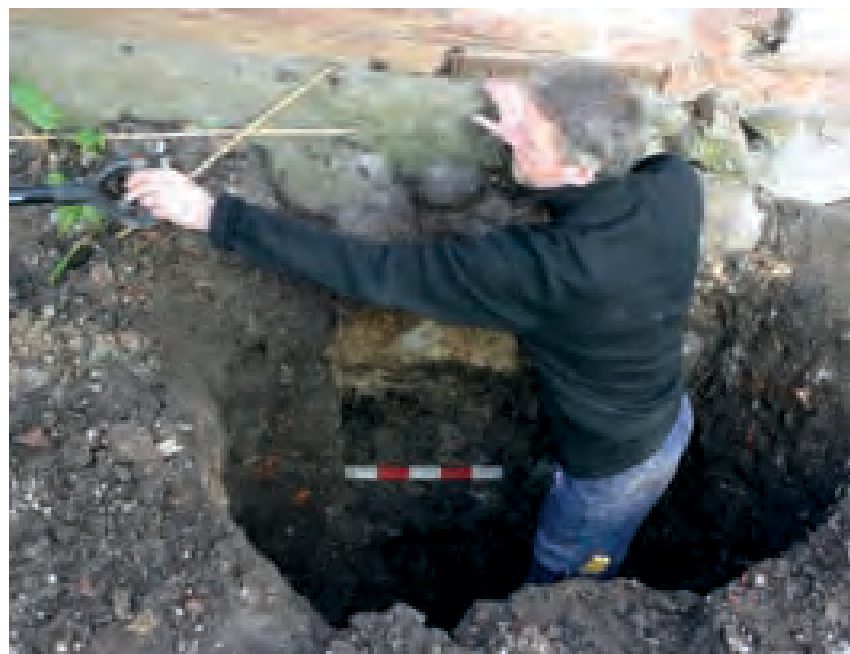
Th.: Der renses op til foto i et af hullerne til understøbning af bindingsværksfløjen.

Right: Cleaning out one of the underpinning holes in the half-timbered wing in preparation for photography.

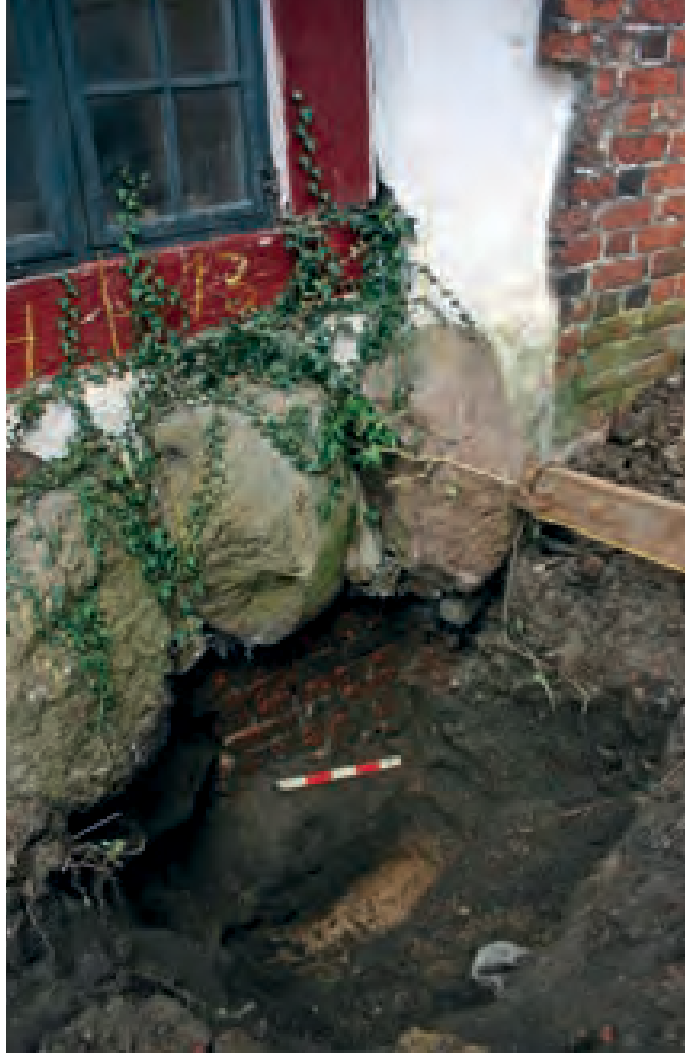
Nordøsthjørnet af østfløjen. Længst til højre gavlen af hovedbygningen og sammenføjningen med bindingsværksbygningen. De store sten under vinduet hører sammen med bindingsværksbygningen, mens murstykket nedenunder er indgået i bispegårdens port mod øst. Odense Bys Museer.

North-east corner of east wing. To the far right, the gable end of the main building and the junction with the half-timbered building. The large stones under the window belong to the half-timbered building while brickwork below was part of the east gate of the Bishop's Palace's original east wing. City of Odense Museums.

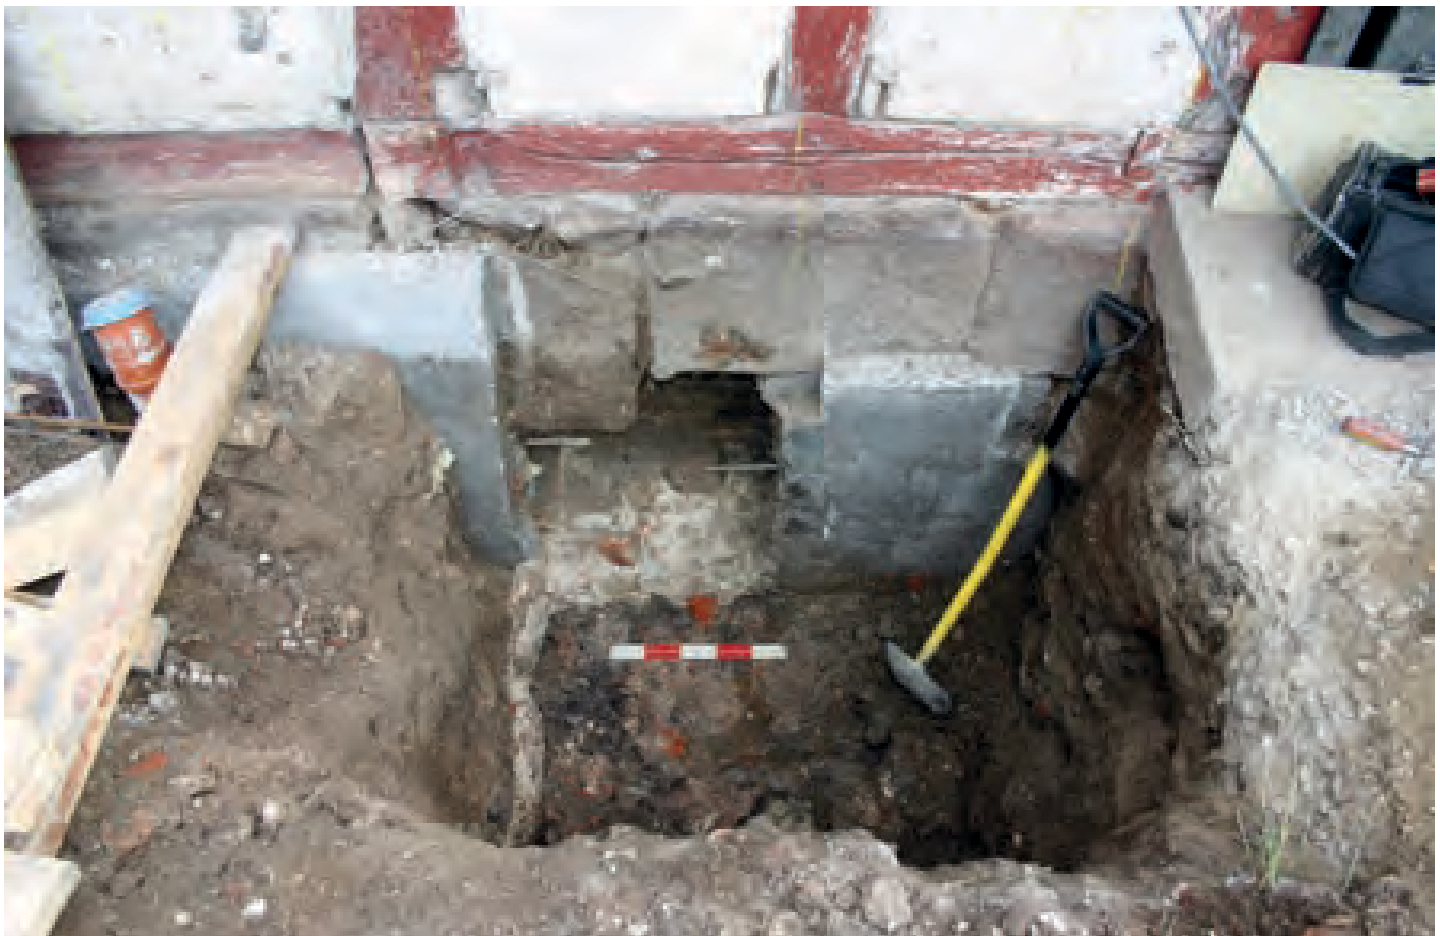
Funderingsprincipper 1. Understøbningen af bindingsværksbygningen foregik af hensyn til bygningens stabilitet i små bidder. Her mangler der kun et lille stykke mellem to færdigstøbte cementkanter. Det hele forbindes af armeringsjernene, som stikker ud af siderne. Odense Bys Museer.

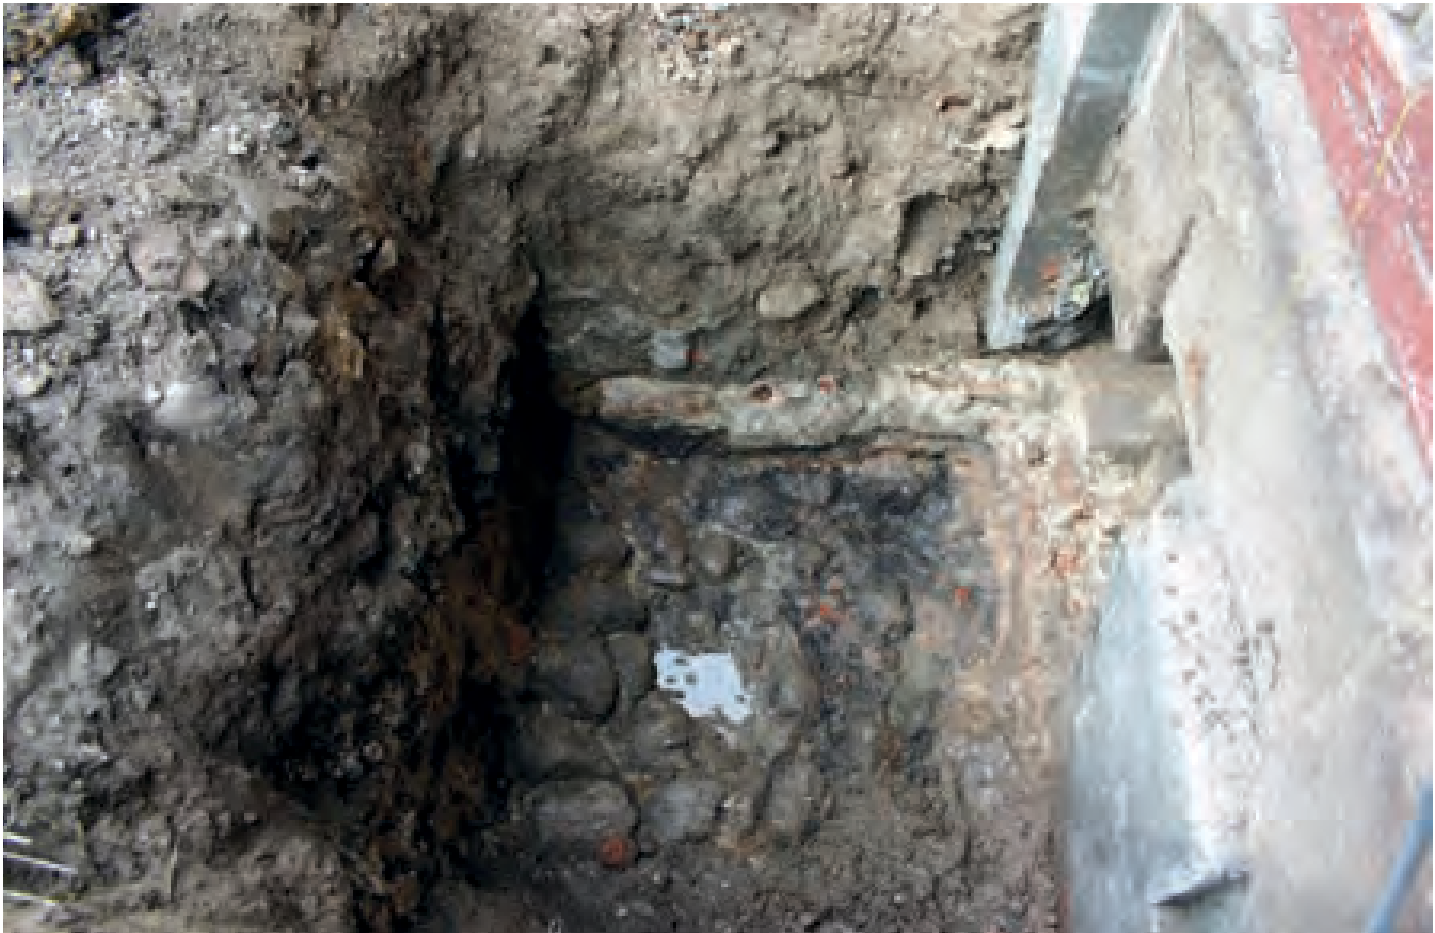
Samme sted ses princippet i det middelalderlige fundament på gårdsiden. På en bane af småstensbrolægning sættes i hver side en række kantstillede mursten, og mellemrummet udstøbes med en blanding af mørtel, teglbrokker og marksten. Til højre i billedet ses to bindere fra det første skifte i kasse-murens sider. Man fortsætter op i højden, samtidig med at "kassen" udstøbes. Odense Bys Museer.

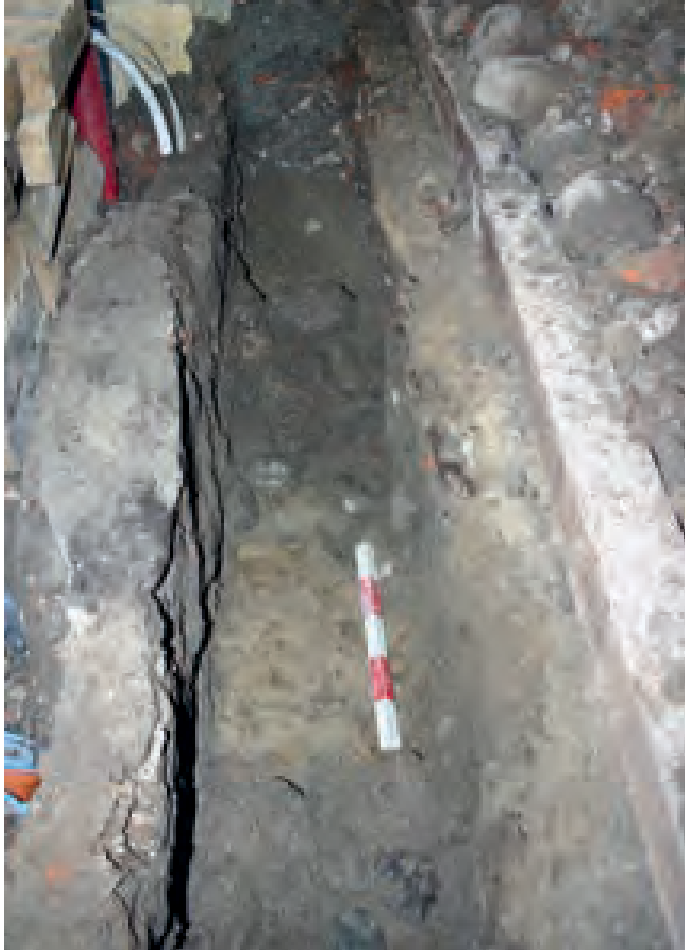
Brolægningen i østfløjens kælder var i vid udstrækning plyndret. Her ses nederst en rest af den gennemgående rende og under målestokken sandlaget under brolægningen. Odense Bys Museer.
