The Arcade Room

Restaureringen af Jomfruklosteret

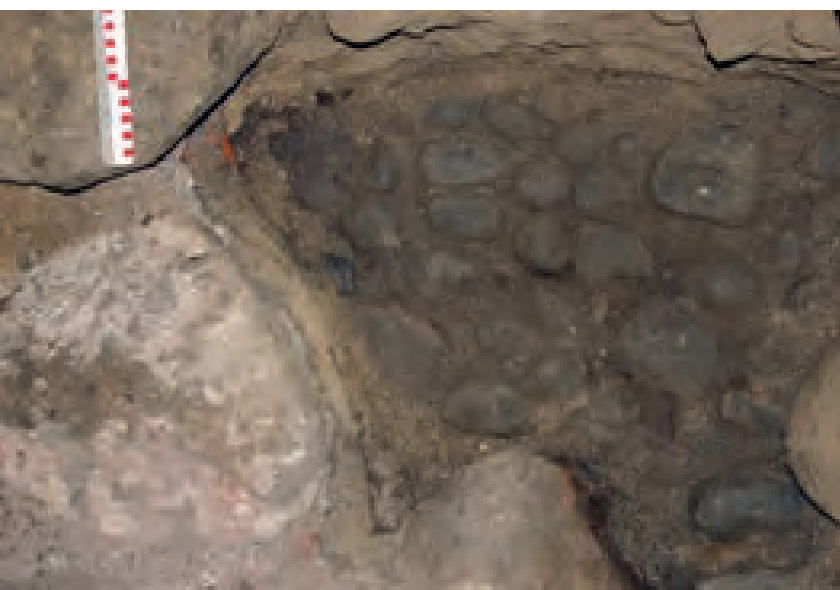
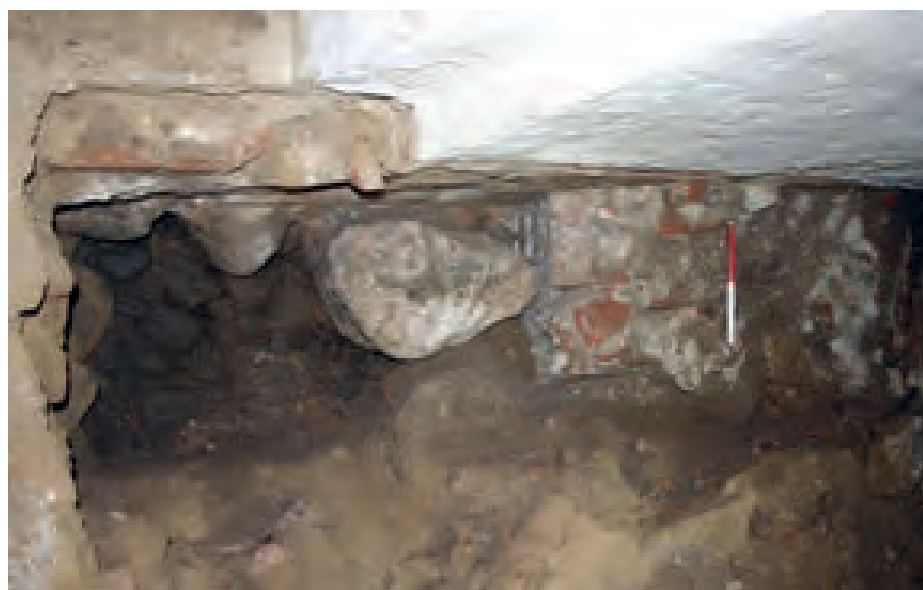
Tv.: Nordøsthjørnet af østfløjen. Brolægningen hører formentlig til portrummet i østfløjen. Den overlejres af flere marksten, som danner fundament for en skalmuring af østfløjens oprindelige nordgavl.

Left: North-east corner of east wing. The paving presumably belongs to the gate room in the east wing. It is overlaid by several field stones, which form the foundation for the facing of the original north gable end of the east wing.

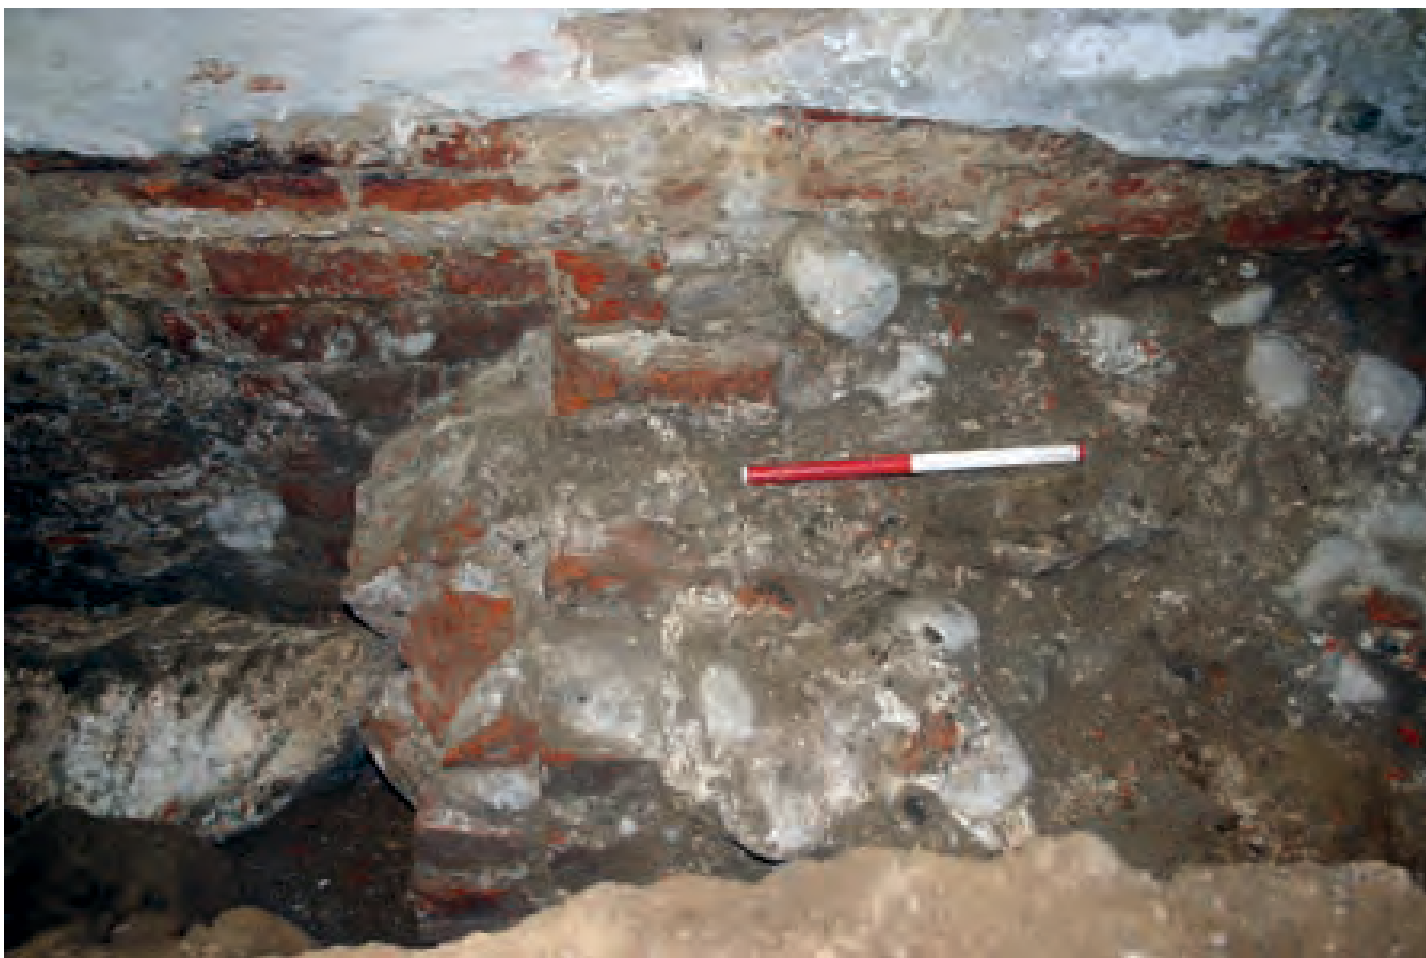
Den sekundære skalmuring forsætter bag om og oven over hvælvpillen og er formentlig i forbandt med ydermuren. Det var ikke muligt at fastslå uden indgreb i murene. Odense Bys Museer.

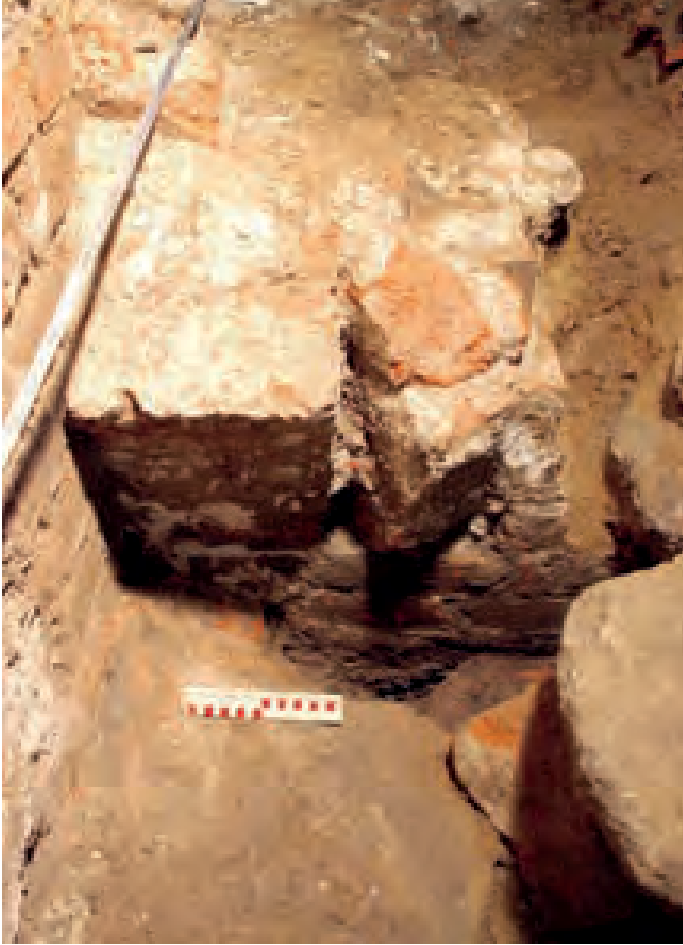
Nærbillede af hvælvpillen. Under målebåndet ses ansatsen til skjoldbuen, der har båret hvælvet langs væggen. Den skrå sten til højre herfor er ansatsen til en halvstensribbe. Odense Bys Museer.

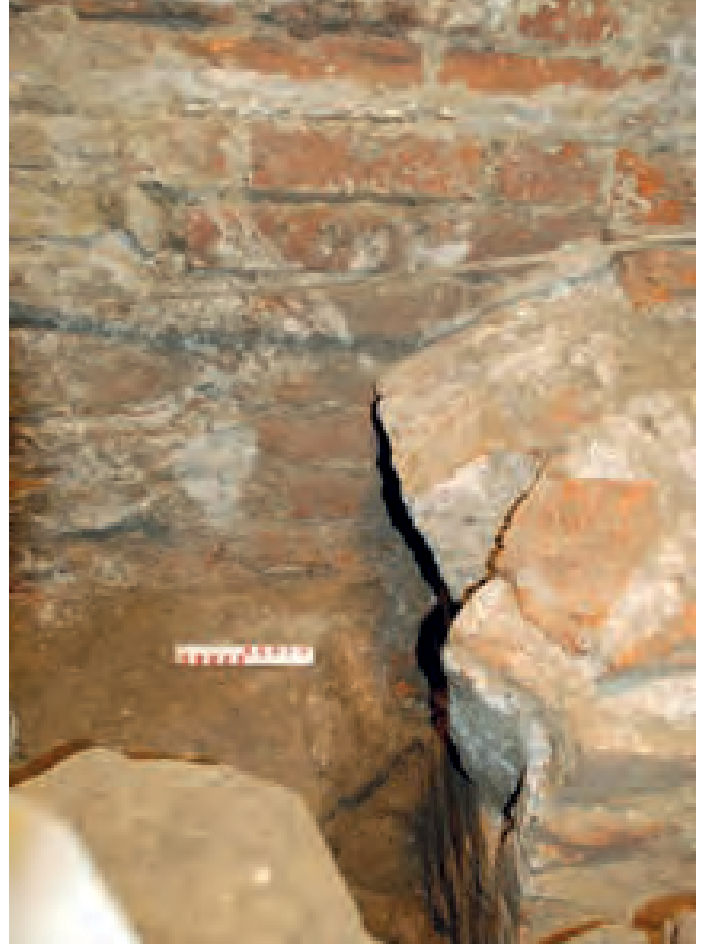
Nærbillede af hvælvpillen. Fortsættelsen af skjoldbuen ses af de manglende pudsrester. Odense Bys Museer.

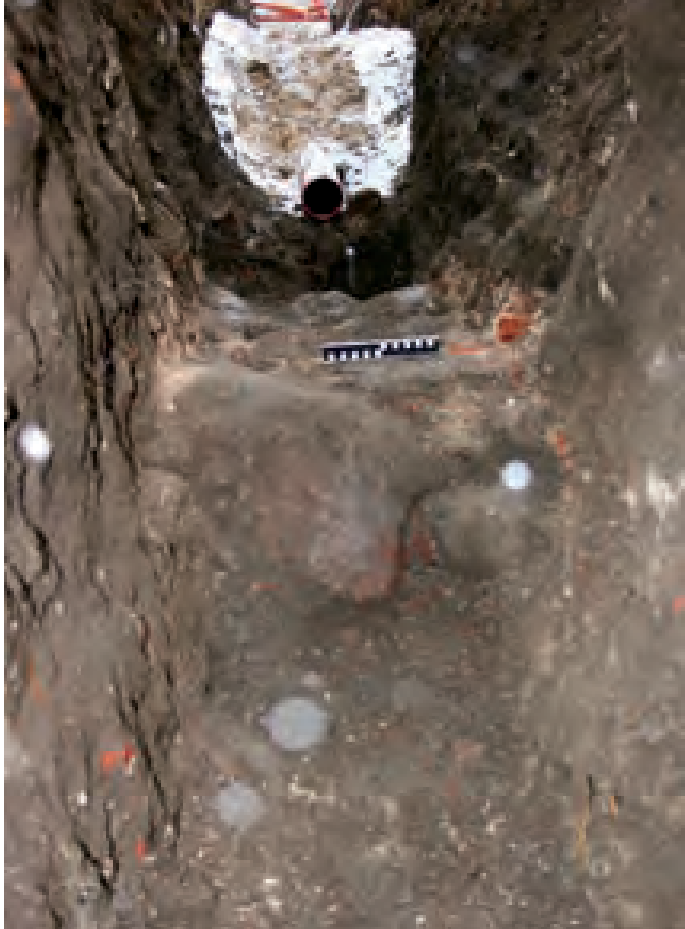
Nord-syd grøften på gårdpladsen skar dens oprindelige sydlige afgrænsning. Fundamentet til muren set fra ydersiden. Odense Bys Museer.

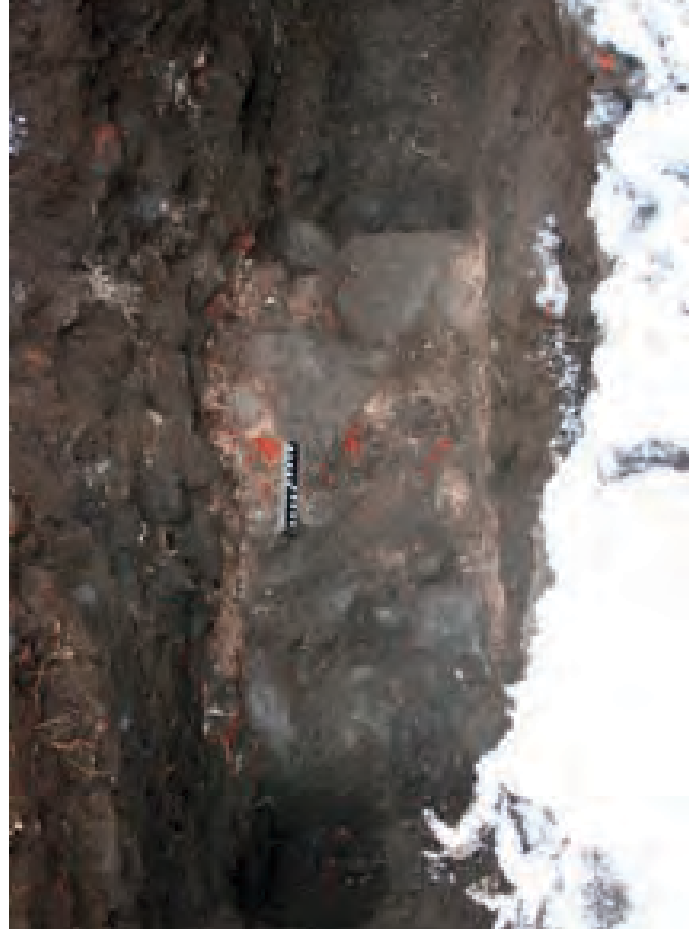
Samme set fra oven. Hen over fundamentet ses et tyndt nedbrydningslag. Havde der stået en sydfløj, havde man både forventet større mængder af nedbrydningsmateriale og spor af brolægning. Odense Bys Museer.

The same seen from above. Over the foundation can be seen a thin demolition layer. If there had been a south wing, larger quantities of demolition material would have been expected, together with traces of paving. City of Odense Museums.

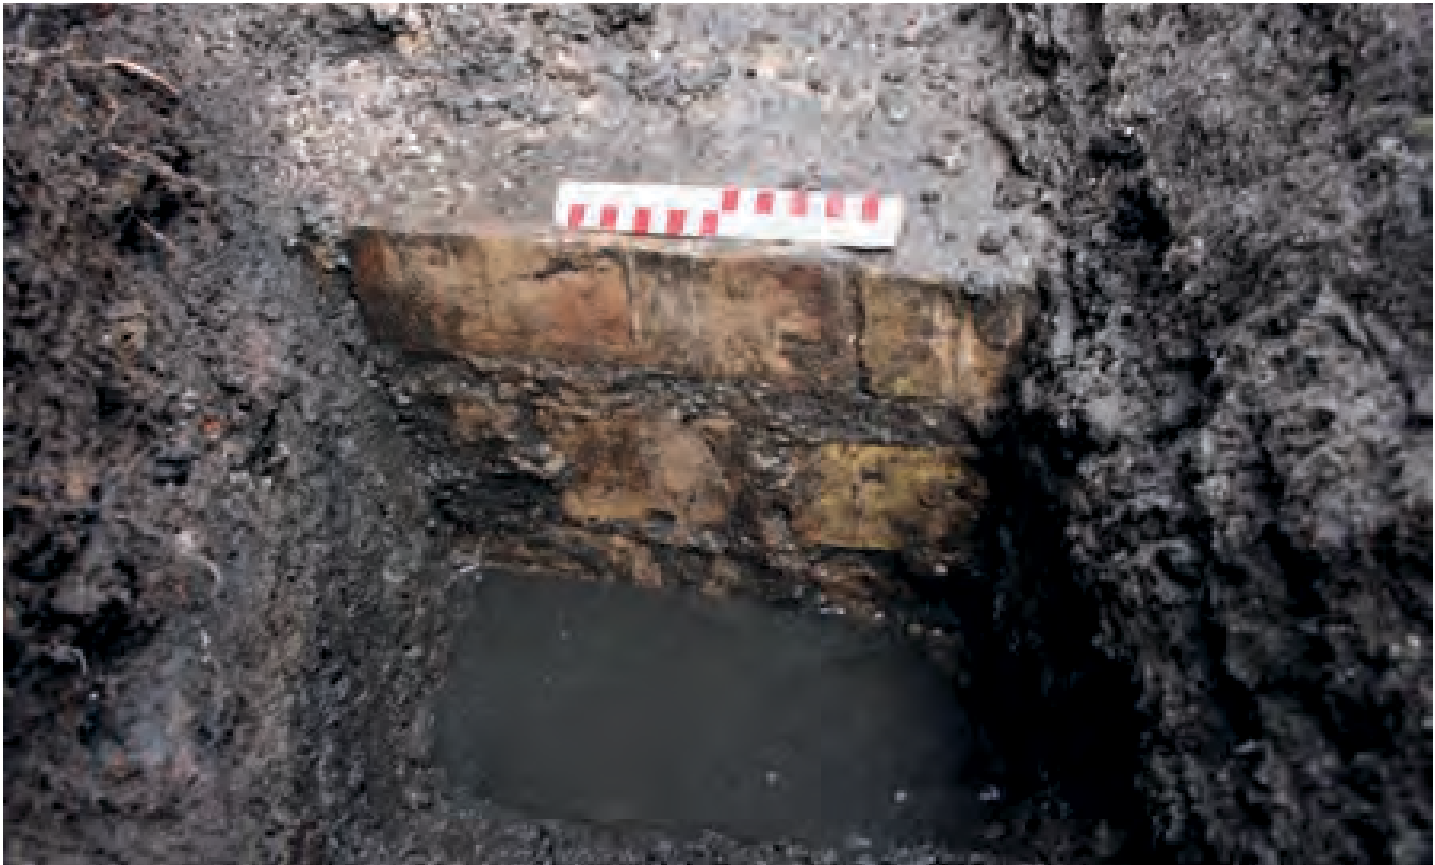
Fortsættelsen af østfløjens østmur godt 8 m syd for gavlen. De "ukurante" gule sten tyder på, at muren ikke har været synlig. Bemærk også de ubehandlede fuger i modsætning til hjørnet ved sydgavlen. Odense Bys Museer.

The continuation of the east wall of the east wing for more than 8 m south of the gable end. The inferior yellow bricks suggest that the wall was not visible. Note also the lack of finish on the joints, compared to the corner of the south gable end on the east wing. City of Odense Museums.

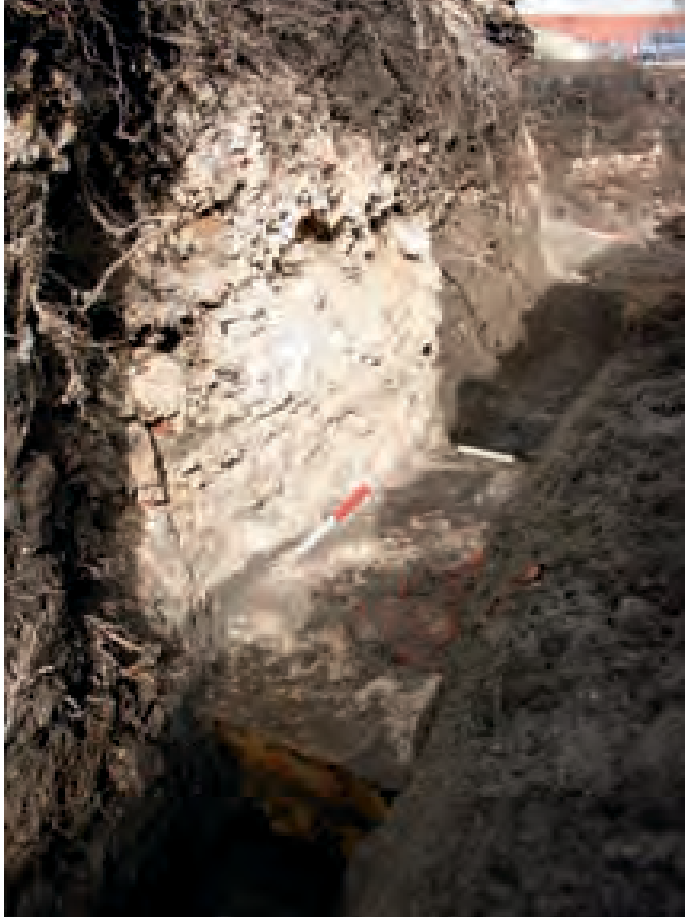
Fortsættelsen af østfløjens østmur godt 8 m syd for gavlen. De lyse nedbrydningsmaterialer afslører terrænhøjden ved murens nedbrydning. Odense Bys Museer.

The continuation of the east wall of the east wing for more than 8 m south of the gable end. The light-coloured demolition materials show the ground level at the time of the demolition of the wall. City of Odense Museums.

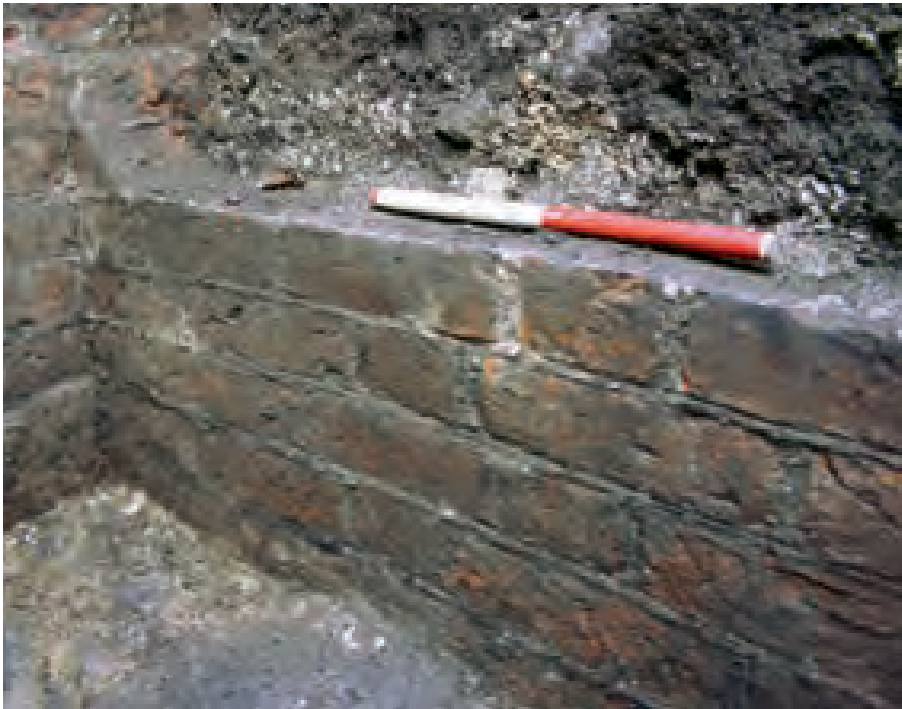
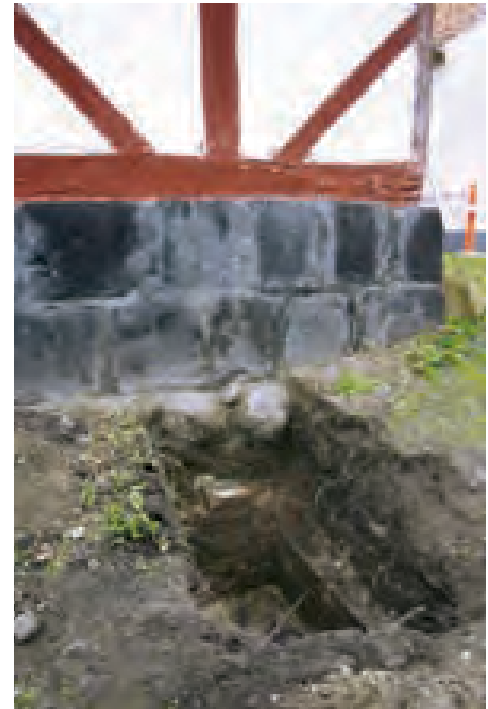
*Tv.: Østfløjens sydgavl og hjørnet ned mod åen.
Th.: Fortsættelsen af østfløjens østmur. Bemærk de fine
ryggede fuger.
Odense Bys Museer.*

*Left: The south gable end of the east wing and the corner closest
to the river.
Right: The continuation of the east wall of the east wing. Note
the finely finished joints. City of Odense Museums.*
